LAND AT MARKSBURY ROAD, BRISTOL

ARCHAEOLOGICAL EVALUATION

commissioned by The Environmental Dimension Partnership
on behalf of Linden Ltd & Homes and Community Agency

May 2016

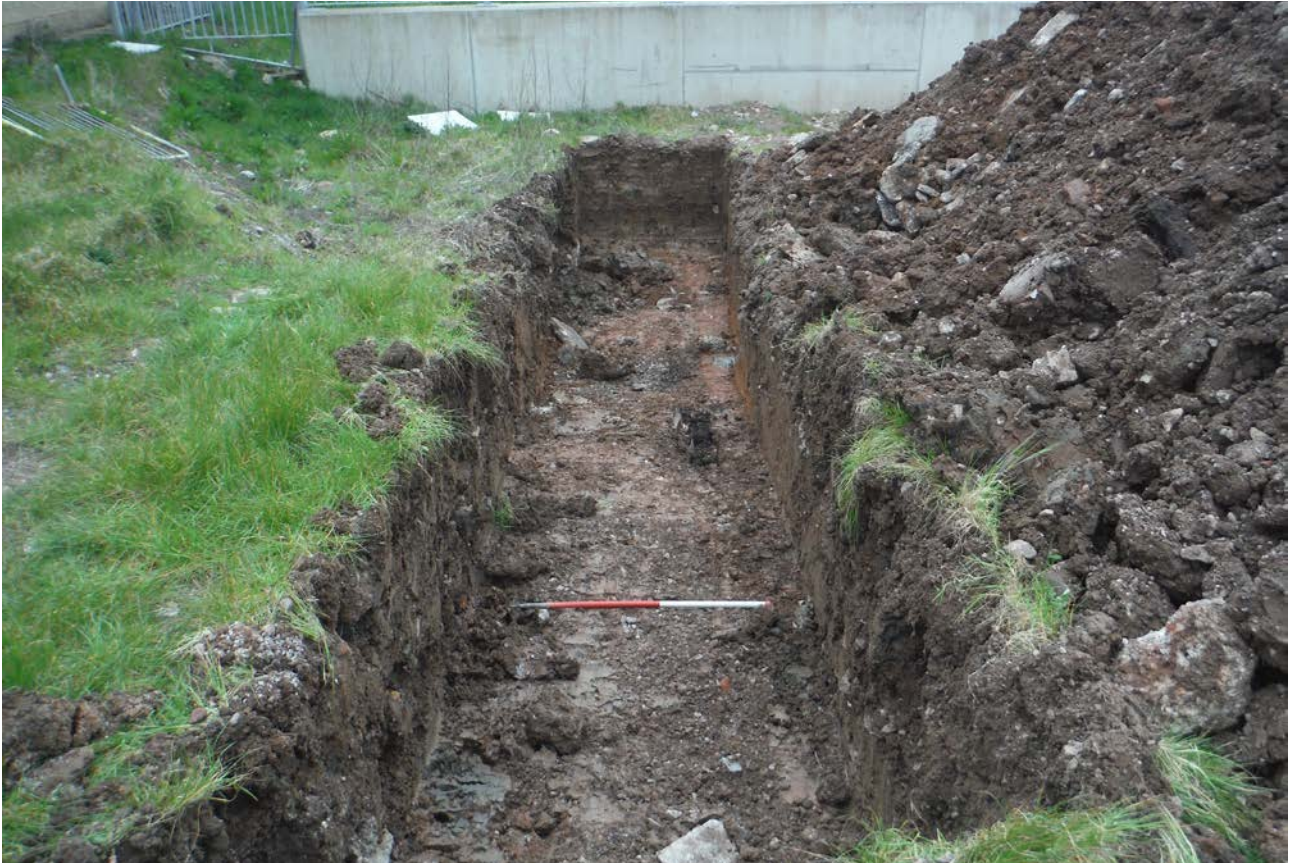
ILLUS 2 West facing shot of Trench 1

4.1 TRENCH 1 (ILLUS 2)

Trench 1 contained modern overburden in three layers. A surface deposit (101) comprised a dark brown, sandy clay, loose with frequent root intrusion. This was deliberately levelled material from the demolition of the previous technical college and contained fragments of construction debris throughout. This deposit reached 0.31m below ground level (BGL). Below this was a brown sandy clay with a red hue (102), this was present between 0.31m and 1.03m BGL and overlay a red clay with a brown hue (103). This deposit at the eastern end was 1.03m below the eastern ground level and 1.80m below the western ground level due to the slope the trench cut through. The natural geology was not encountered in this trench and excavations ceased at 1.80m due to concerns over the stability of its sides.

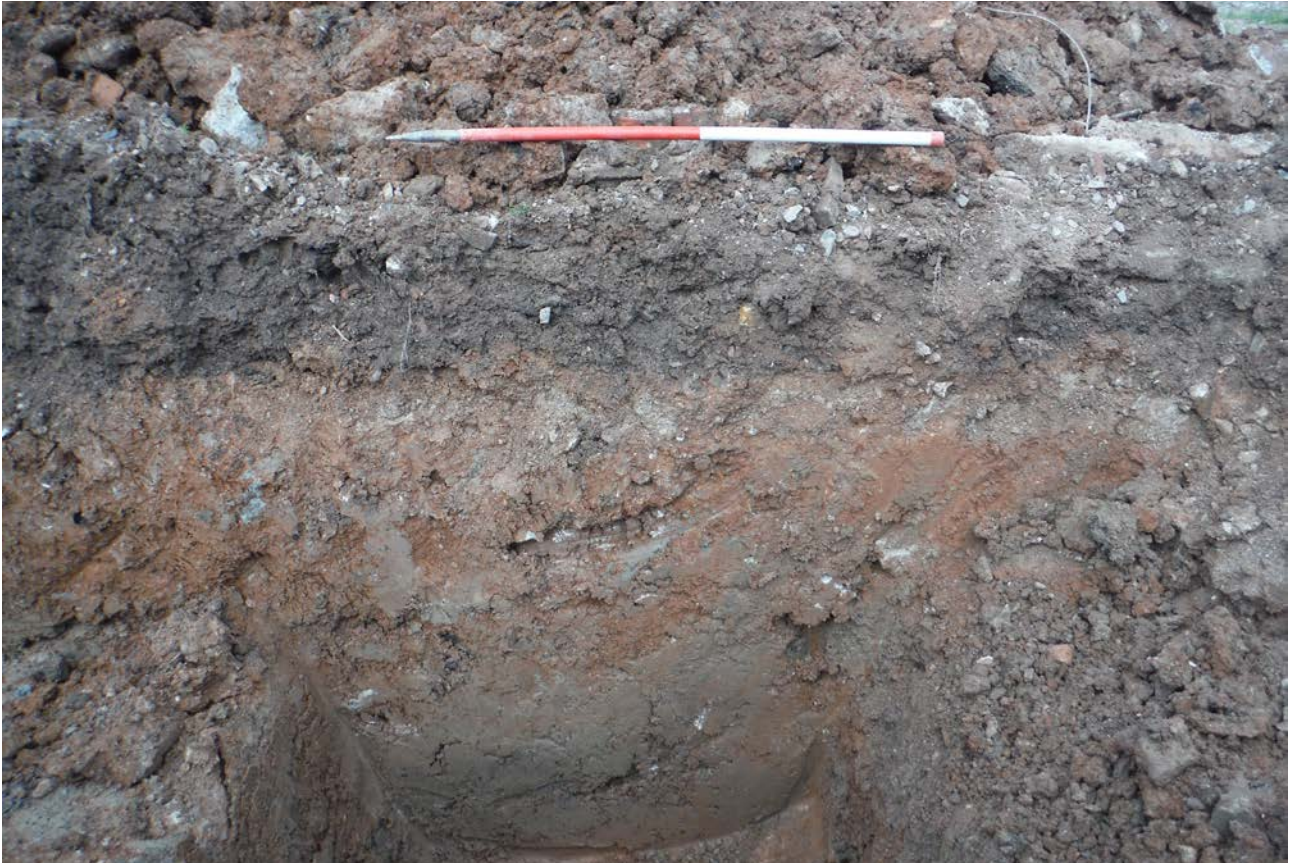
ILLUS 3 East facing section of sondage in Trench 2

Excavation in Trenches 1 and 2 ceased at a depth of 1m due to the nature of the unconsolidated material through which they were cut. A sondage was excavated in Trench 2 in an attempt to establish the depth at which geological material was present. Excavations ceased

at a depth of 1.97mBGL, due to safety considerations, and remained within made-ground. A very large concrete block 5m from the southern end of Trench 2 prevented the maximum safe depth from being achieved as it extended outside of the edges of the trench.

4.2 TRENCH 2 (ILLUS 3)

The stratigraphy in Trench 2 matched that of Trench 1 in nature however was slightly shallower. The surface deposit (201) extended to 0.29m BGL and the first subsoil deposit (202) was present between 0.29m and 1.00m. Below this was the third deposit of made ground (203) that was seen at the maximum excavated depth for this trench of 1.97m in a sondage at the centre of the trench. This was excavated to establish the depth of the natural geology below ground level, however, it was not reached due to the instability of the side of the trench.

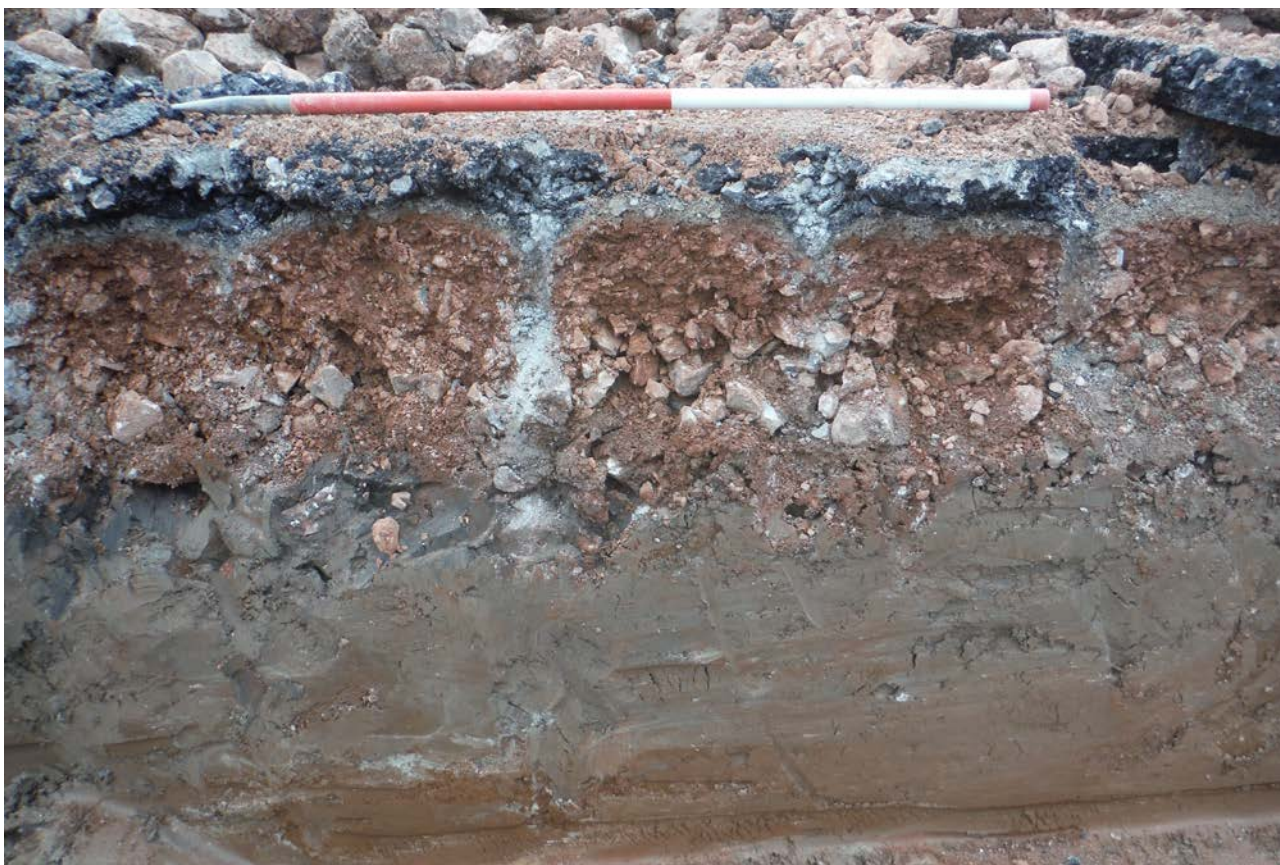
ILLUS 4 North east facing section in Trench 4

4.3 TRENCH 4 (ILLUS 4)

Trench 4 was excavated in a car park in the south east of the site. The tarmac surface (401) extended to a depth of 0.08m BGL. Beneath this was a red stone hard core deposit associated with the carpark (402) that measured between 0.08m and 0.44m BGL. This overlay a grey silty clay with a red hue (403) that contained very few inclusions and was present between 0.44m and 1.04m BGL. The natural geology (404) was present at 1.04m BGL and was a brown sandy clay with a red hue and frequent patches of degraded stone.

Trench 4, within the car park where no obvious levelling had taken place, revealed much less substantial deposits of made-ground and the natural geology was reached across the whole length of the trench. No archaeological finds or features were revealed.
