OLD PLACE YARD, BICESTER

TRIAL TRENCHING

commissioned by Environmental Design Partnership
on behalf of Cherwell District Council

May 2016

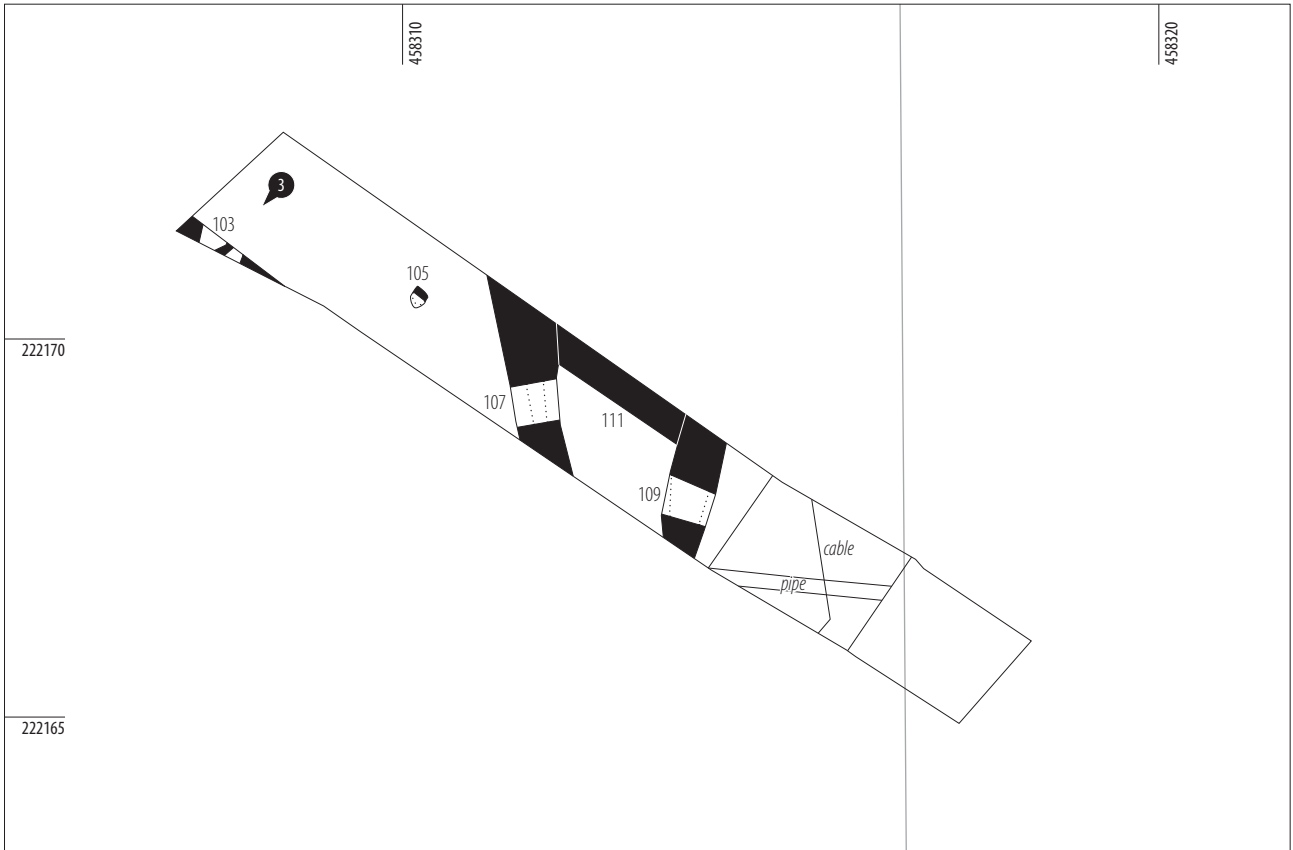
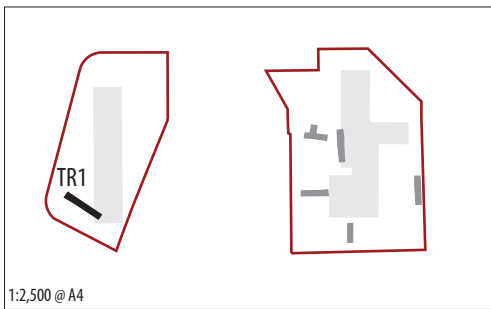
ILLUS 2 Plan of Trench 1

The earliest deposit recorded was a natural geological deposit of limestone brash (102) identified at 0.60m below ground surface (70.14m aOD). Towards the western end of the trench and observed extending 2m east-west in section only, the geological deposit was overlain by a dark grey sandy clay deposit with limestone fragments (112). This was encountered at approximately 0.50m below ground level and survived to 0.09m deep.

Immediately east of the post-hole was a ditch [107], oriented north-south and 0.62m wide and 0.24m deep. Pottery of possible Iron Age date was recovered from the fill (106). An environmental sample was taken from the ditch and contained charcoal, animal bone, burnt bone, snail shell, burnt seed, pottery and CBM. Approximately 1.6m to the west of this was a further heavily truncated ditch [109], also oriented north-south and measuring 0.58m wide by 0.08m deep. No dateable material was recovered from its fill (108).

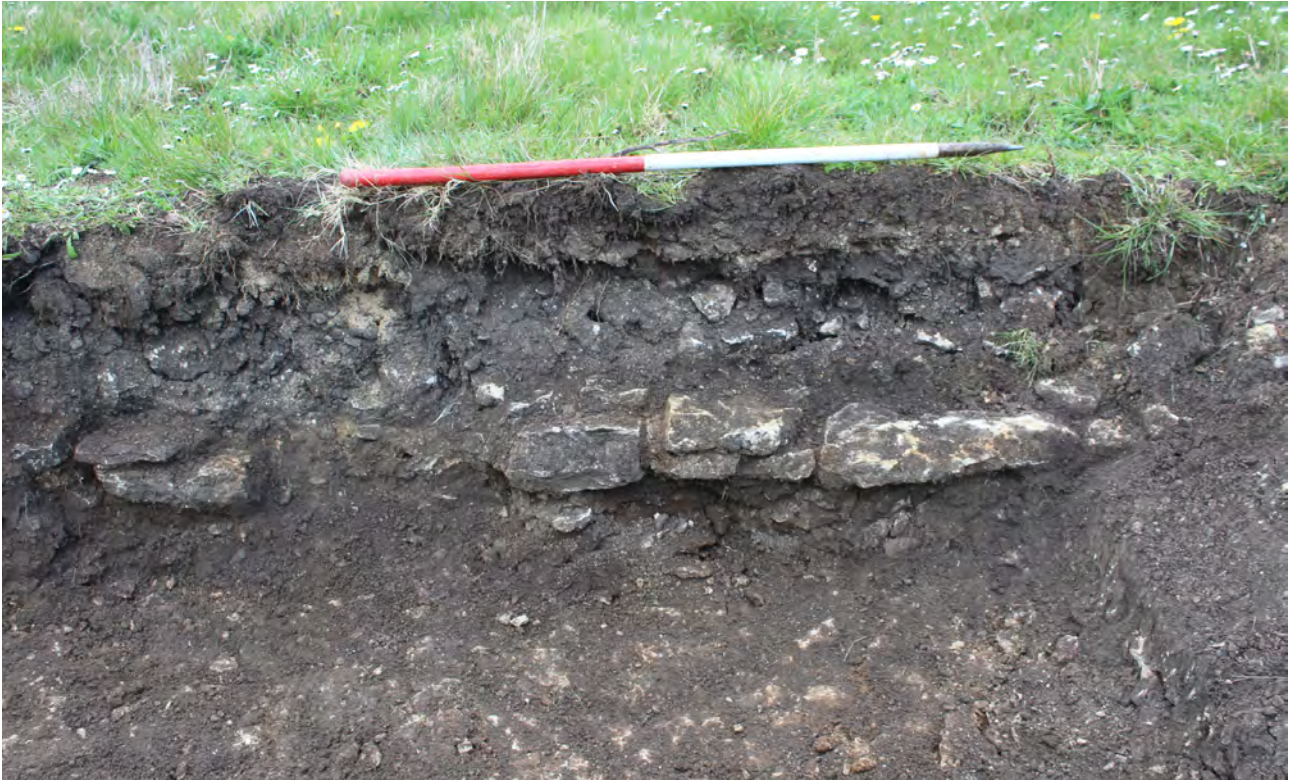
ILLUS 3 NE facing view of dry-stone wall [103]

At the southwestern end of the trench a northwest-southeast oriented wall foundation [103] was partially exposed (Illus. 3). The foundation appeared to survive to a maximum of two random courses in height, with some fragments of a yellow-brown gritty sandy clay, probable mortar also observed. The foundation overlay an earlier deposit (112). No specific function could be ascribed to the wall foundation.

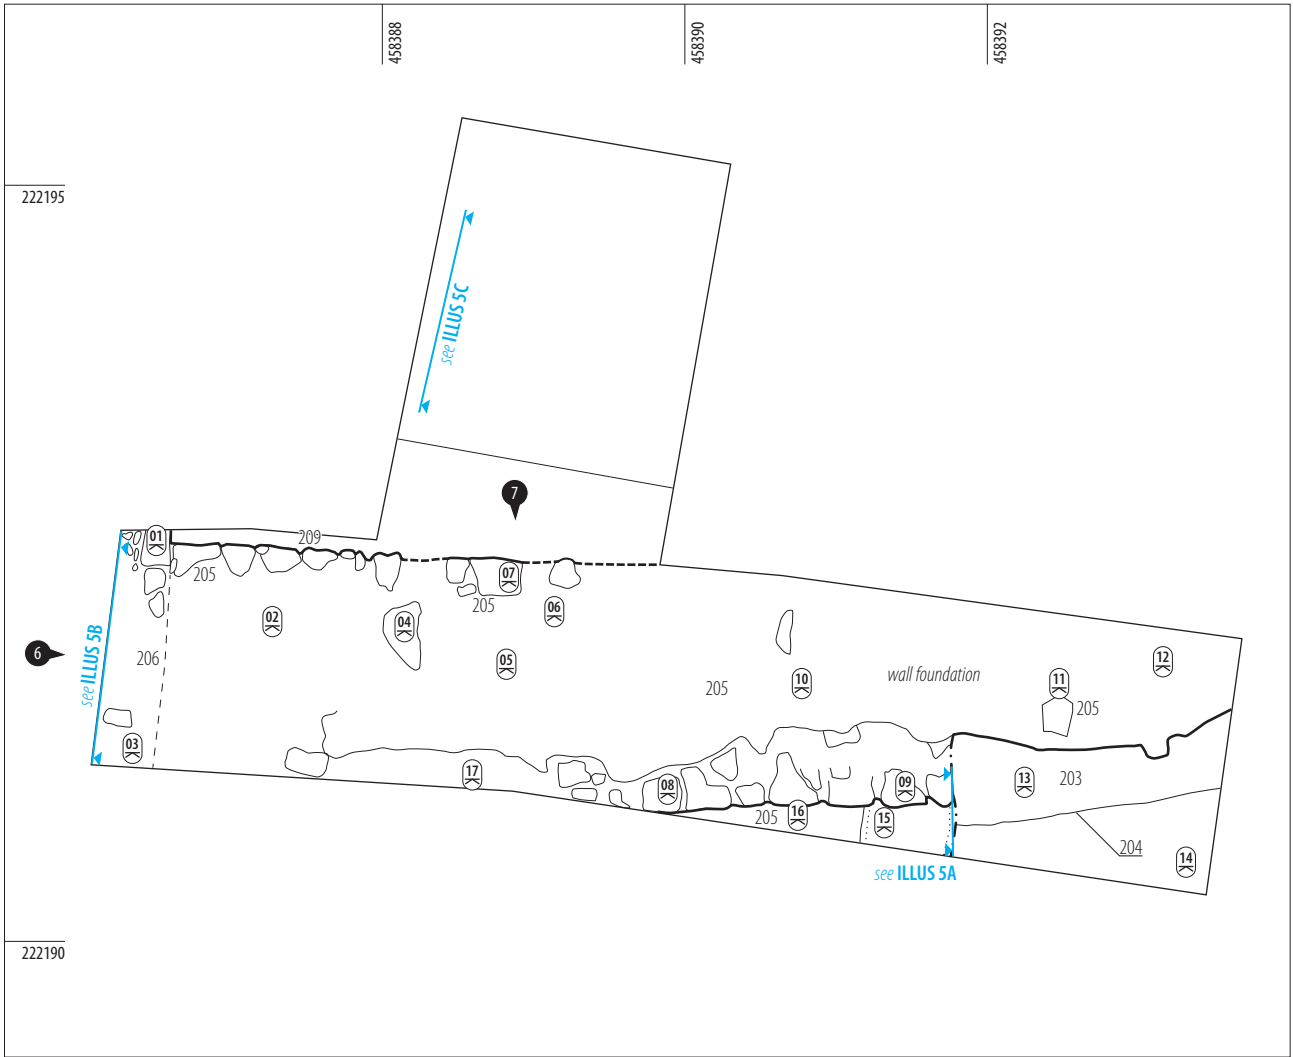
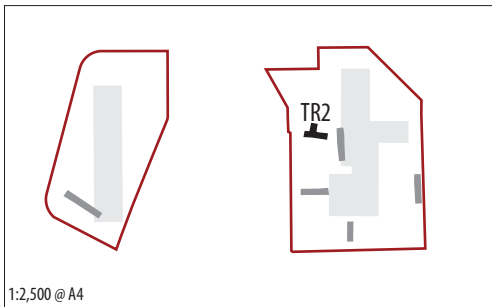
ILLUS 4 Plan of Trench 2

The earliest deposits encountered were a mid-blueish grey sandy clay containing limestones (208) (67.59m aOD); and within the extension to the north a mid-yellowish brown sandy clay containing stones (213) (67.51m aOD). The latter deposit was interpreted as a subsoil formation whilst (208), exposed in a sondage, was noted to contain charcoal and animal bone fragments.

Overlying this deposit (208) was a 0.40m deep mid-yellowish brown sandy clay (207). Mortar, limestone and charcoal fragments, concentrated towards the upper part of the deposit suggested a level of contemporaneity with the construction of wall foundations.

Cutting (207) an east-west oriented rubble wall foundation [205] was recorded extending beyond the limits of the trench to the east (Illus. 6). The foundation measured 1.50m wide and greater than 6.8m long, and consisted of roughly hewn and natural limestones of variable sizes bonded by a yellow-brown gritty sandy clay containing occasional charcoal fragments. The northern face was partially exposed in the extension to the trench and displayed up to 5 random courses of limestones (Illus. 7). Due to the constant excessive ingress of water and the depth of the trench (1.35m in extension) the base of the foundation could not be ascertained. The top of the wall foundation was encountered in places at 0.45m below ground surface between 68.14m and 67.79m aOD, with the recorded lower extent at 67.46m aOD. The foundation was interpreted as relating to the demolished southern wall of the priory church. In this case all that survived was the core of the foundation and footing the rest having been robbed out or removed through later levelling of the site.

On the same foundation and oriented north-south was the partial remains of what appears to be a later wall foundation [206] at the western extent of the trench. This measured greater than 0.40m wide and extended beyond the trench limits to the west, south and north. This foundation was more highly disturbed and loose, but built in a similar way to foundation [205] with no discernible facing between the north-south and east-west components. The function of the wall foundation was not clear. It aligned with the inner western cloister wall to the south and may have been part of the western end of the church to the north, or possibly a pilaster base, and its highest surviving point was recorded as 67.98 to 67.86m aOD.

Cutting through this sequence was a steep sided flat based cut [215] which was interpreted as a robber trench. A similar profiled cut was noted in a sondage to the south of foundation [204] and observed to follow the southern line of wall foundation [205]. The two cuts were interpreted as relating to robbing of masonry from the wall foundations. Clay pipe probably dating to the 17th -19th century was recovered from the fill of robber trench (203).

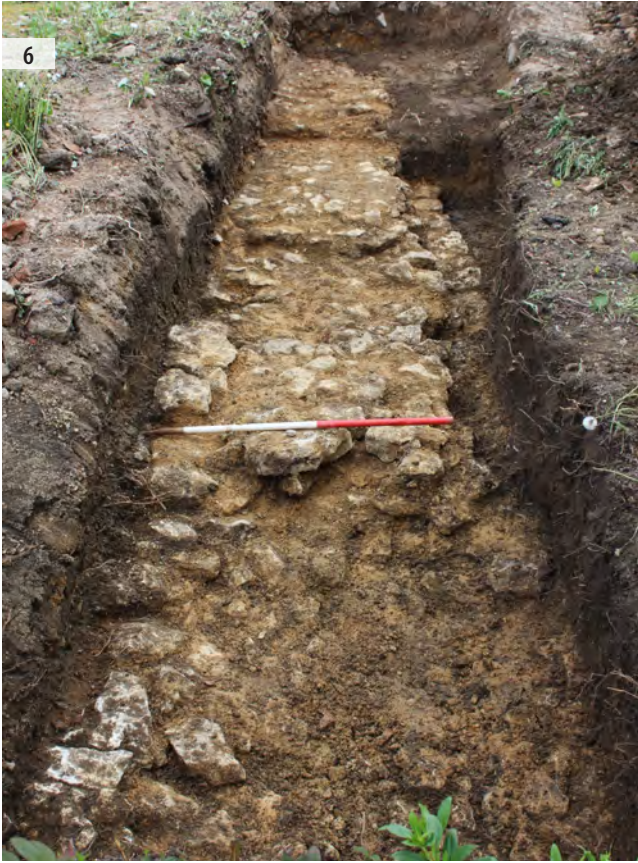
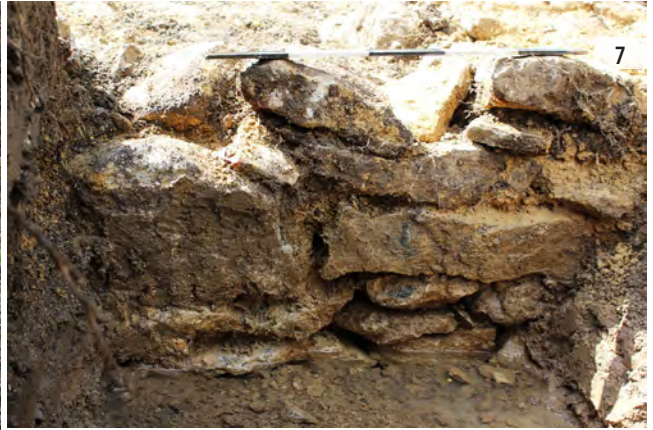
ILLUS 6 E facing view of wall foundation [205] **ILLUS 7** View of northern face of wall foundation [205] in trench extension

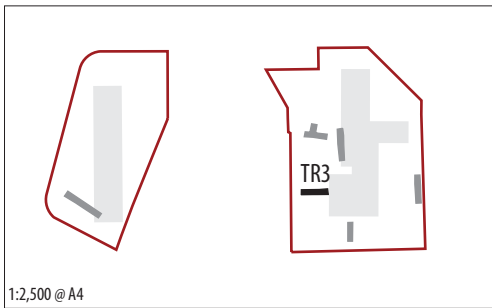
ILLUS 8 Plan of trench 3

A greater than 0.60m wide, north-south oriented, rubble wall foundation [303] (Illus. 10) was identified (largely in section) at the extreme west end of the trench. The foundation consisted of variable sizes of limestone blocks bonded with a yellow brown gritty, sandy clay mortar and was encountered at 67.84m aOD (0.45m below ground surface). The foundation was heavily disturbed and loose, and the base was not identified.

Overlying [303] was a dumped deposit of mortar and limestone fragments (310) and a mid- grey gritty-sandy-clay (311) containing frequent mortar, limestone and charcoal, which were both interpreted as relating to levelling following demolition of the wall foundation.

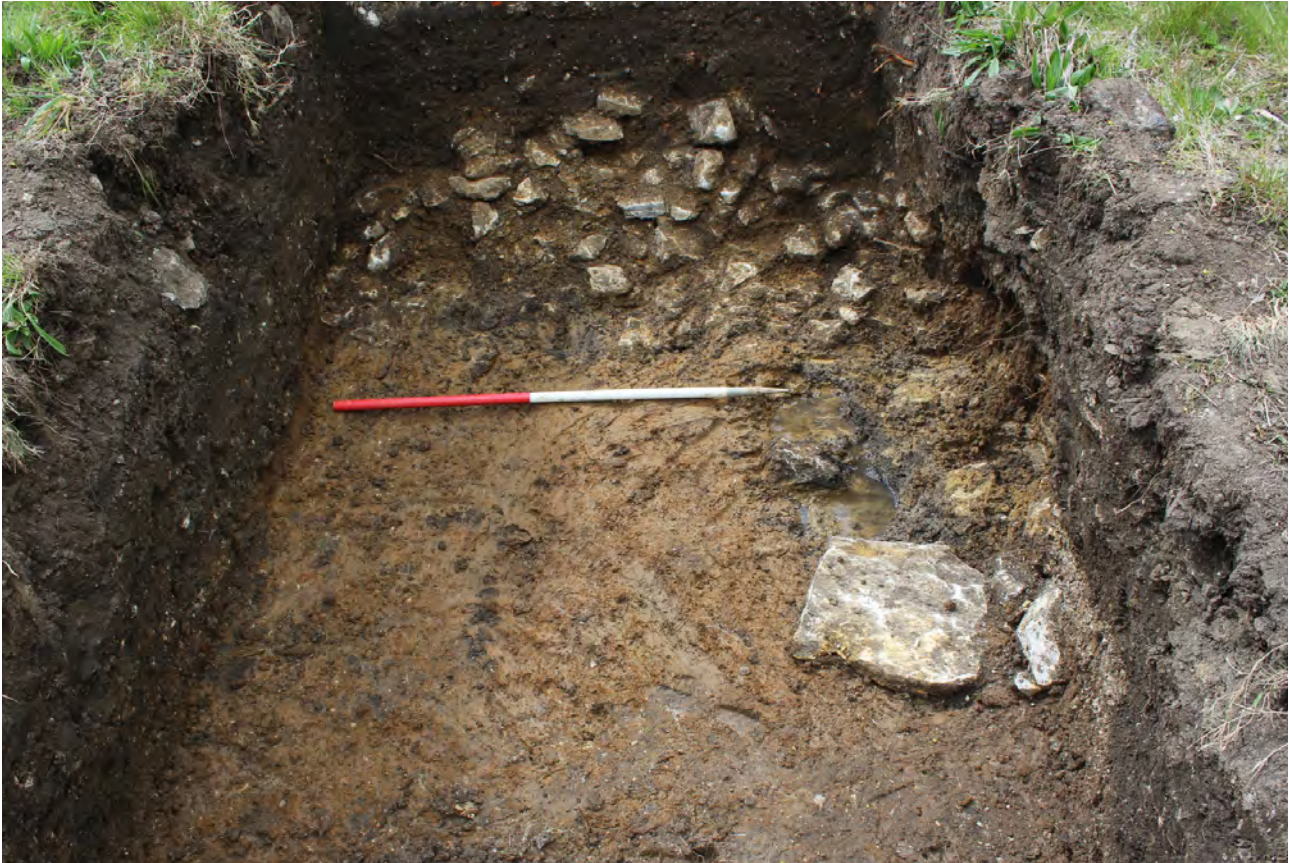
ILLUS 10 W facing general view of wall foundation [303]

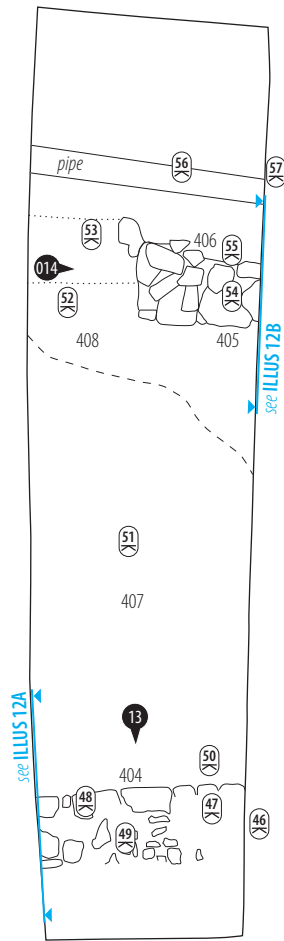
ILLUS 11 Plan of trench 4

The earliest deposit encountered was a dark bluish grey sandy clay (408) at 67.16m aOD. Overlying this was a dumped layer of sandy clay and stones (407) which was identified as relating to the grubbing up of the wall foundations. Disarticulated human remains (Patela and broken humerus) were noted within this demolition layer and, although they were damaged, they appeared to be in a fairly robust condition. These were left in situ in accordance with the WSI.

At the southern end of the trench a wall and its foundation [404] were partially exposed in section (Illus. 13). The wall consisted of roughly hewn limestones bonded in a yellow-brown gritty sandy clay mortar and surviving to at least 0.60m depth between 67.78 and 67.11m aOD, the top lying approximately 0.45m below ground surface. The foundation represented remains of the southern outer-cloister wall.

A heavily disturbed wall foundation [405] was recorded in the expected location of the inner cloister wall approximately 3m to the north of this at 67.36m aOD and comprised rough limestones in a similar mortar bond to [404]. The foundation ended before the western baulk (Illus. 14) perhaps indicating a probable opening or entrance to the inner cloister, or alternatively indicating that the foundation has been entirely removed by Post-medieval/Modern impacts at this point.

Overlying the inner cloister wall [405] was a loose, light brownish grey, sandy clay with stones (406) interpreted as a dumped deposit related to robbing of the wall foundation. Sealing this and butting against the outer cloister wall [404] a levelling deposit of mid grey sandy clay (402) was identified sealed by a further dumped demolition deposit of dark brownish yellow deposit comprising mortar, stone and sandy clay (403). This was sealed by the present topsoil (401).

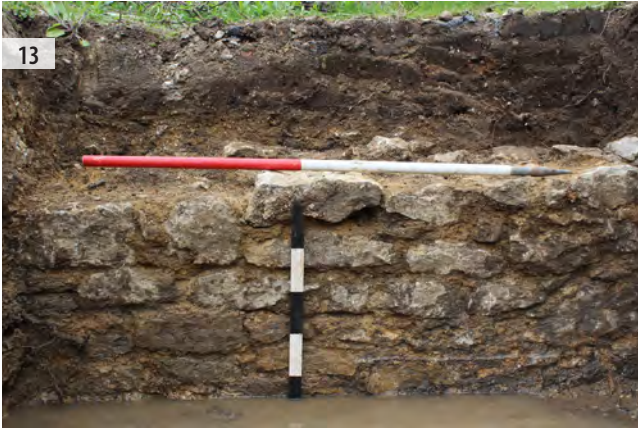
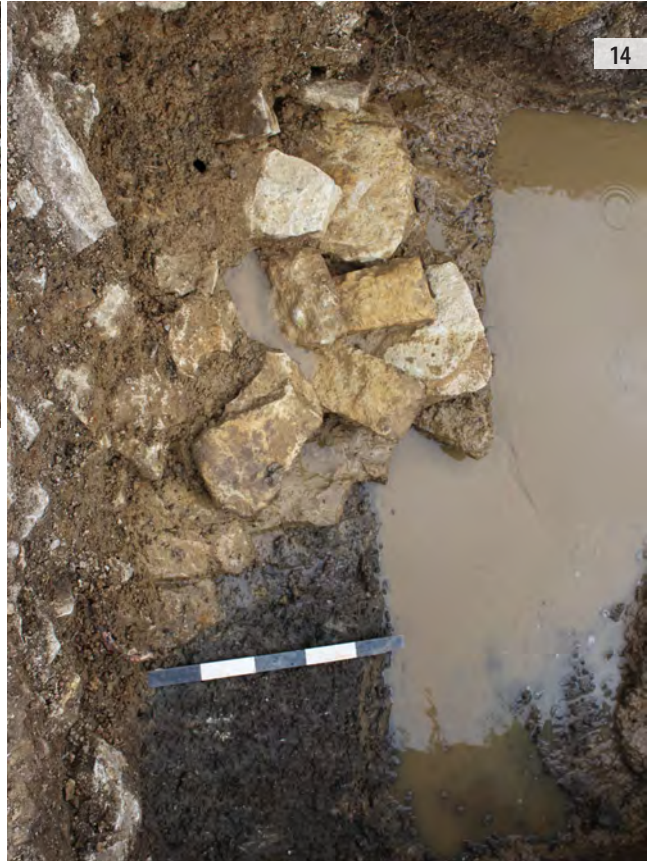
ILLUS 13 N facing elevation, wall [404]
ILLUS 14 Plan view of wall foundation [405]

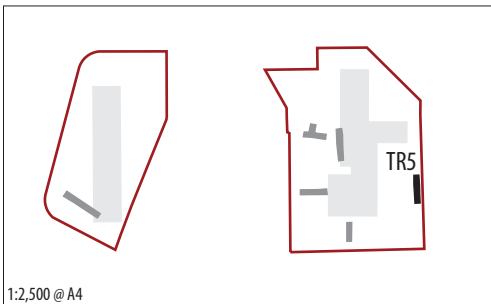
ILLUS 15 Plan of Trench 5

An east-west oriented, robbed out wall foundation [511], was identified in the southern end of the trench, at 67.37m aOD. This contained mortar, sandy clay and limestone fragments (512) representing the debris from removal of the wall foundation.

An east-west oriented limestone wall foundation [510] was identified to the north of this, its top at a height of 67.70m aOD. (Illus 17) The foundation comprised limestones of variable sizes and was roughly faced to the north and south. A sondage against the northern face revealed at least 3 random courses. This was abutted by a further wall foundation [508] oriented north-south and partially exposed against the eastern edge of the trench. A lower step foundation [509] beneath the main foundation [508] was also recorded with a sondage excavated against the northern edge of the trench revealing this to comprise 4 uneven, random courses of roughly hewn limestones. Both wall foundations and step foundation were bonded in a yellow brown sandy clay mortar.

Associated with the step foundation [508] and abutting its western edge was a light yellowish grey sandy mortar with limestone fragments (506). This was interpreted as a setting deposit for an overlying row of variably sized limestones [505] which was identified as the disturbed remains of a stone floor associated with the walls. The top of the floor deposits were encountered at 67.77m aOD.

Wall foundation [510] was identified as probably relating to the northern wall of the chapter house, with wall foundations [508] and [505] relating to a further structure to the north.

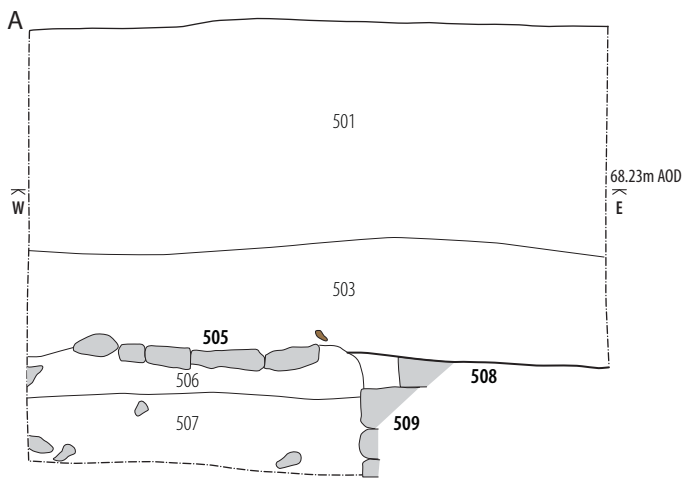
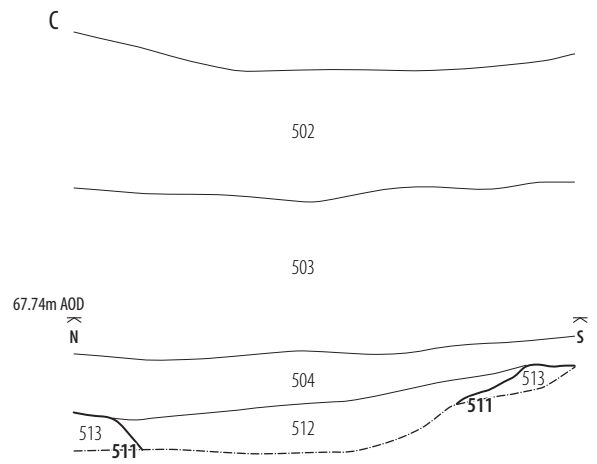
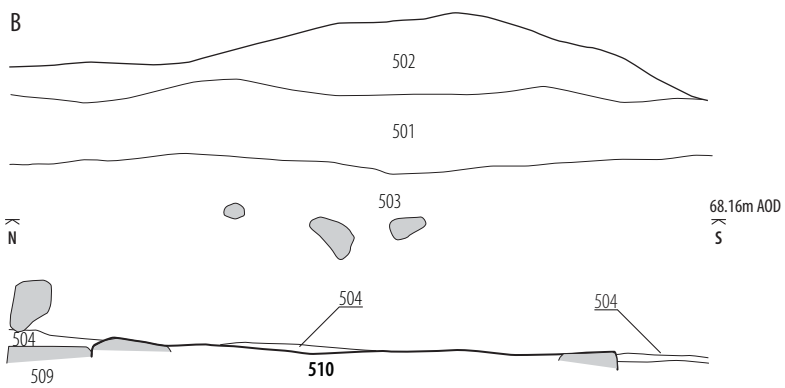
ILLUS 16 Section drawings Trench 5

The wall foundations were overlain by a coarse layer of greyish yellow sandy mortar and limestone fragments (504) deriving from the demolition or robbing of the foundations. Oyster shell, pottery and tile of medieval provenance was recovered from the deposit. Disarticulated human bone (Phalanges and a vertebrae) were noted within (504) indicating the disturbance of a grave in the area. No evidence of a grave cut was identified within the trench.

Sealing this and the identified foundations and floor surface, a 0.23m thick reddish brown silty clay (503) was recorded. This appeared to be a subsoil formation, post-demolition, over the remains identified, though this may equally may have been some form of imported levelling deposit.

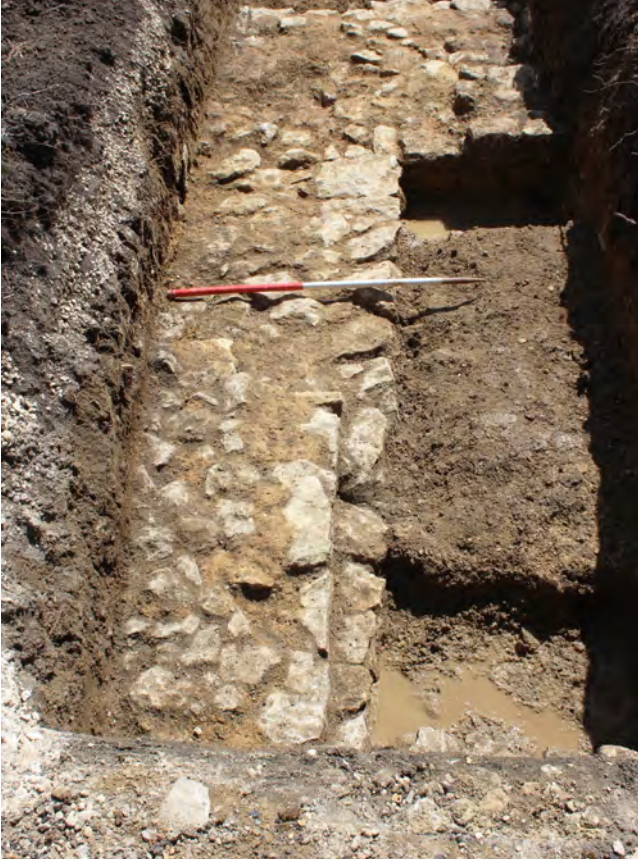
ILLUS 17 S facing view of wall foundations [509] and [510]

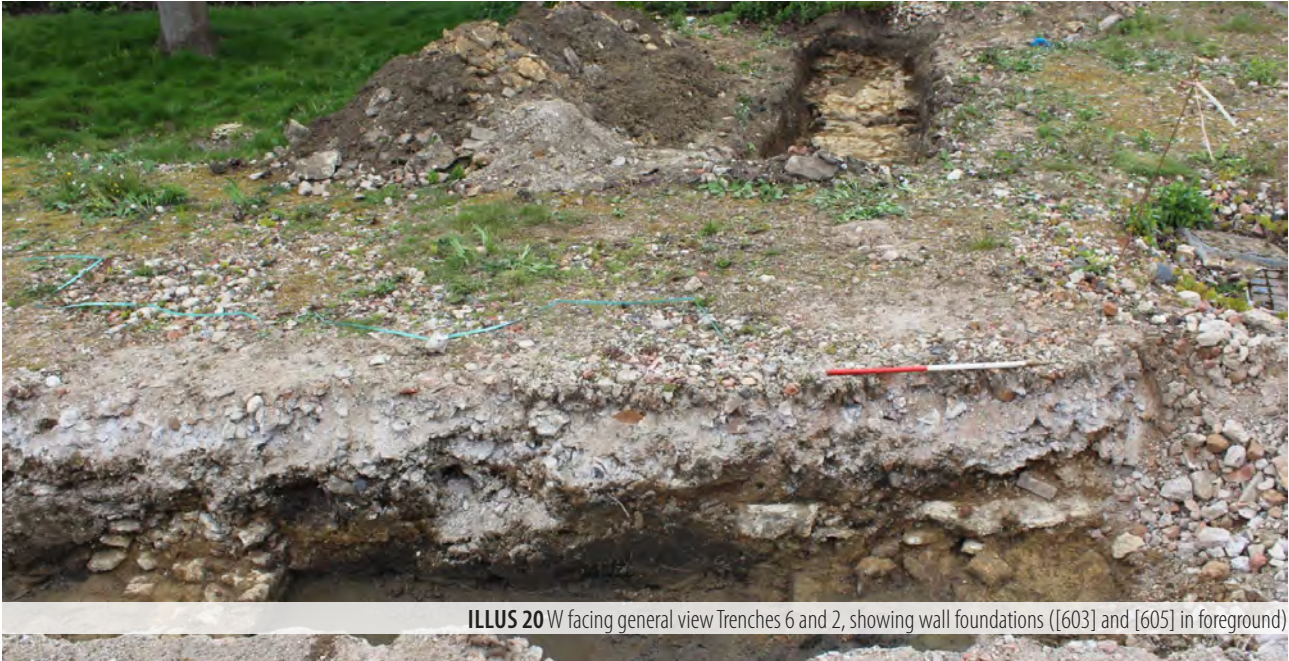
An east-west linear foundation trench [606] cut through (608). It measured 1.40m wide and contained a limestone foundation made up of variably sized roughly hewn limestones [605] in a sandy mortar and limestone matrix (607). It was roughly faced to the south and north with at least 3 uneven random courses surviving. The base of the foundation could not be ascertained due to excessive ingress of water from the foundation cut. The foundation measured 1.22m wide with the top recorded at 67.60m aOD, 0.95m below ground level.

Approximately 2.70m to its north, the heavily disturbed remains of a further east-west wall foundation [603] was recorded at 67.70m aOD. The foundation comprised roughly hewn limestones of variable sizes bonded in a yellow-brown sandy clay mortar with at least 1 course surviving. The problem of water ingress prevented fuller excavation to establish the foundation depth. The eastern end of the foundation was entirely cut away by a modern foundation cut.

ILLUS 20 W facing general view Trenches 6 and 2, showing wall foundations ([603] and [605] in foreground)
