ST MARY'S FARM, KINGSLAND

ARCHAEOLOGICAL EVALUATION

commissioned by GPT Properties Ltd

August 2016

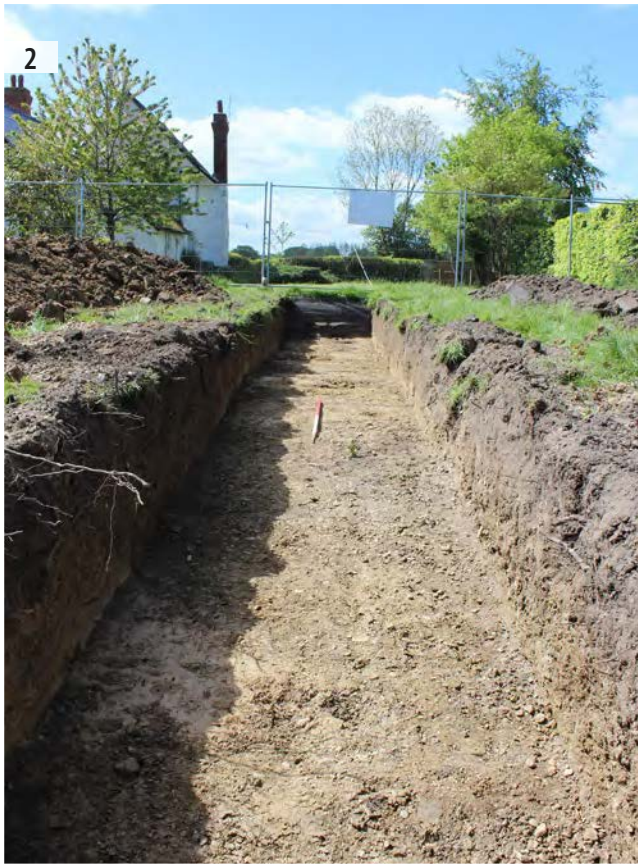
ILLUS 2 Trench 1 looking south-west **ILLUS 3** Trench 2 looking north-west **ILLUS 4** Trench 3 looking north-east **ILLUS 5** Trench 4 looking north-east

Trench 1 measured 15m long and 1.6m wide and was the most south-westerly of the trenches, located just to the west of one of the farms buildings scheduled for conversion as part of the redevelopment. The natural geology was represented by compact, yellowish buff silt clay, encountered at a depth of 0.90m below the current ground surface (BGS). This deposit became progressively more gravelly toward the northern end of the trench and rose gradually to a depth of only 0.40m BGS. Part of a shallow, sub-circular pit [0105], 0.70m wide and

0.25m deep was revealed in the north-eastern corner of the trench. It was infilled with a single deposit of dark brown silty-clay with frequent charcoal flecking (0106). No artefacts were found in association with this deposit. The feature was sealed by a layer of brownish yellow silt-clay subsoil (0101), which became more gravelly toward the northern part of the trench. A small terminating linear feature [0107] was encountered at the southern end of the trench, truncating the subsoil deposit. It was infilled with dark brown silty, sandy clay (0108) containing fragments of sandstone. Given its morphology and position in the stratigraphic matrix, it was deemed fairly likely that the feature represented relatively recent garden activity. The surface deposit was represented by a 0.35m deep deposit of dark brown, friable clay-silt topsoil.

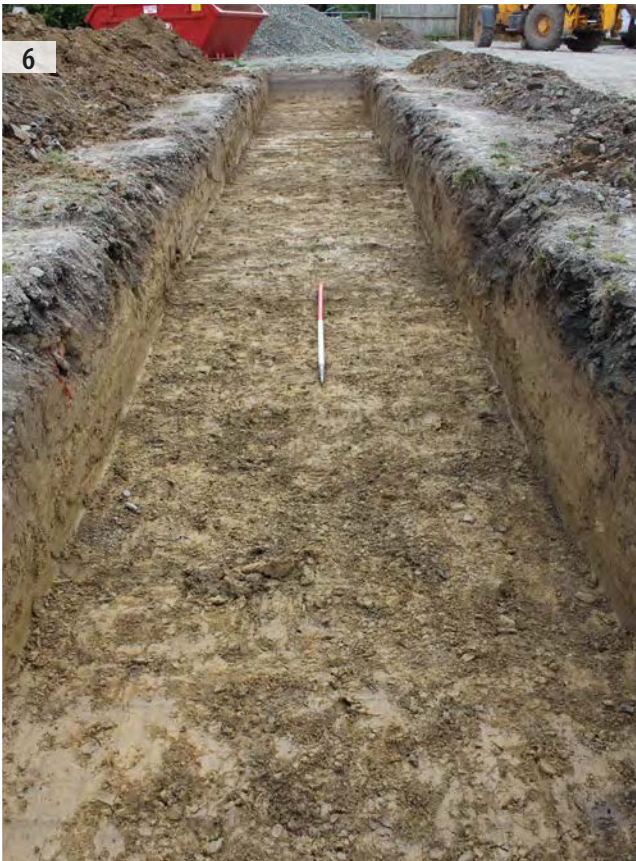
ILLUS 6 Trench 5 looking east-south-east **ILLUS 7** Trench 6 looking south-east
ILLUS 8 Trench 7 looking north-west **ILLUS 9** Trench 8 looking south-west

Trench 5 was 15m long and located roughly at the centre of the site, it was positioned on an approximate east-west alignment. The natural gravels (0502) were encountered at a depth of between 0.50 and 0.80m BGS and were sealed by subsoil, followed by the same rubble and hard-core surface as seen across the majority of the site. No archaeological features or deposits were encountered within this trench.
