STUDLEY CASTLE HOTEL, WARWICKSHIRE

LEVEL 4 BUILDING RECORDING OF 1938 ACCOMMODATION BLOCK

commissioned by PWP Architects
on behalf of Warner Leisure Hotels

15/02705/LBC

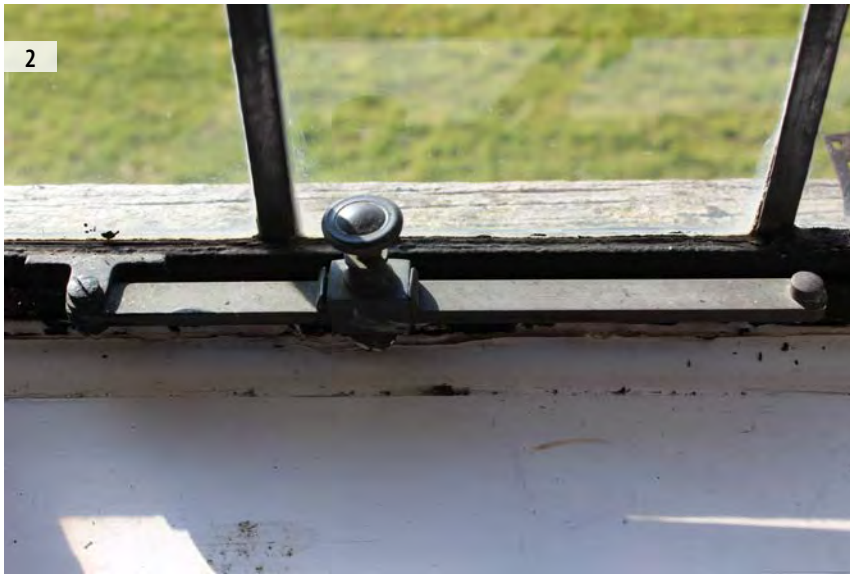
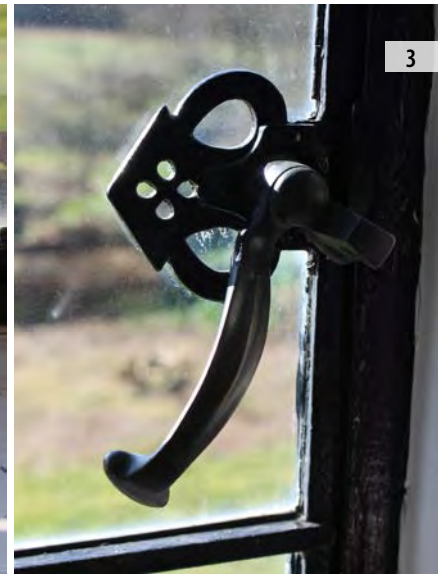
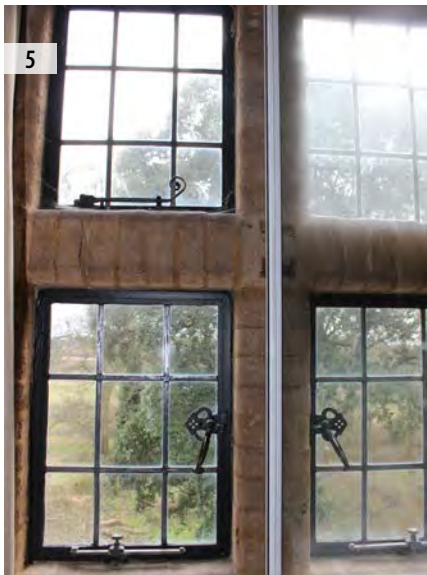
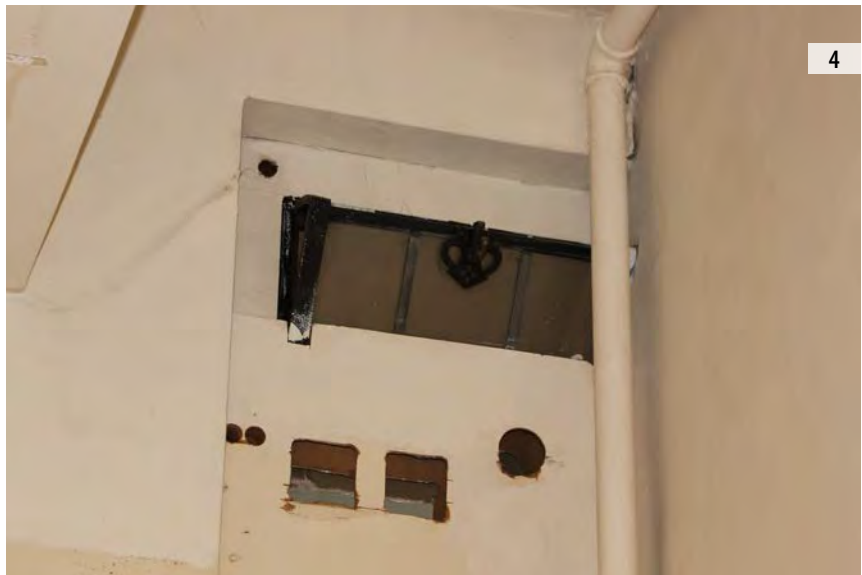
ILLUS 2 Example of window stay **ILLUS 3** Example of window latch **ILLUS 4** Hopper window **ILLUS 5** Scroll end window stay

The majority of the windows had metal glazing bars, the casement windows generally had screw-down stays (Illus 2) and perforated heart shaped back plates to the latches (Illus 3). The same heart-shaped motif was found on the catches for the hopper windows in the corridor wall and above the fire escape doors (Illus 4). There were a few examples of multi-position stays with scrolled ends (Illus 5).

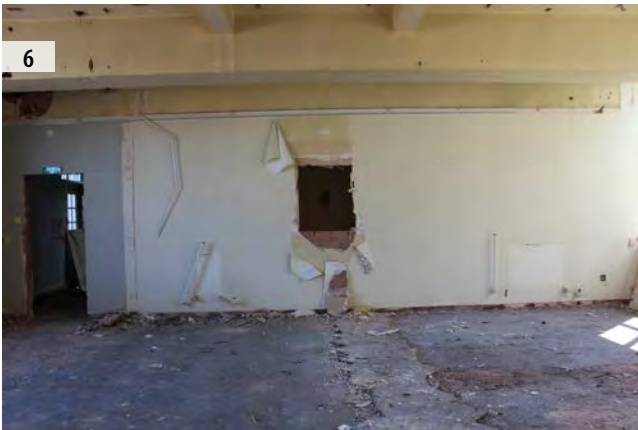
ILLUS 6 RSJs in ground floor rooms **ILLUS 7** Fireplace **ILLUS 8** Brackets for gas pipes

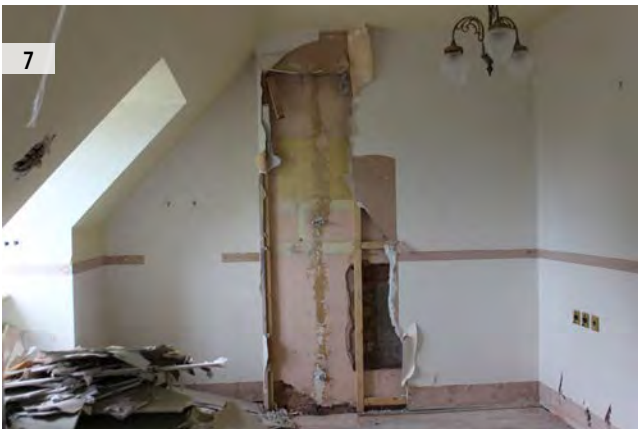
corridors of the upper floors. The blocked in fireplace openings observed on the third floor were raised above the floor level (Illus 7) and brackets for pipework were revealed by removal of the suspended ceiling in the first floor corridor (Illus 8).

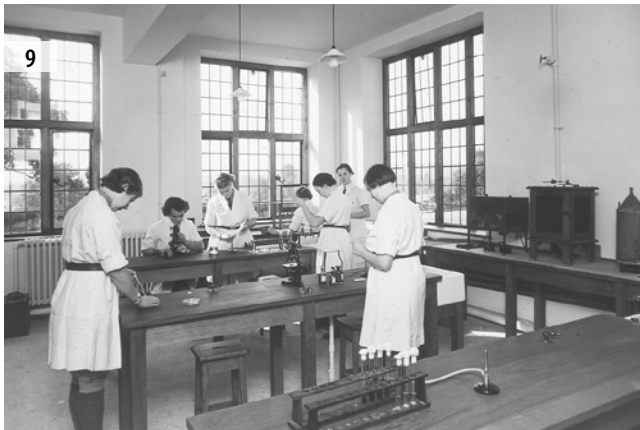
ILLUS 9 College laboratory **ILLUS 10** First or second floor college bedroom **ILLUS 11** College before 1938 **ILLUS 12** College shortly after completion

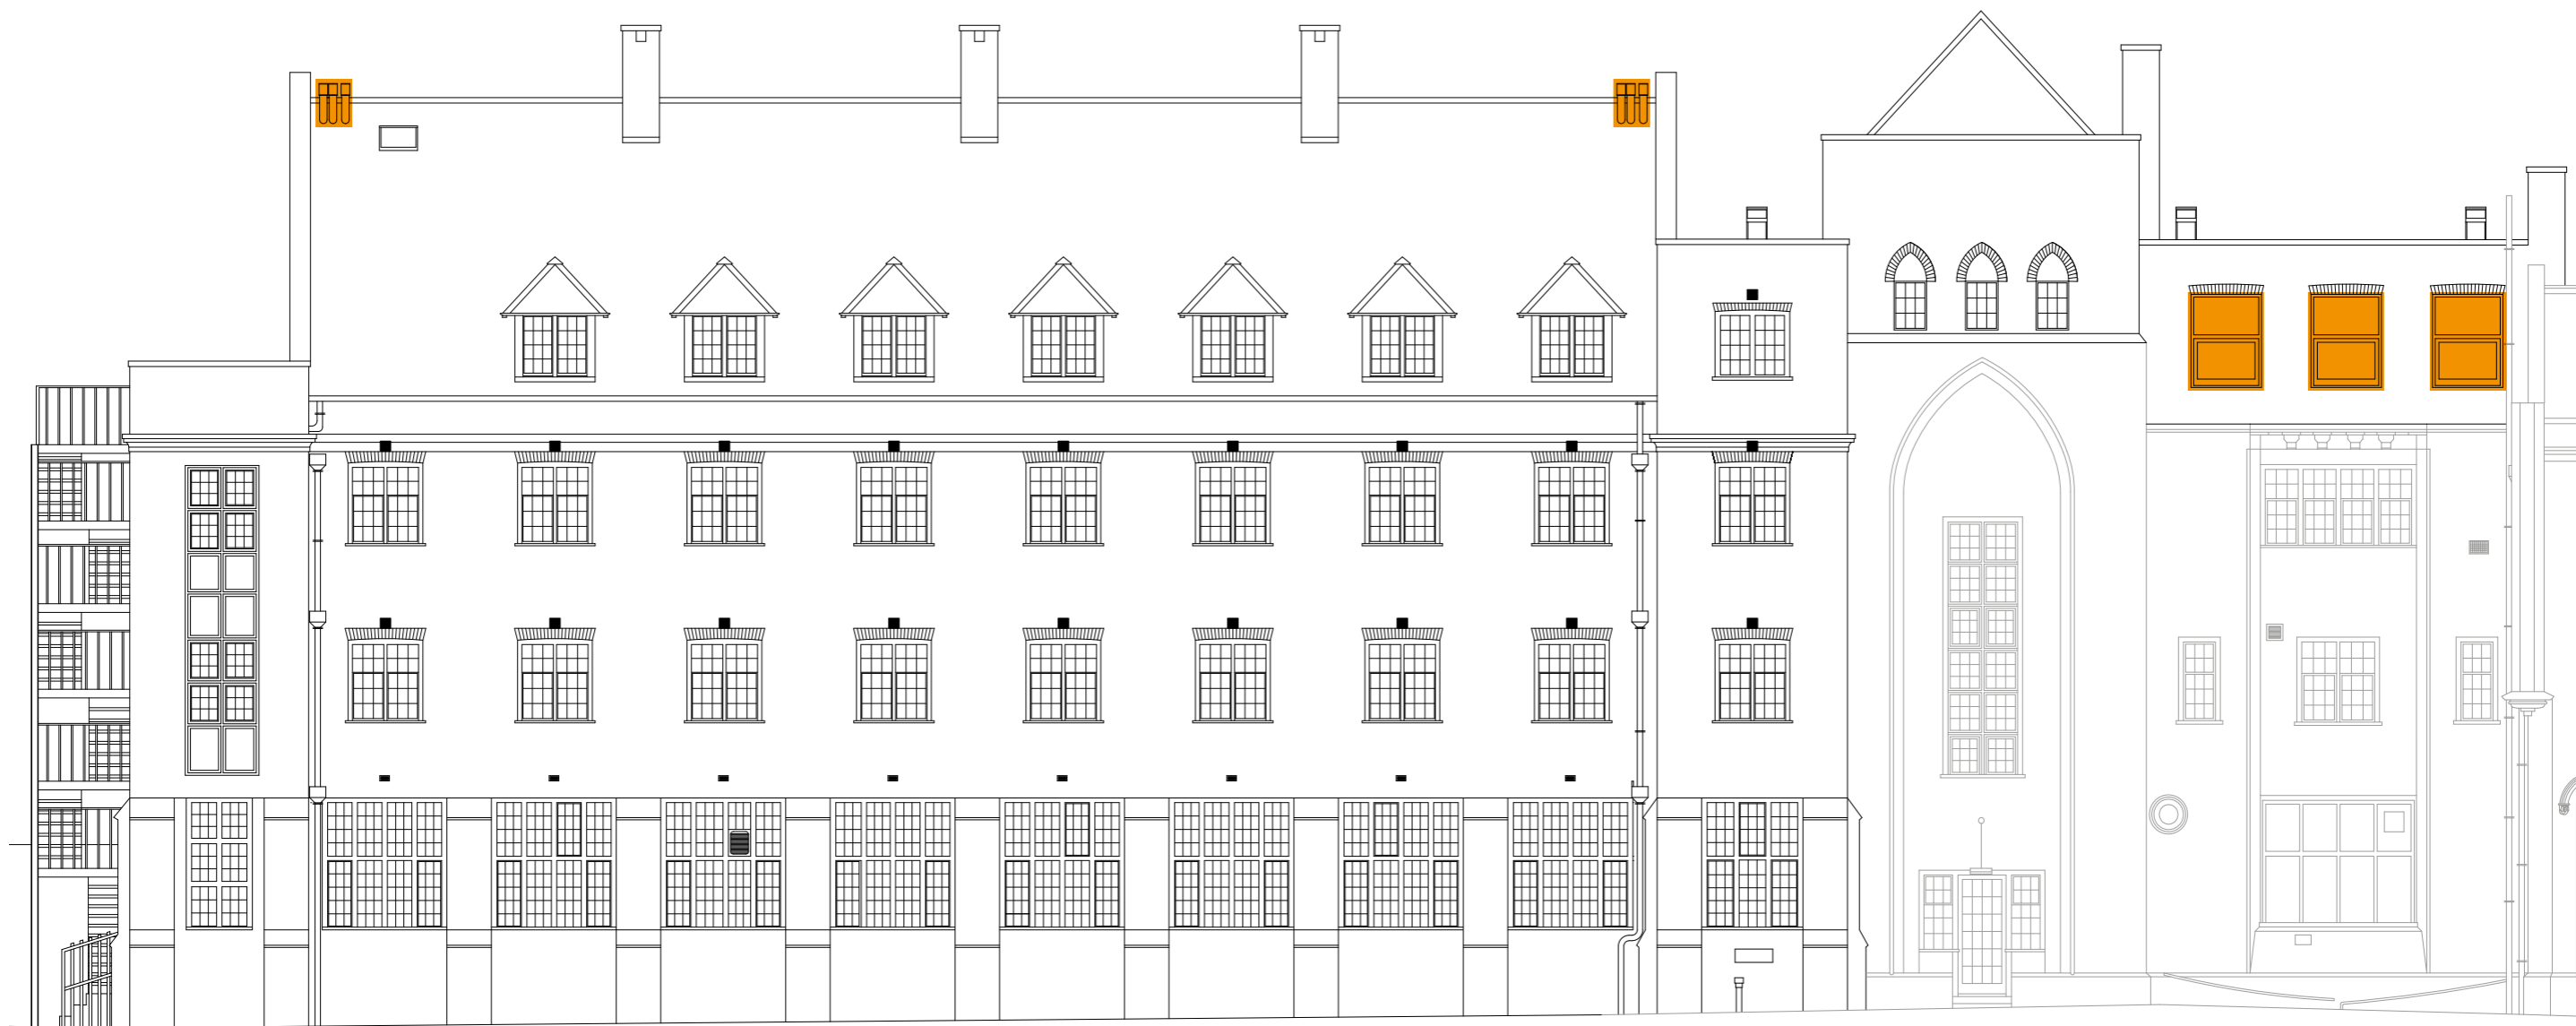
ILLUS 15 South elevation of 1938 wing showing phasing

A full gazetteer description of all elements of the building is provided in Appendix 1. In summary, the building is of brick with a gabled tiled roof to the majority and flat roofs to the end bays. The building is arranged over four floors in ten bays (eight equal bays with projecting bays to each side), with large ground floor windows to the principal south facing elevation and smaller windows to the first and second floors. The third floor has gabled dormer windows to seven bays. There are three brick built chimney stacks evenly spaced along the ridge of the roof (Illus 14). The north elevation of the building differs to the south elevation largely in the size of the ground floor windows (Illus 16). To the east of the 1938 wing brick extensions to the main castle building at third floor level have also been included in the recording. The wing abuts the castle to its east which obscures much of the east elevation, although a ground floor window is present in the projecting bay. The west elevation contains two large ground floor windows and a metal fire escape serving the upper three floors, a fire escape door has been inserted to the ground floor (Illus 15).

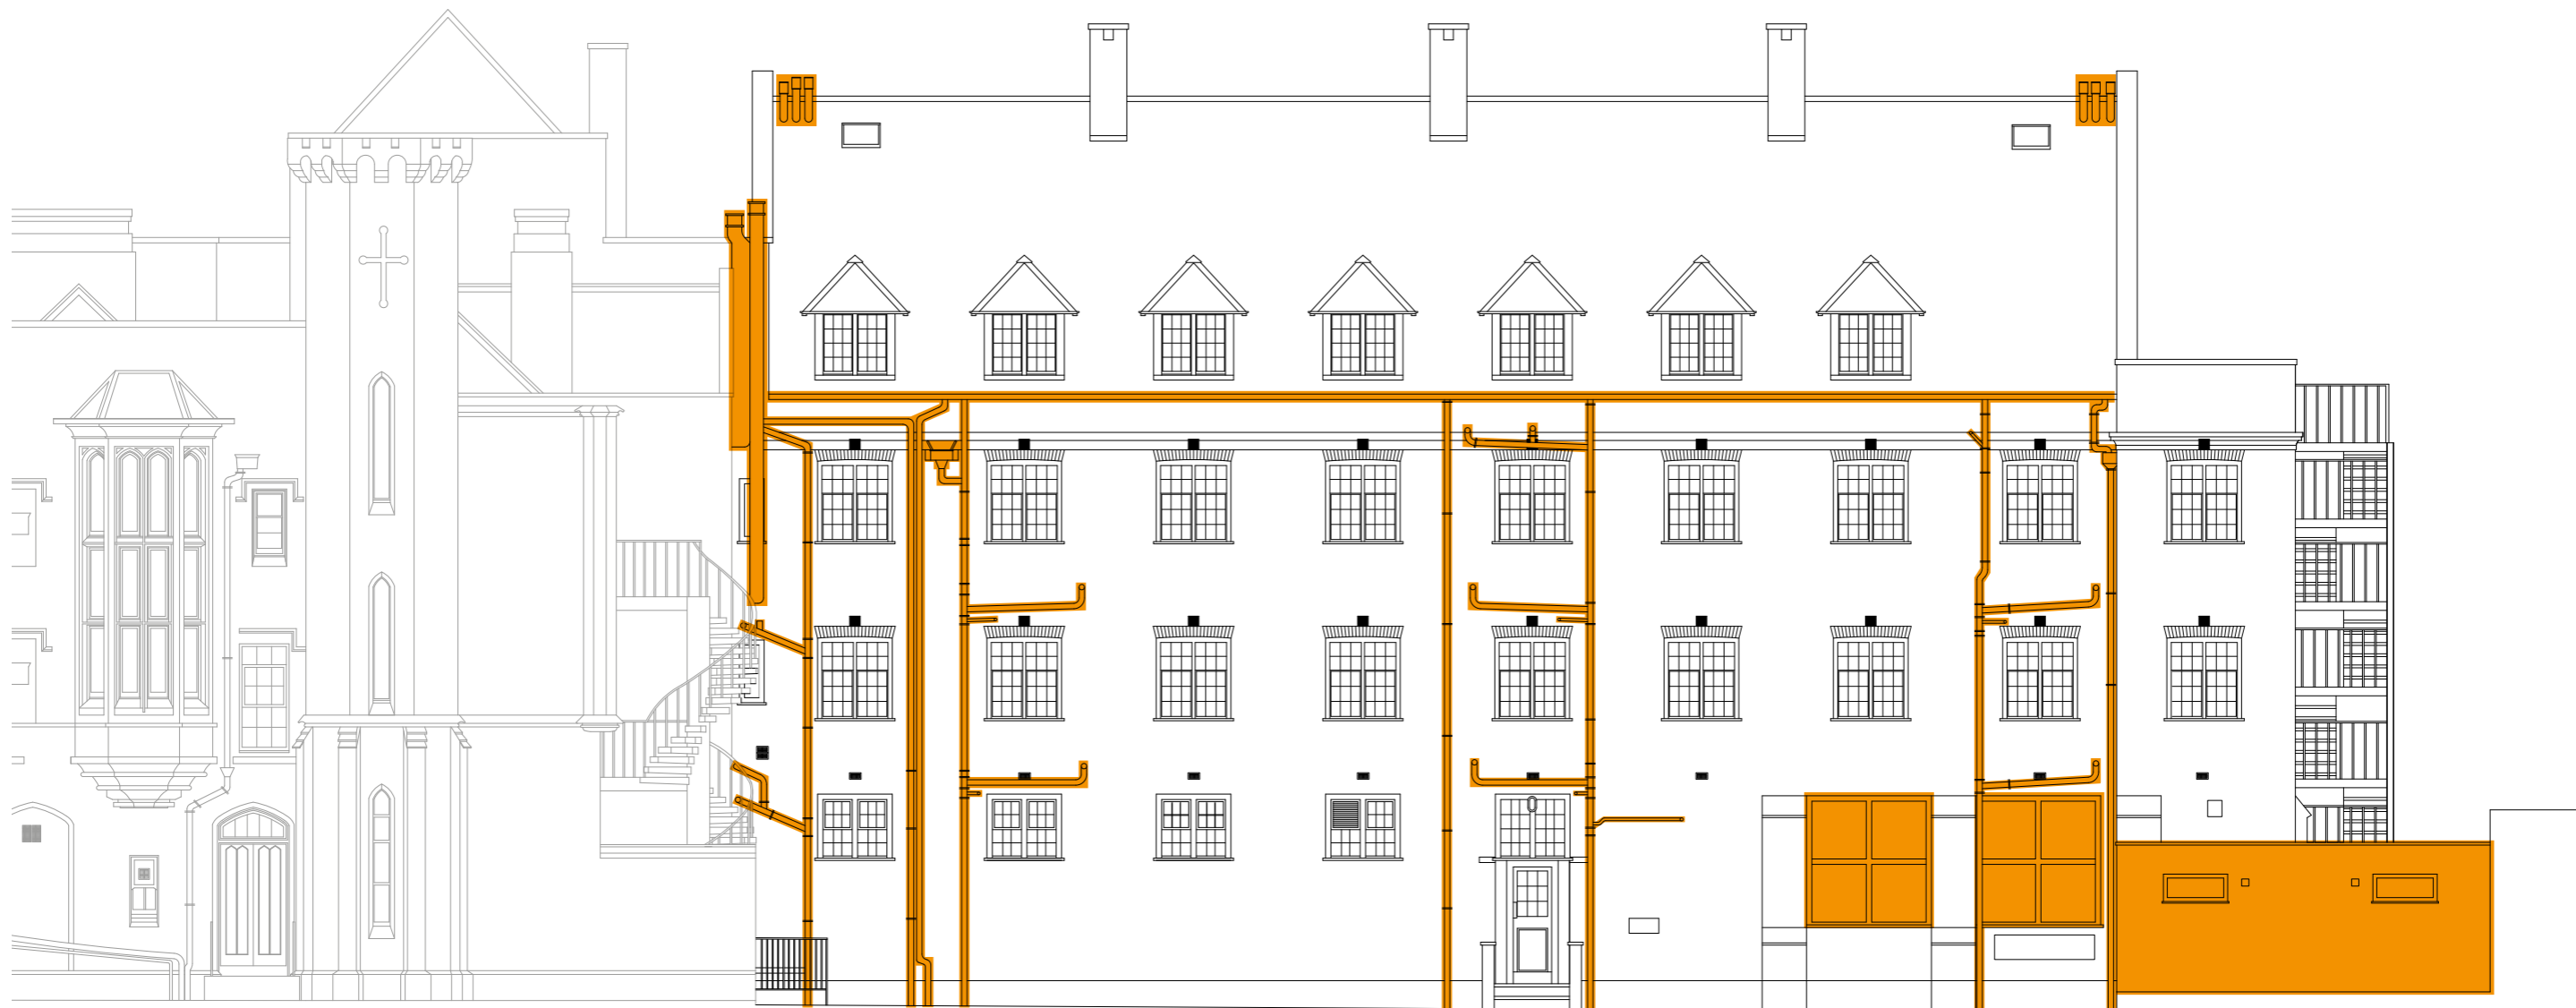
ILLUS 17 North elevation of 1938 wing showing phasing

The north facing elevation of the 1938 wing is very similar to the south facing elevation, with the main differences on the ground floor level. The westernmost bay is partially obscured by the abutting castle but there are narrow, louvred windows to the first and second floors (that on the second floor partly obscured by stainless steel pipes) and a three part timber mullioned window to the third floor – the left and right panes are side hung casements, to the centre is a fixed light below a top opening casement (Photo 056). To the next four bays there are timber mullioned windows similar to but shorter than those to the upper floors and without the lintels. There are ceramic vents above these windows. The fifth bay has the same style of window, but immediately below this is a part glazed door accessed via steps within low brick walls in English Garden Wall bond (Photo 009).

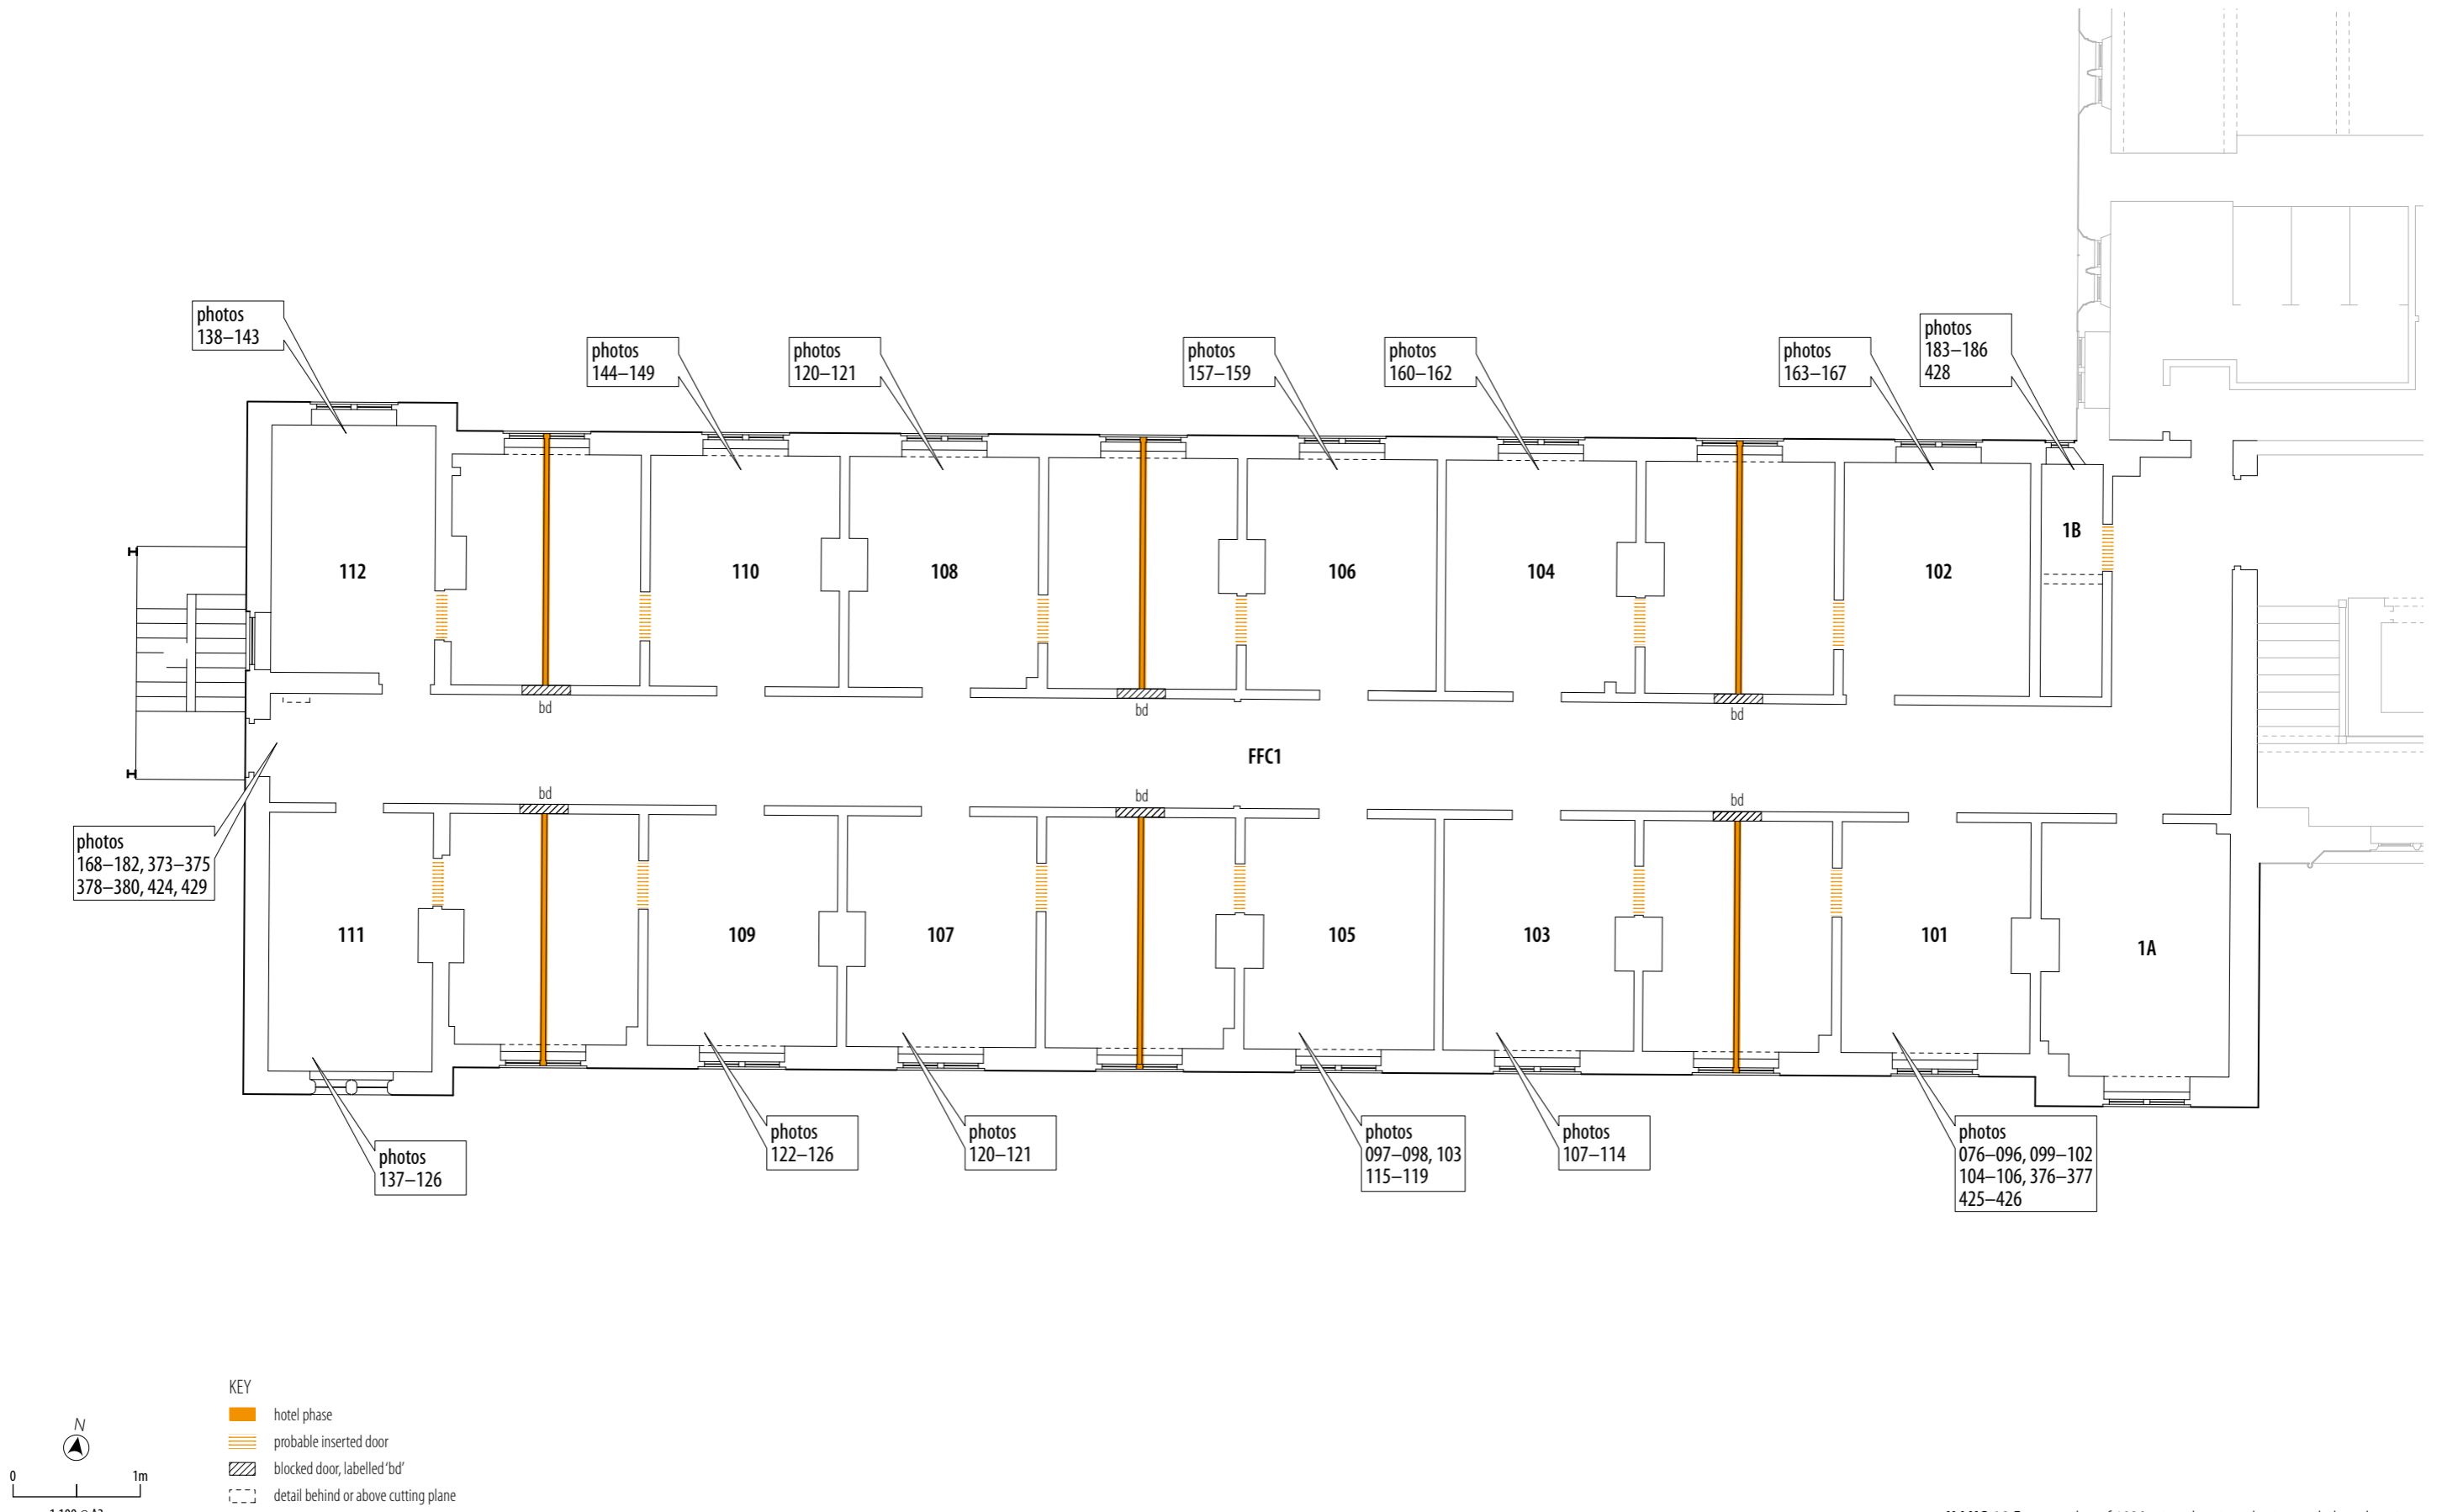
ILLUS 19 First oor plan of 1938 wing showing phasing and photo locations

The hotel bedrooms on the first and second floors had been created by the insertion of partitions through earlier bedrooms to create en suite bathrooms/shower rooms and the insertion of doorways through original walls to access these facilities. The original layout would have consisted of ten bedrooms on the south side of the corridor and seven on the north side on each floor – each of these rooms being heated by a fireplace – plus apparently unheated rooms in the northeast and northwest corners of each floor. With 17
