LAND ADJACENT TO STRATFORD ROAD, WOOTTON WAWEN, WARWICKSHIRE

ARCHAEOLOGICAL EVALUATION

commissioned by Waterloo Housing Group in association
with Warwickshire Rural Housing Association

December 2016

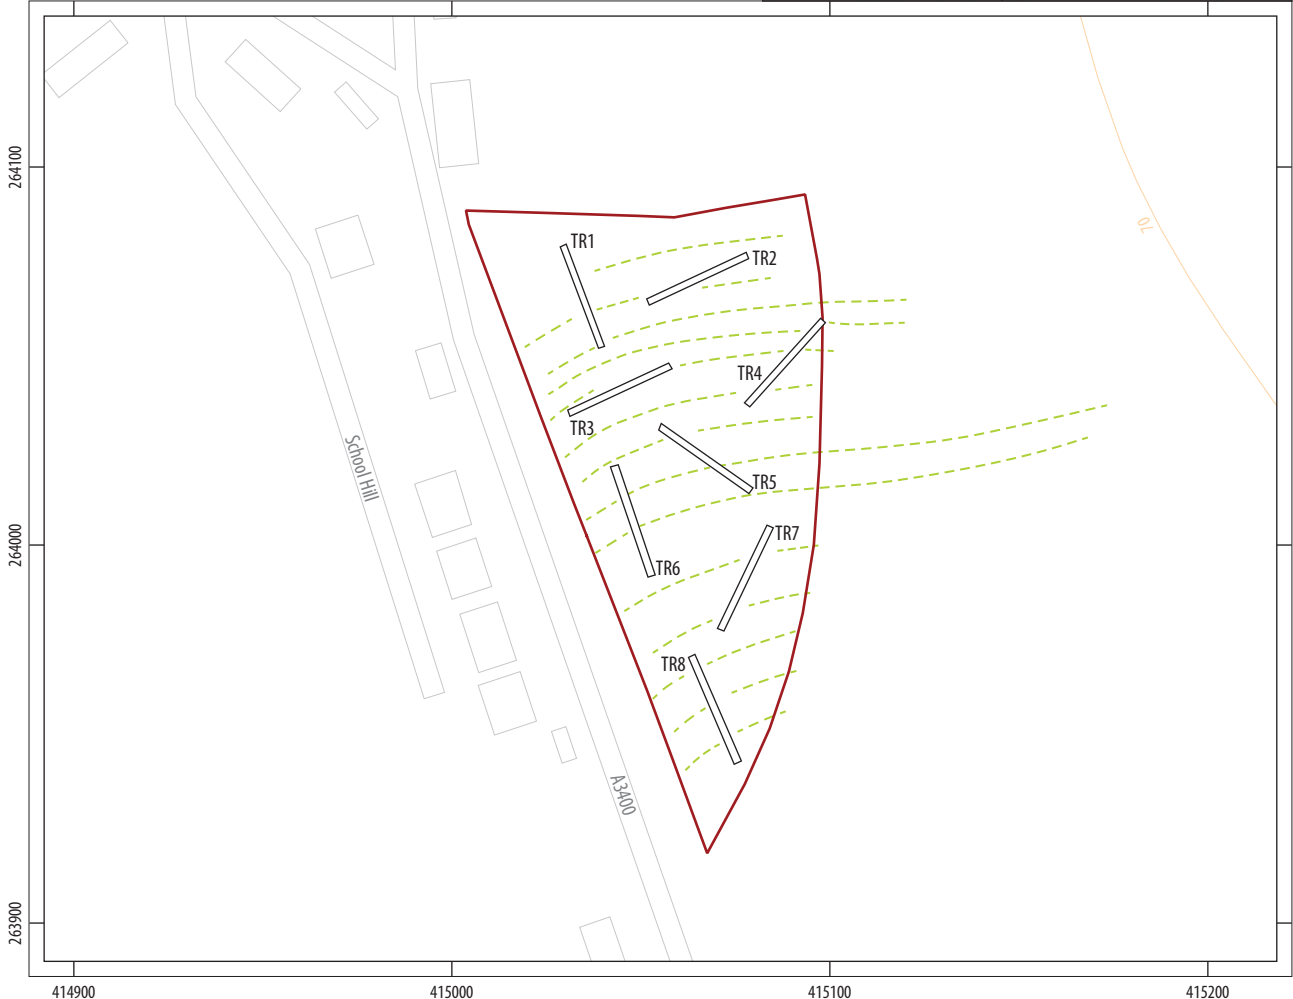
ILLUS 1 Site location

KEY
 [red line] development boundary
 [white rectangle] trench location
 [dashed green line] ridge and furrow

The site has an area of 9,500m² and is located at NGR 415022, 264060. The footprint of the eight trenches is located on a flat plateau with the ground falling away to the east (Illus 1). The site lies within the parish of Wootton Wawen, north of the historic village centre, adjacent to a small area of ribbon development associated with the village school and a former public house called the New Inn on the first Edition Ordnance Survey map. It is currently under pasture (Illus 2).

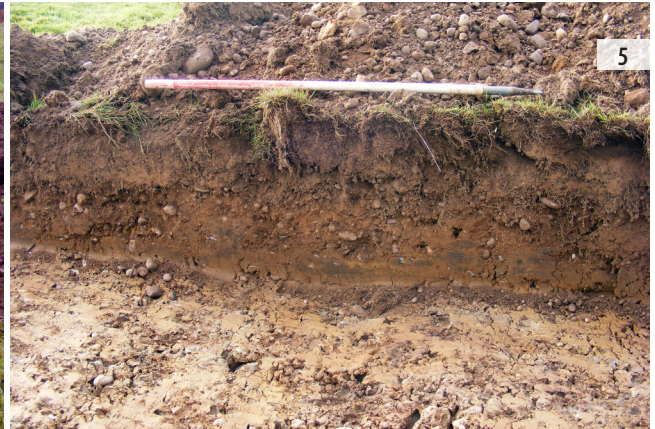
ILLUS 5 Trench 5, section showing topsoil/plough soil, facing SW

The basic site stratigraphy consisted of a topsoil (1001), composed of a dark greyish brown, sandy silt, measuring approximately 0.2m thick, overlying a sub-soil (1002), composed of a mid-orange brown, silty clay containing abundant rounded pebbles. This lower deposit equated to the medieval plough soil, and measured from 0.3 to 0.5m thick. The natural substrate was a very firm reddish clay, with patches of gravel. This sequence of deposits was seen in the sections of all the trenches.
