ALMSHOUSES, CHURCH WALK, LUDLOW, SHROPSHIRE

ARCHAEOLOGICAL WATCHING BRIEF

commissioned by Treasure and Son

December 2017

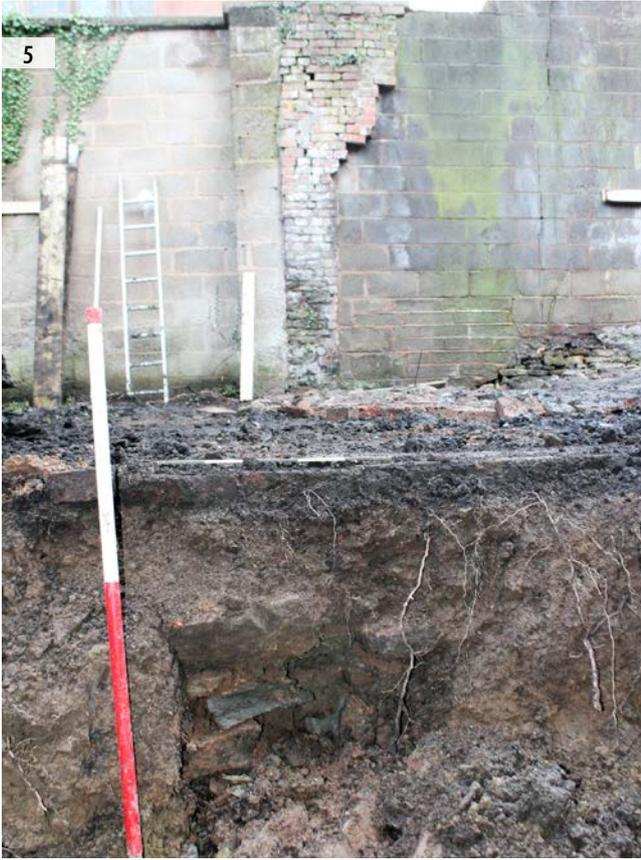
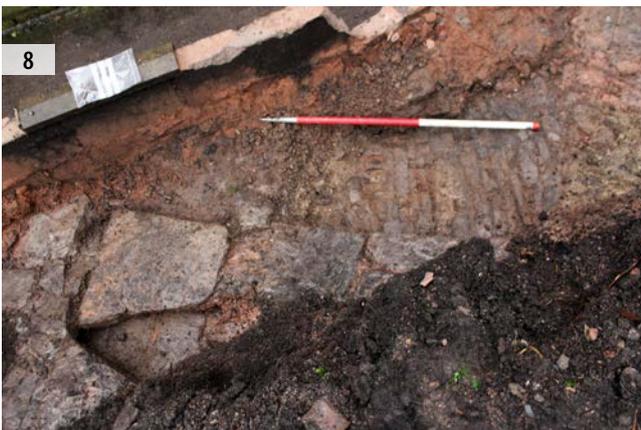
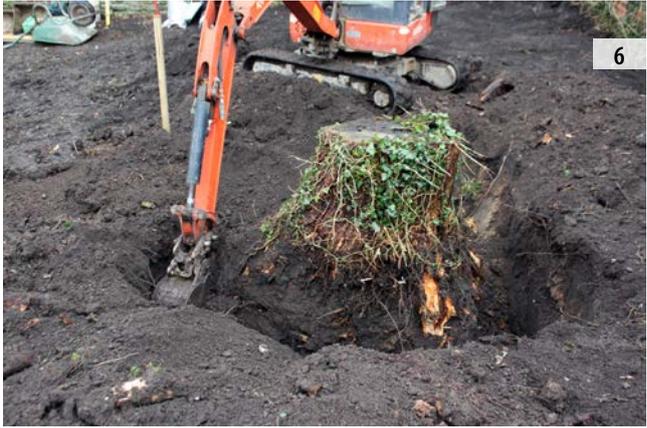
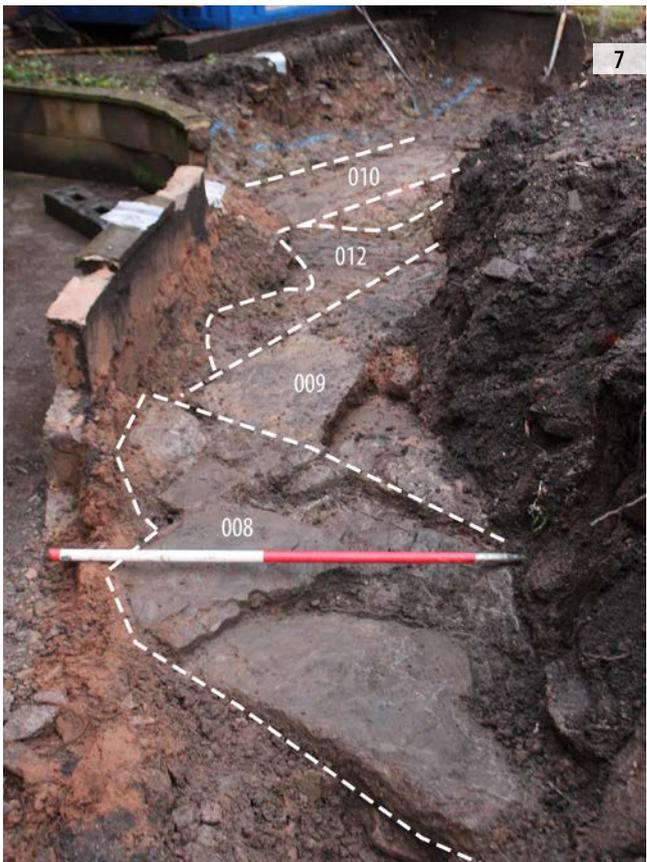
ILLUS 5 Wall foundation [014], showing scar on existing boundary wall, looking north
ILLUS 6 Removal of tree stump 3, looking east
ILLUS 7 View of wall foundations [008, 009, 010] and surface (012), looking east
ILLUS 8 Plan view of wall foundation [009] and stone surface (012)

of the site. The wall was observed to have gone through an element of modern rebuilding with part of its east-west length constructed of breeze blocks (Illus 5). Phases of construction or alteration were evidenced with sections of brick and stone construction, the latter possibly relating to the historic fabric of the original wall.

Within the southern retaining wall trench at 105.75m AOD, two stone wall foundations [008] and [009] (Illus 7) were identified. Oriented north-south [008] extended beyond the limit of excavation to the north and measured at least 0.75m wide with two rough courses surviving. Foundation [009] abutted [008] and was oriented east-west, extending beyond the limit of the trench to the west. Two courses survived measuring at least 1.05m wide. Both foundations were bonded with a light red clay containing gritty chalk or lime and charcoal fragments. The two foundations appeared to define the south-eastern corner of a building.

Cutting the possible subsoil (011) was a stone wall foundation [014] (Illus 5) which was oriented east-west turning north-south. The foundation survived to 3 or 4 course of roughly hewn blocks bonded with a soft light yellow sandy mortar. The foundation extended west beyond the site boundary in the direction of Church Walk. The north-south segment of the foundation lined up with the scar of a former wall in the extant Church Walk boundary wall and is likely to have represented a former outer wall of the Churchyard. The top of the foundation was recorded at 105.92 AOD.

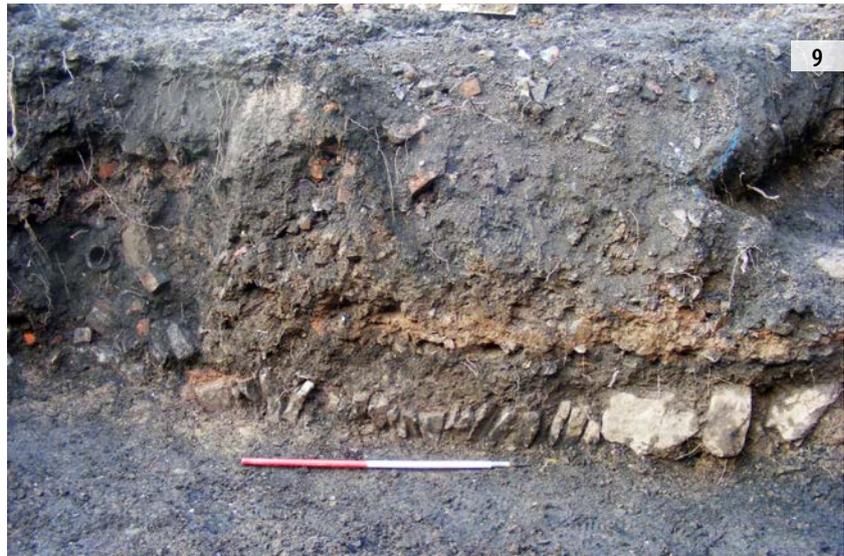
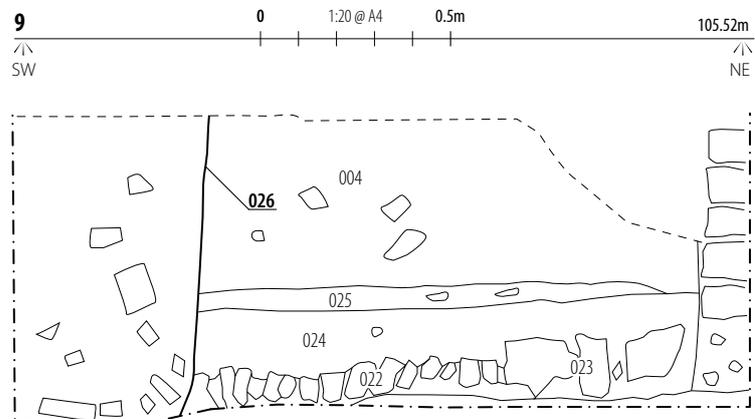
ILLUS 9 Stone surface (022) looking north-west and south-east facing section showing surface (022)

Further to the east, approximately 4m, and identified in the base of the section of the foundation trench a similar stone surface [022] (Illus 9) was recorded. Angular stones, up to 0.20m deep, were set vertically into a yellow-brown sandy clay (020). A similar deposit, (013) was identified with patchy survival around the wall foundations [008], [009], [010] and stone surface [012] and was interpreted as being a buried medieval soil horizon, contemporary with the structural remains.

To the eastern end of [022] three angular stone blocks [023] (Illus 9) abutted the vertically laid stones and were interpreted as a form of edging or revetting of the stone surface. The possibility of these stones relating to a truncated wall foundation cannot be precluded, though no bonding material was observed nor any continuation of the feature to the north or south due to the limited trench excavation.

Located to the north of the perimeter foundation trench and associated with demolition and construction were deposits (007) and (025) (Illus 9). Containing frequent charcoal, chalk or lime fragments, mortar and ceramic building material fragments with a large amount of oyster shell, (007) measured some 0.18m thick and extended greater than 0.90m north-south. The deposit was interpreted as being a dump of material related to construction on the site. A clay pipe bowl dating to 1660-1680 was recovered from the layer. Similarly (025) was a 2.50m long, 0.12m thick dump of orange-yellow sandy clay overlying the buried soil (024) and was also interpreted as a dump of material relating to construction and/or demolition on the site.

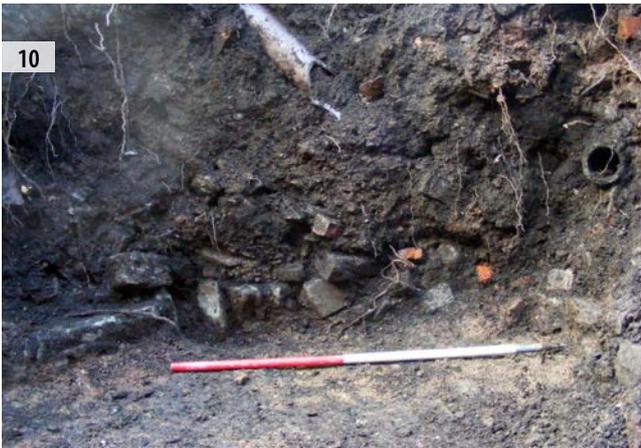
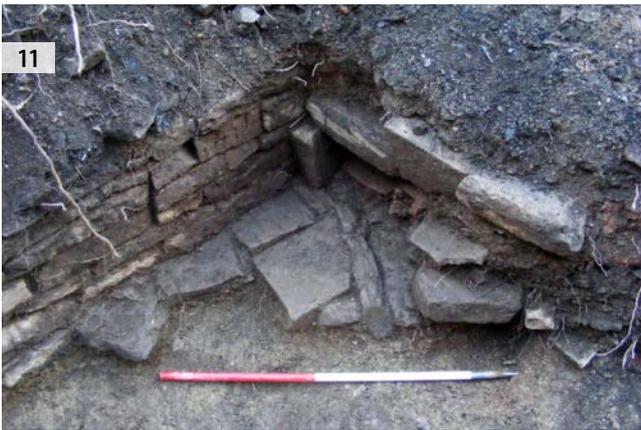
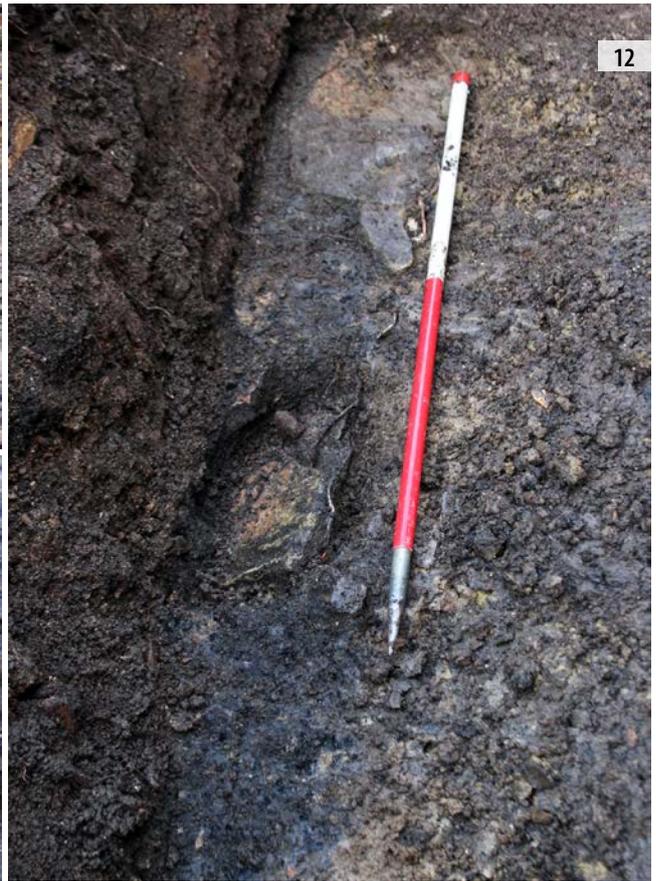
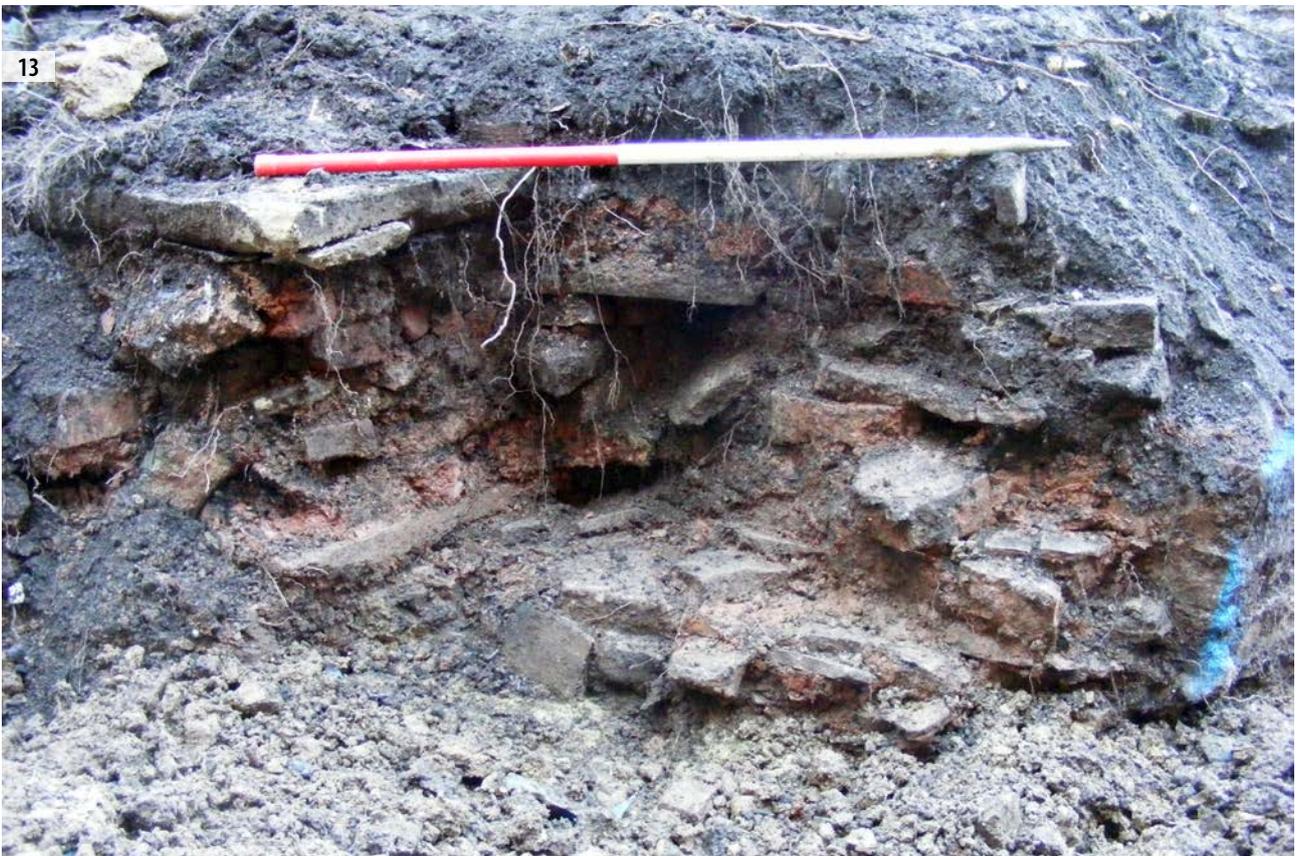
ILLUS 10 Stone surface (035) below evaluation trench backfill, looking north-west **ILLUS 11** Plan view of stone surface (019) **ILLUS 12** Wall foundation [032], looking north **ILLUS 13** Corner of wall foundation [016] and demolition rubble (017), looking north-west

A further laid stone surface [019] was identified within the foundation trench (Illus 11) with angular stone slabs laid primarily horizontally over the buried medieval soil (020). During post-excavation assessment, remnants of this surface were observed to continue to the east and assigned a context number (035) (Illus 10). This appeared to represent variably surviving remnants of a continuation of a stone surface linking with [022] evidencing a continuous laid stone surface extending some 4m east-west and 9m north-south.

To the extreme north and east of the foundation trench, a linear feature [032] (Illus 12) was partially exposed, oriented north-south and measuring greater than 0.30m wide and 2m long extending beyond the limits of the excavated area to the north, south and west. The feature was filled with a dark grey slightly silty sandy clay (031) which contained frequent angular stones, charcoal fragments and occasional animal bone. Pottery dating to the 13th century was recovered from (031). From test investigation some of the stone was set in situ whilst the majority were randomly dumped. The feature was interpreted as a robbed out wall foundation which had been backfilled with general debris. As the feature lay predominantly outwith the excavation area and below formation level for the development, fuller investigation was not afforded.

Oriented north-south and located in the section of the foundation trench, a wall [016] (Illus 13–14) was identified measuring greater than 2.02m north-south, extending north beyond the excavation limit. The width of the wall could not be ascertained but it was noted to return and run east-west. The wall was constructed of roughly hewn, angular stone slabs and comprised 5 to 6 rough courses bonded in a pinkish orange clay. No foundation cut was visible. The top of the wall was recorded at 106.04m AOD.

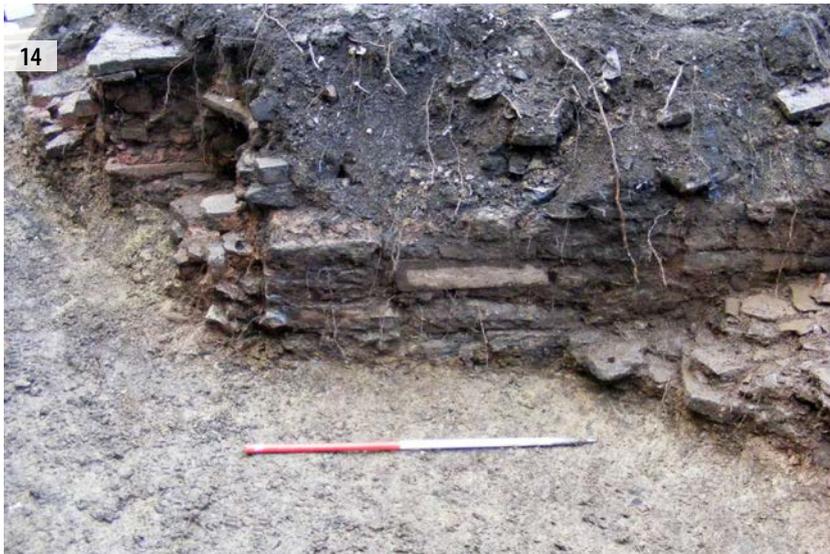
ILLUS 14 Wall foundation [016], looking west and east facing elevation of wall foundation [016]

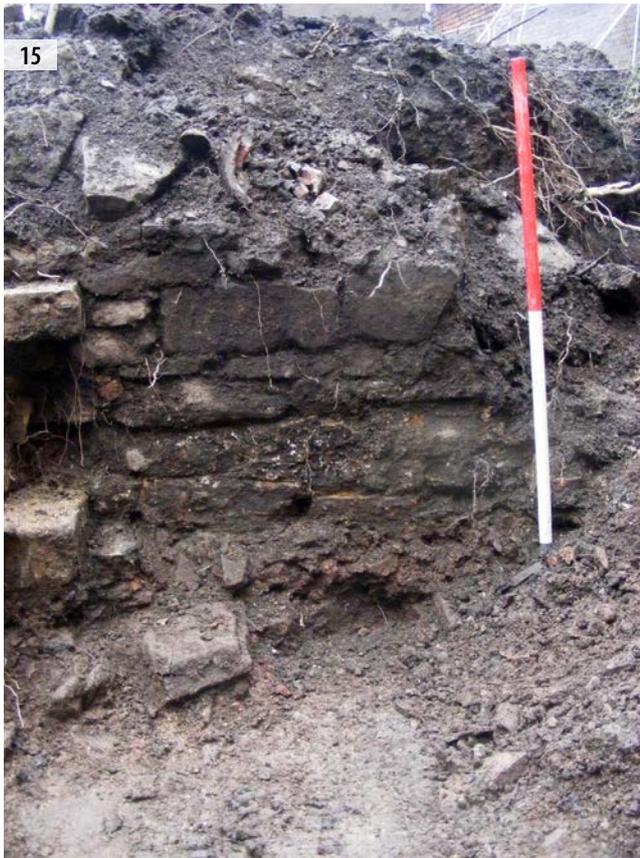
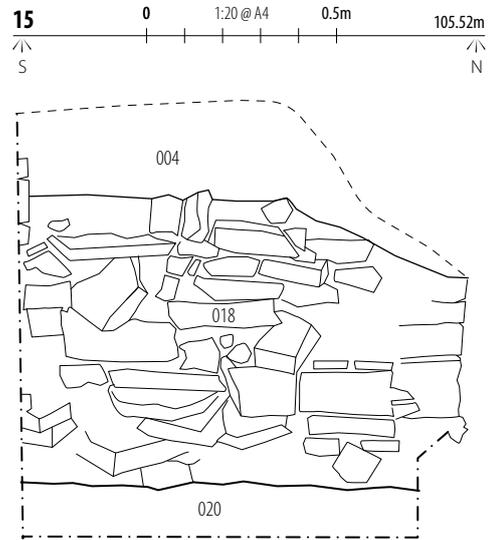
ILLUS 15 Wall foundation [018] looking south and east facing elevation of wall foundation [018]

Slightly east of [016] was a further wall [018] (Illus 15). The wall was oriented east-west and comprised six courses of roughly hewn stone slabs or blocks, demonstrating a similar construction methodology to [016]. Due to the limit of the excavated area, no relationship between [016] and [018] could be positively attested, though it is likely they were associated. The top of wall [018] was recorded at 106.08m AOD and it appeared to have a foundation deposit of orange brown sandy clay (021), though this may equally have been a disturbed medieval soil horizon in line with (013) and (020).

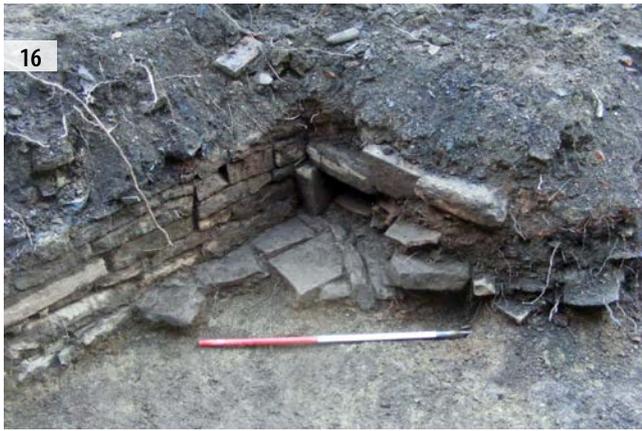
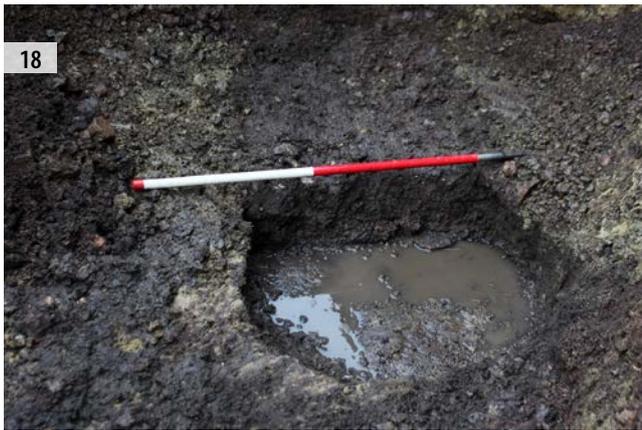
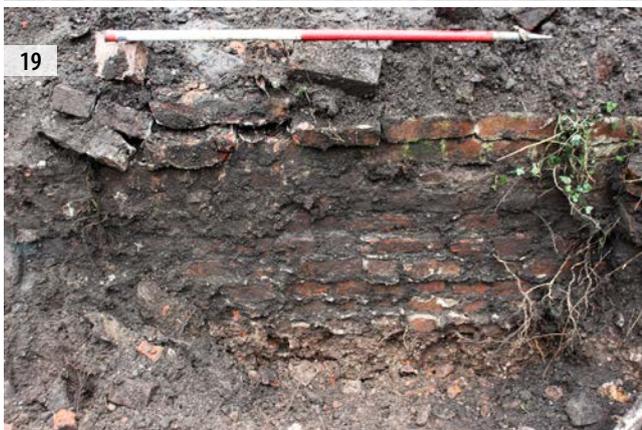
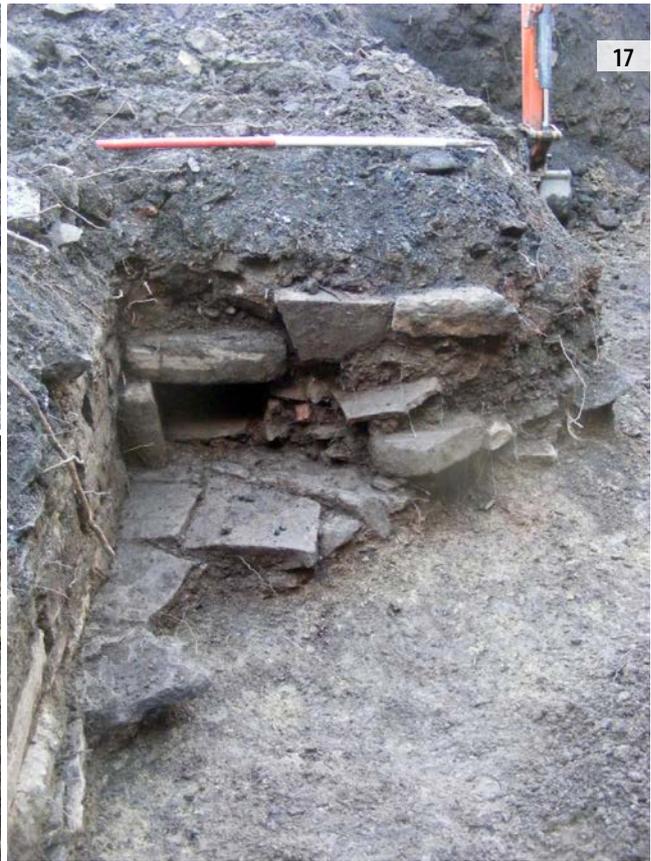
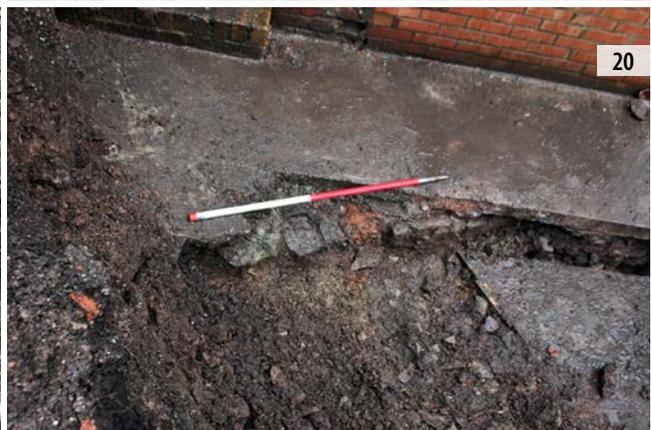
ILLUS 16 General view of wall foundation [016] and stone surface (019), looking north-west **ILLUS 17** South facing elevation of wall [016] **ILLUS 18** Section through pit [030], looking north **ILLUS 19** Wall foundation [005], tree stump pit 1, looking north **ILLUS 20** Stone culvert remnant [028], plan view

It was observed that both walls overlay and were constructed on the earlier stone surface. Wall [018] overlay [035], and [016] was constructed upon [019] (Illus 16 and 17).

Immediately north of the culvert at approximately 105.60m AOD, an oval pit [030] measuring 0.78m wide and slightly greater than 1.50m long was identified as a midden pit with near vertical sides and a flat base (Illus 18). The pit survived to 0.21m depth and was filled with a dark grey slightly silty sandy clay. Pottery dating to the 14th–16th centuries was recovered from the feature together with animal bone, iron slag and stone tile. An environmental sample taken from the deposit was found to contain further animal bone and charcoal and would support interpretation of the feature as a midden pit.

Also located beneath and within the topsoil was a brick wall [005] (Illus 19) and associated brick surface [006]. The brick wall was partially visible above ground and on clearance of vegetation both elements were observed in the central northern area of the site. The wall was oriented east-west and was noted to branch to the north. During reduction of the western segment of the site for foundation construction, the brick surface was observed to lie below the topsoil deposit and extend to the limits of the present site boundaries.

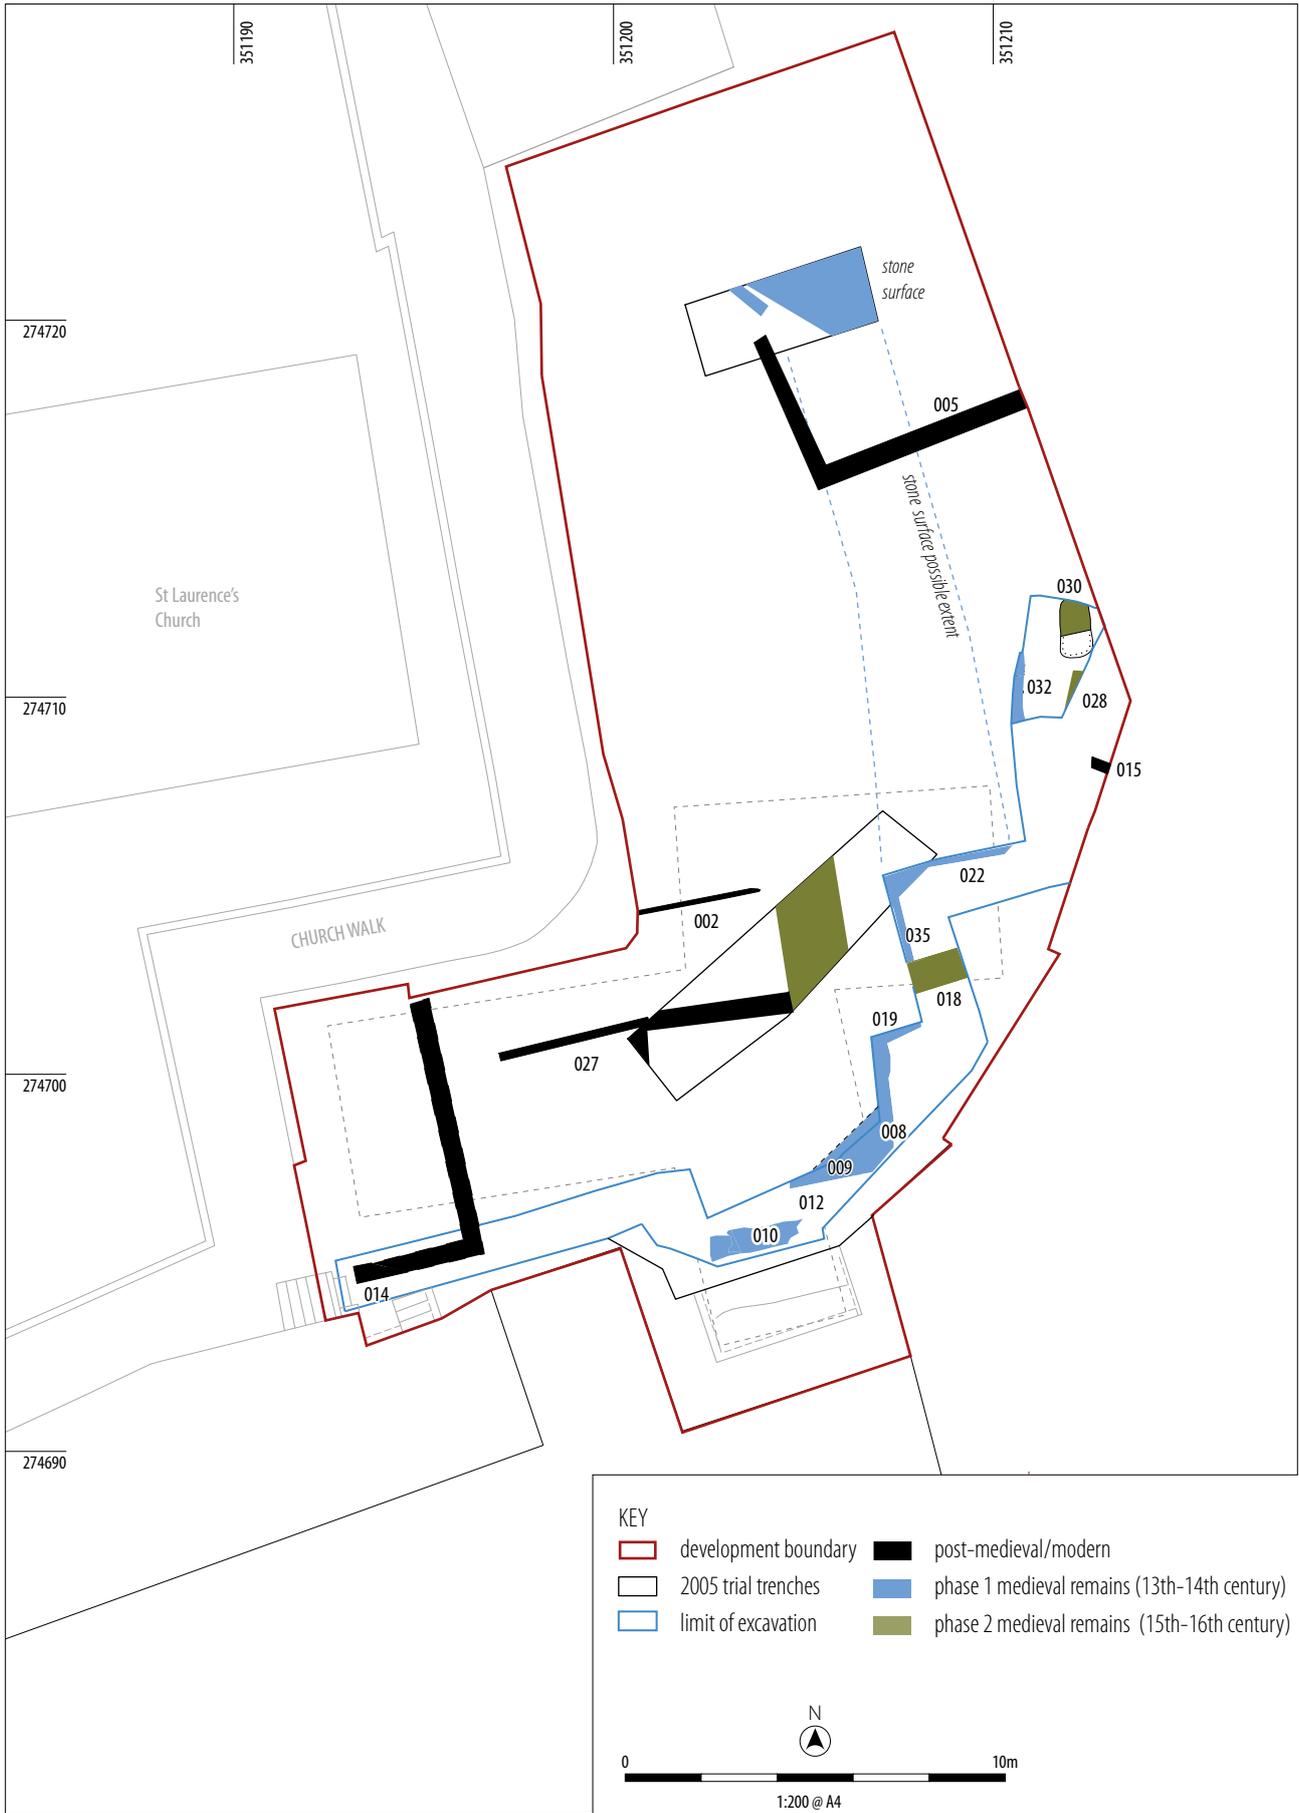
- development boundary
- 2005 trial trenches
- limit of excavation
- post-medieval/modern
- phase 1 medieval remains (13th-14th century)
- phase 2 medieval remains (15th-16th century)

The earliest phase relates to medieval activity on the site in the form of the south-eastern corner of a building, an associated stone surface, a further stone wall foundation and stone surface, represented by contexts [008, 009, 010, 012, 032 and 019/022/035/023].
