# CATHEDRAL RESTAURANT, HEREFORD CATHEDRAL

## ARCHAEOLOGICAL EVALUATION

commissioned by Robert Kilgour Architects Ltd  
on behalf of Dean and Chapter, Hereford Cathedral

September 2017

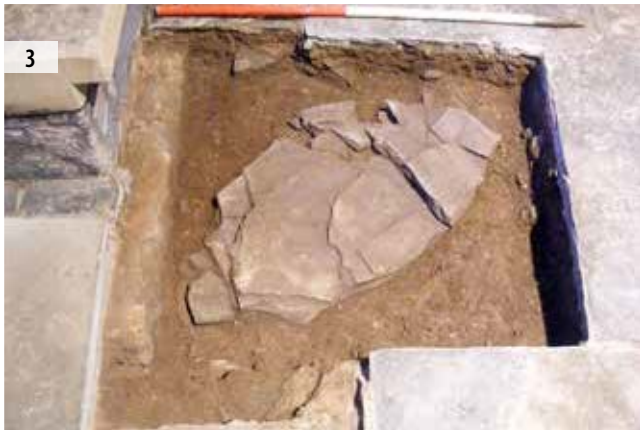
**ILLUS 3** Fragment of possible old stone floor surface looking north **ILLUS 4** Post-excavation of Test Pit, showing cuts [005] centre, and [008] on right, looking north  
**ILLUS 5** South facing section showing current and previous floor leveling deposits

Immediately below the current floor and levelling deposit, a fragmented stone slab (003), measuring 0.93m x 0.48m and aligned NE-SW was encountered. The slab did not display evidence of tooling for edges or facing; it was elliptical in shape, and was 0.05m thick. Occasional fragments of similar stone were observed at the same level. Collectively these stones may represent the remains of an earlier floor surface (Illus 3). These stones were underlain by a levelling deposit of silty clay (004), with frequent stone inclusions and occasional disarticulated bone fragments which may be from disturbed burials in lower deposits.

Below this it seems likely that the remains of an earlier stone floor may survive in a poor state of preservation. This floor (003), along with its associated levelling deposit (004), reach a depth of 0.29–0.30m. The level of this possible previous floor is at, or just below, the level of the stepped out foundation of the west wall of the east cloister (Illus 5). This raises the possibility that this well faced masonry was at least partially visible when this floor was in use.
