CUSTOS LODGE, VICARS CHORAL, HEREFORD CATHEDRAL

ARCHAEOLOGICAL TRIAL PIT EVALUATION

commissioned by Robert Kilgour Architects Ltd
on behalf of Dean and Chapter, Hereford Cathedral

March 2017

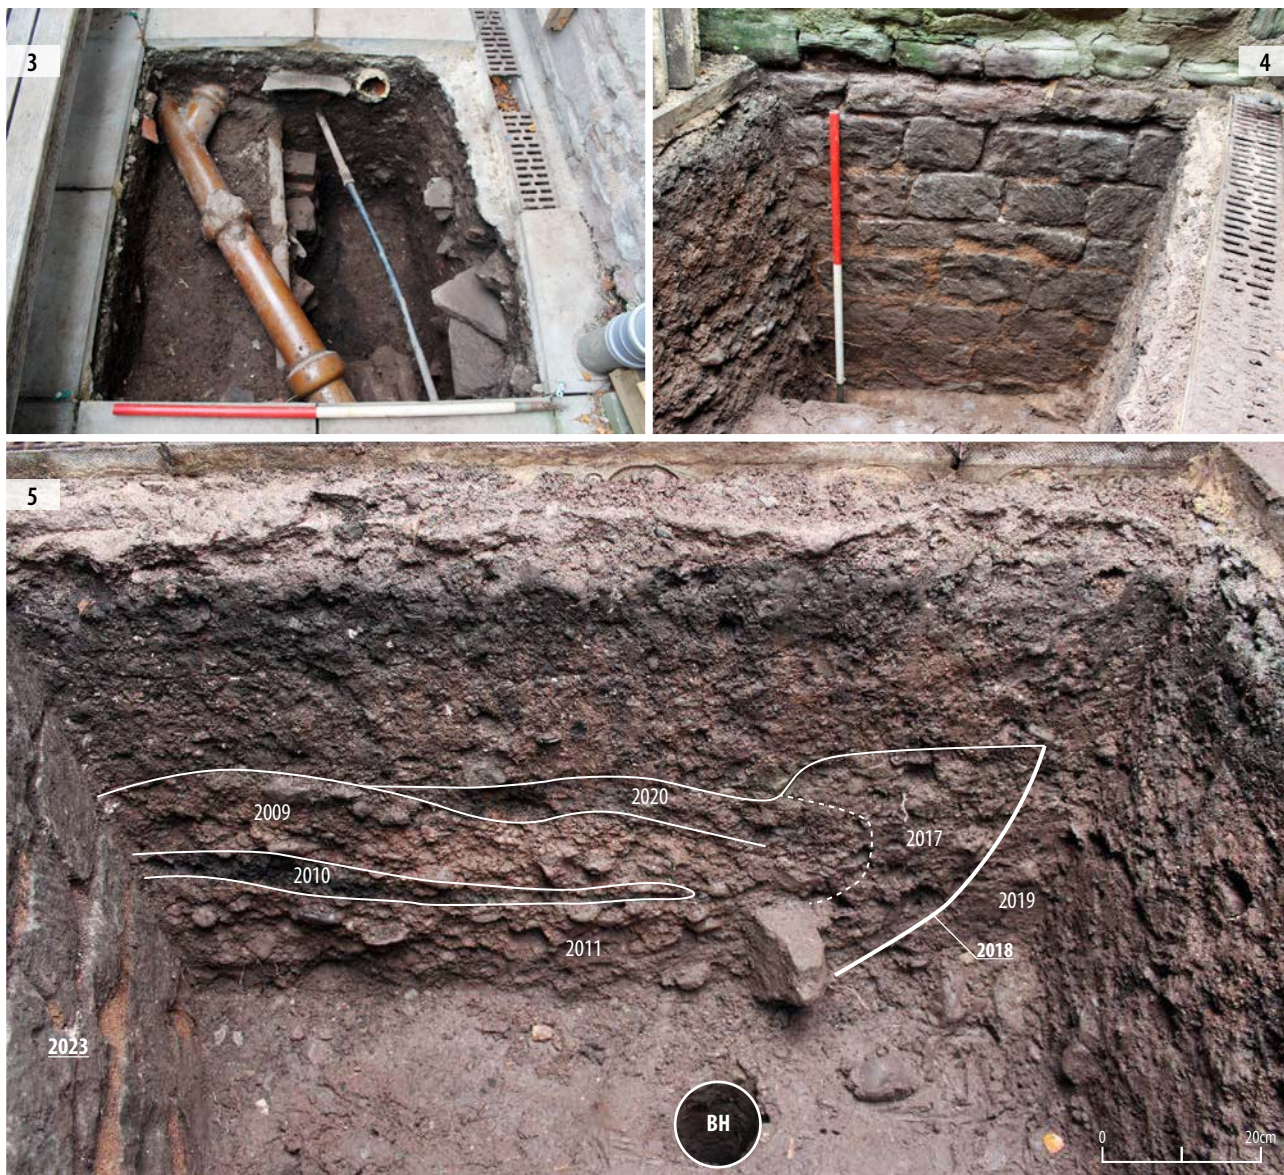
The excavated trench measured 1.2m x 1.2m by 1m deep (Illus 3). The concrete paving slabs had been removed by the main contractor prior to excavation as specified in the WSI.

ILLUS 3 Trench 1 post-excavation facing north **ILLUS 4** Trench 2 post-excavation facing west including Bishop’s Palace garden wall **ILLUS 5** Trench 2 facing north. Path deposits against Bishop’s Palace garden wall

Undisturbed archaeological deposits were observed from a depth of 0.44m BGL, sealed below the make-up and levelling deposits described (Illus 5). Four deposits were observed (2009), (2020), and (2017) being fills of a cut [2018] made through underlying deposit (2019). The primary fill (2017) of this cut was a soft greyish sandy clay. At the base of this fill, were stones that measured up to 0.35m x 0.20m x 0.15m and ran parallel to (and 1.0m to the east of) the Bishop's palace wall [2023]. They formed the base level of kerbing that retained a deposit to their west.

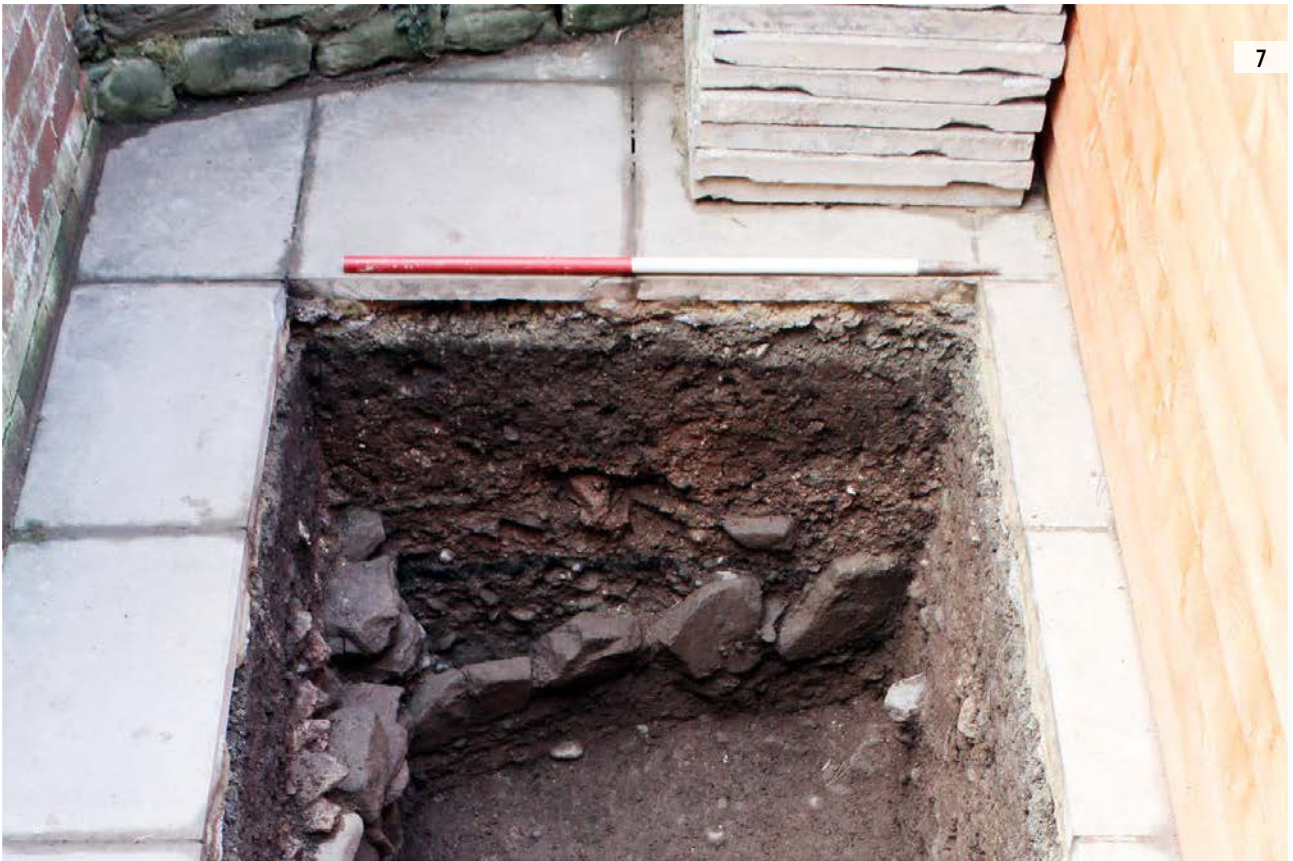
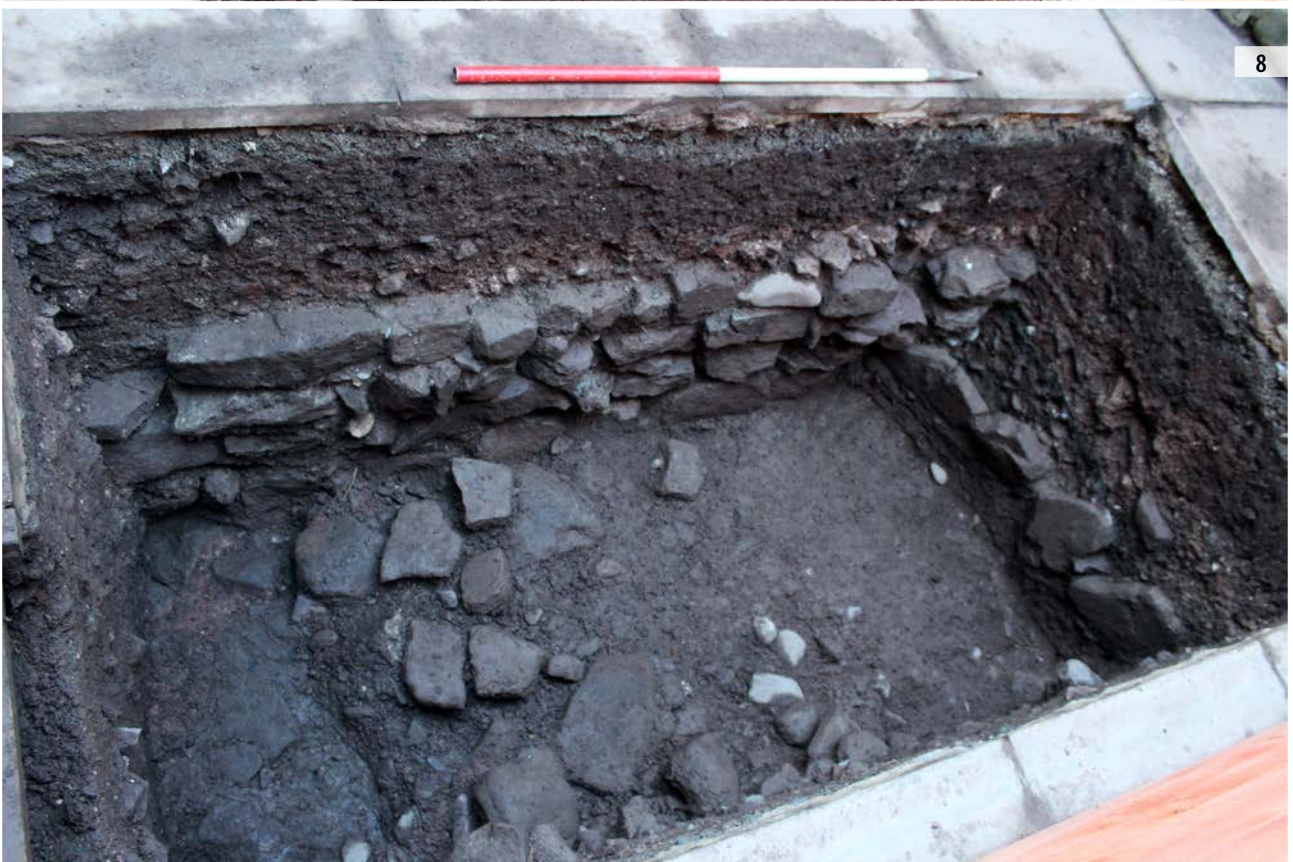
ILLUS 7 Trench 3 facing west. Alignment and level of gravel path which runs along Bishop's Palace wall and through Trench 2 to northwest; runs up to wall visible in section to the south **ILLUS 8** Trench 3 mid-excavation facing southwest, showing path, walls and surface

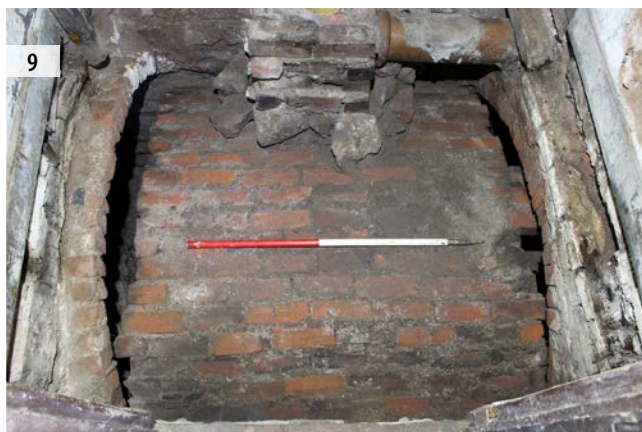
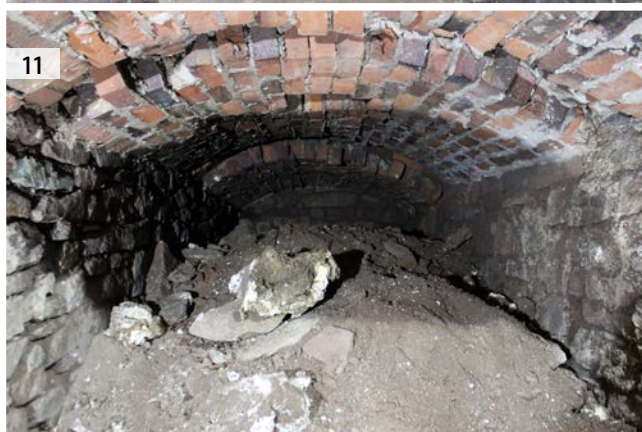
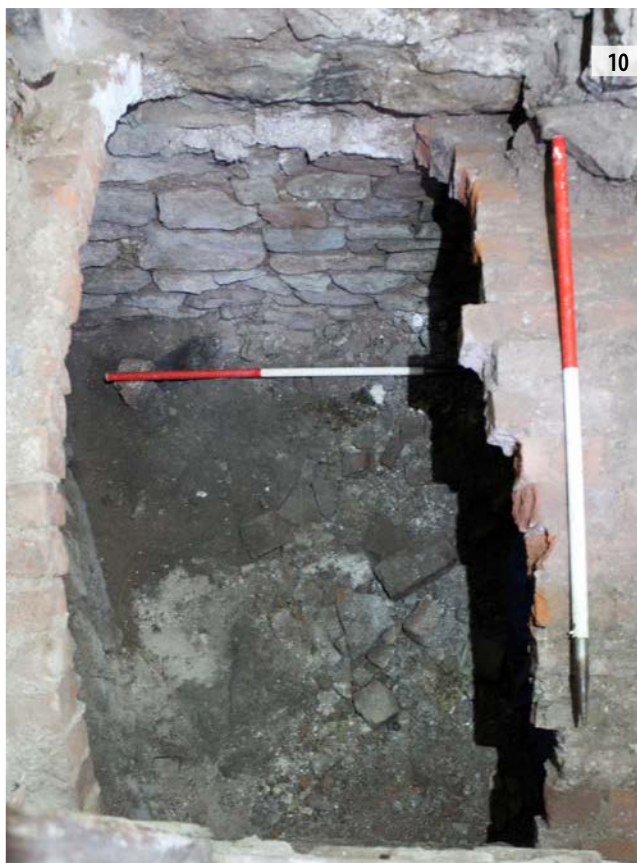
ILLUS 9 Trench 4, brick vaulting exposed below floor of extant Victorian building, facing north **ILLUS 10** Trench 4, partially removed brick vaulting revealing void below prior to excavation, facing north **ILLUS 11** Trench 4 facing east. View along the void beneath brick vaulting

extant structure, which were found to be constructed upon brick arched foundations [2090]. Underlying (2024) and [2078], was a deposit of sandy clay (2025), between large stones which filled the gap between the south wall and the sloping sides of an east-west aligned brick vault [2070]; the same sequence of deposits was evident against the north wall. These stones also ran north to south along both the east and west sides of the room, where they blocked voids between the brick vault [2070] and brick arches [2090] (Illus 9).

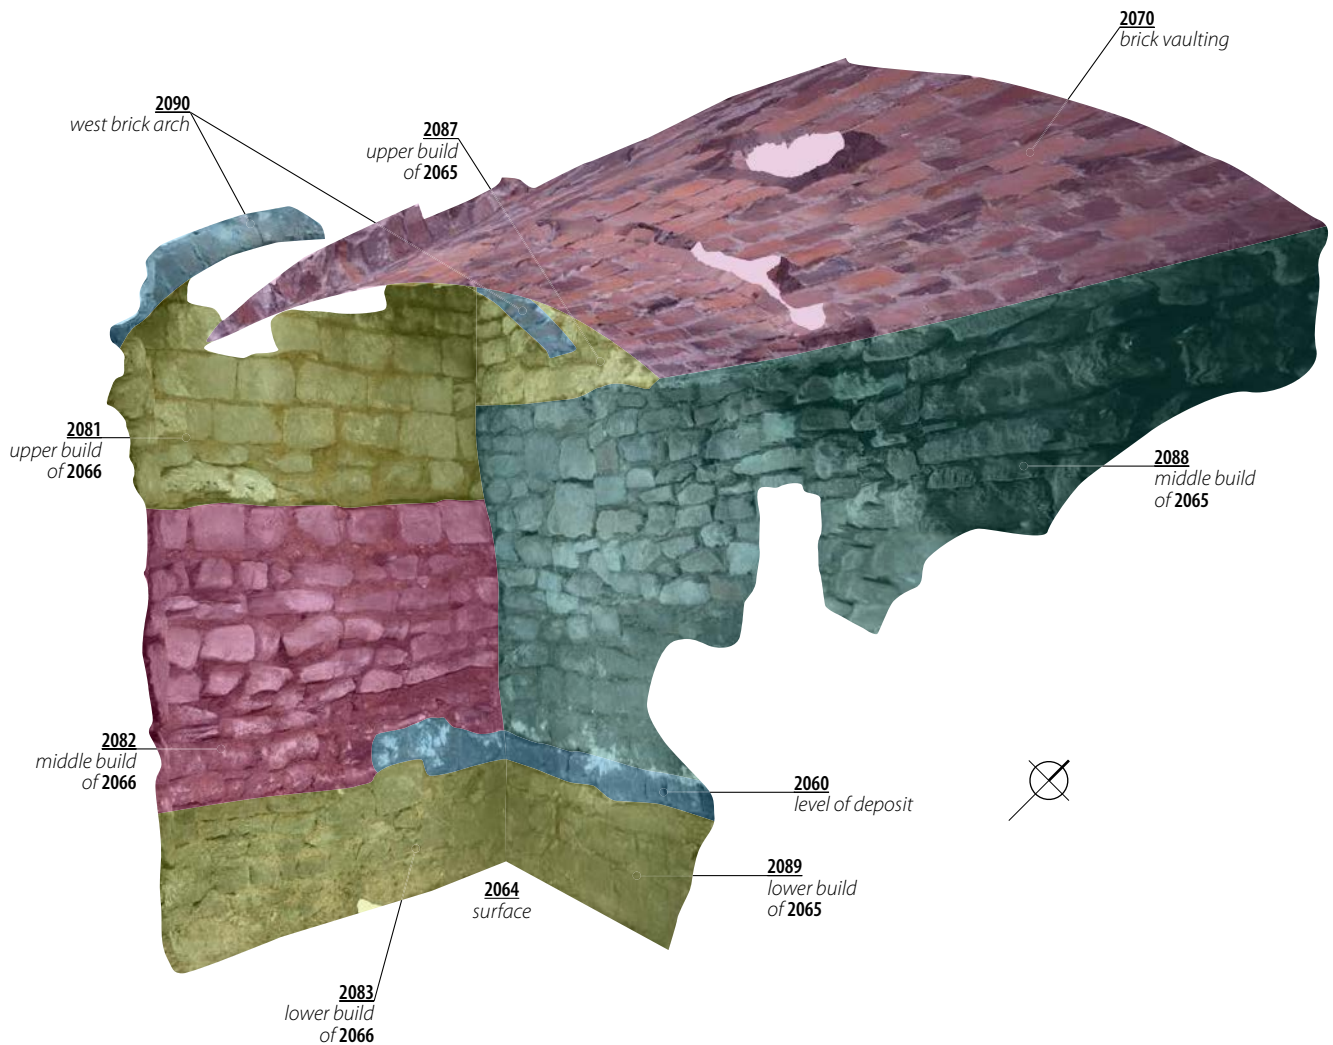
ILLUS 12 Trench 4. Image taken from photogrammetric survey of the brick vaulted area below the extant victorian building, looking to northwest corner

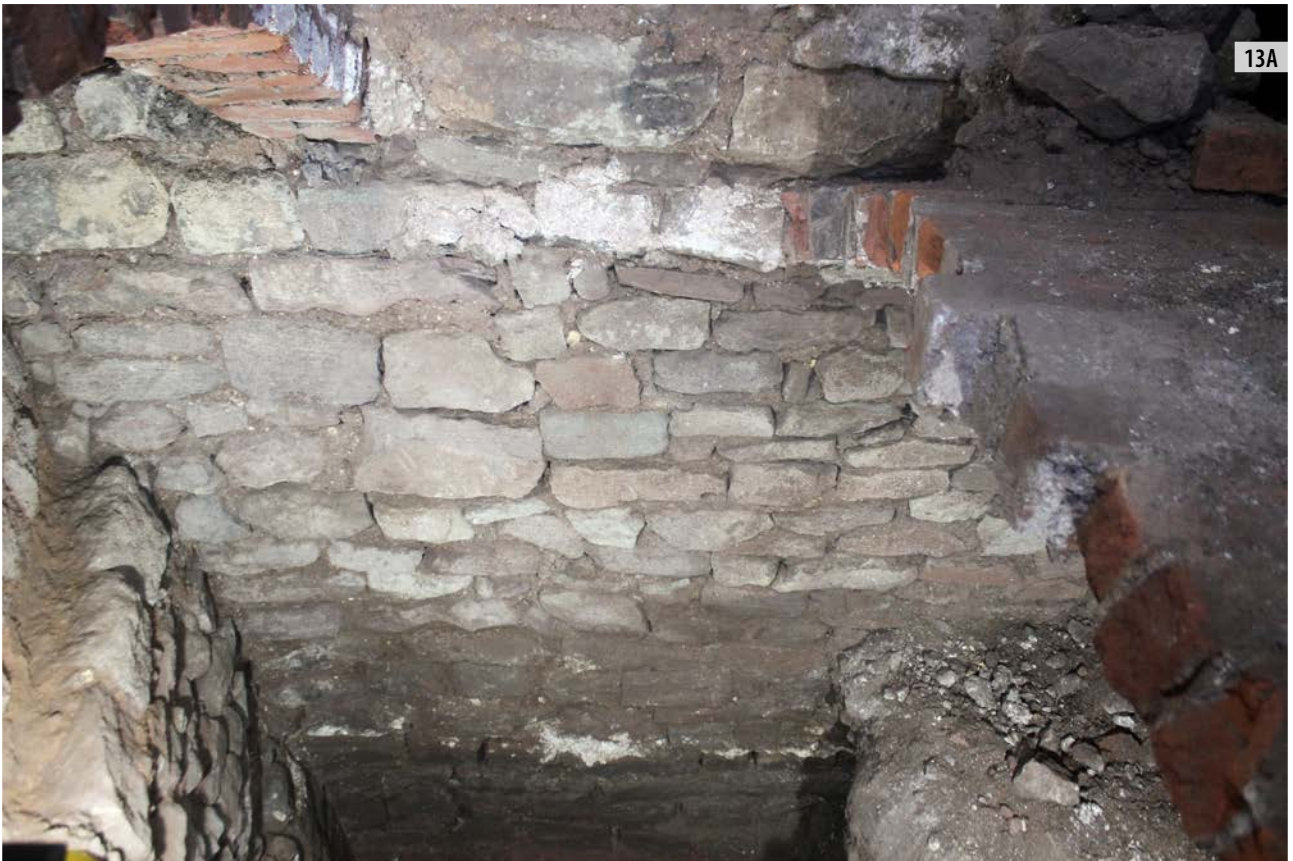
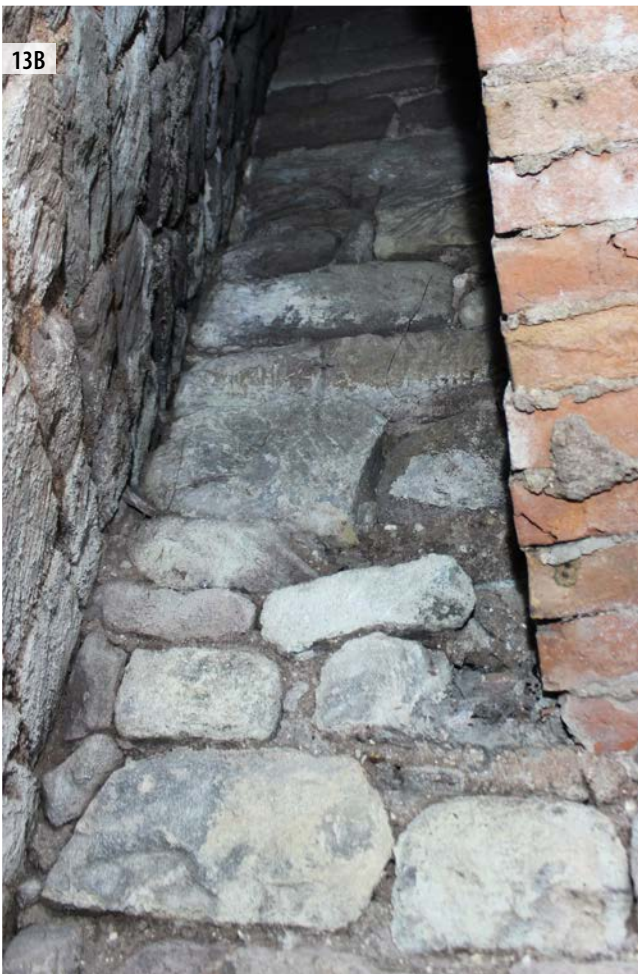
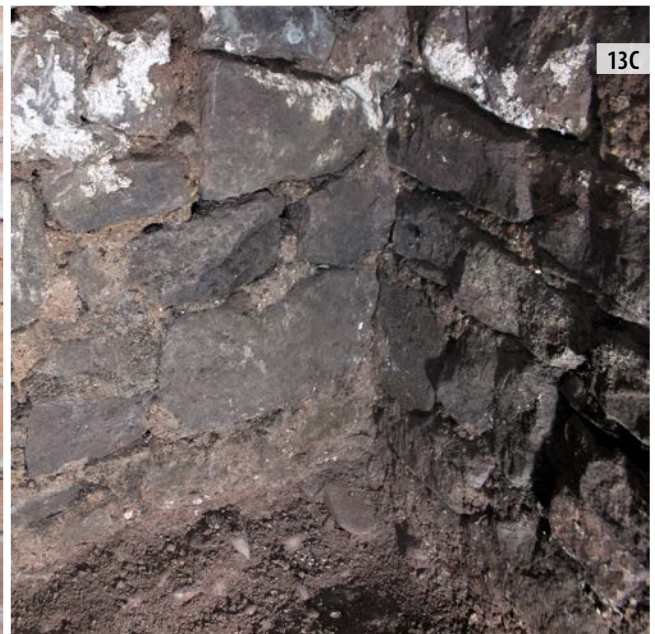
ILLUS 13 Trench 4 **A)** Current ground level to base of walls, facing north **B)** Walls butting at higher levels, facing north **C)** Walls tied in together at base, facing northwest
