ABBAY VIEW ROAD, PINVIN

ARCHAEOLOGICAL EVALUATION

commissioned by Adcock Associates
on behalf of Bridgeview Pension Scheme

W/11/01867

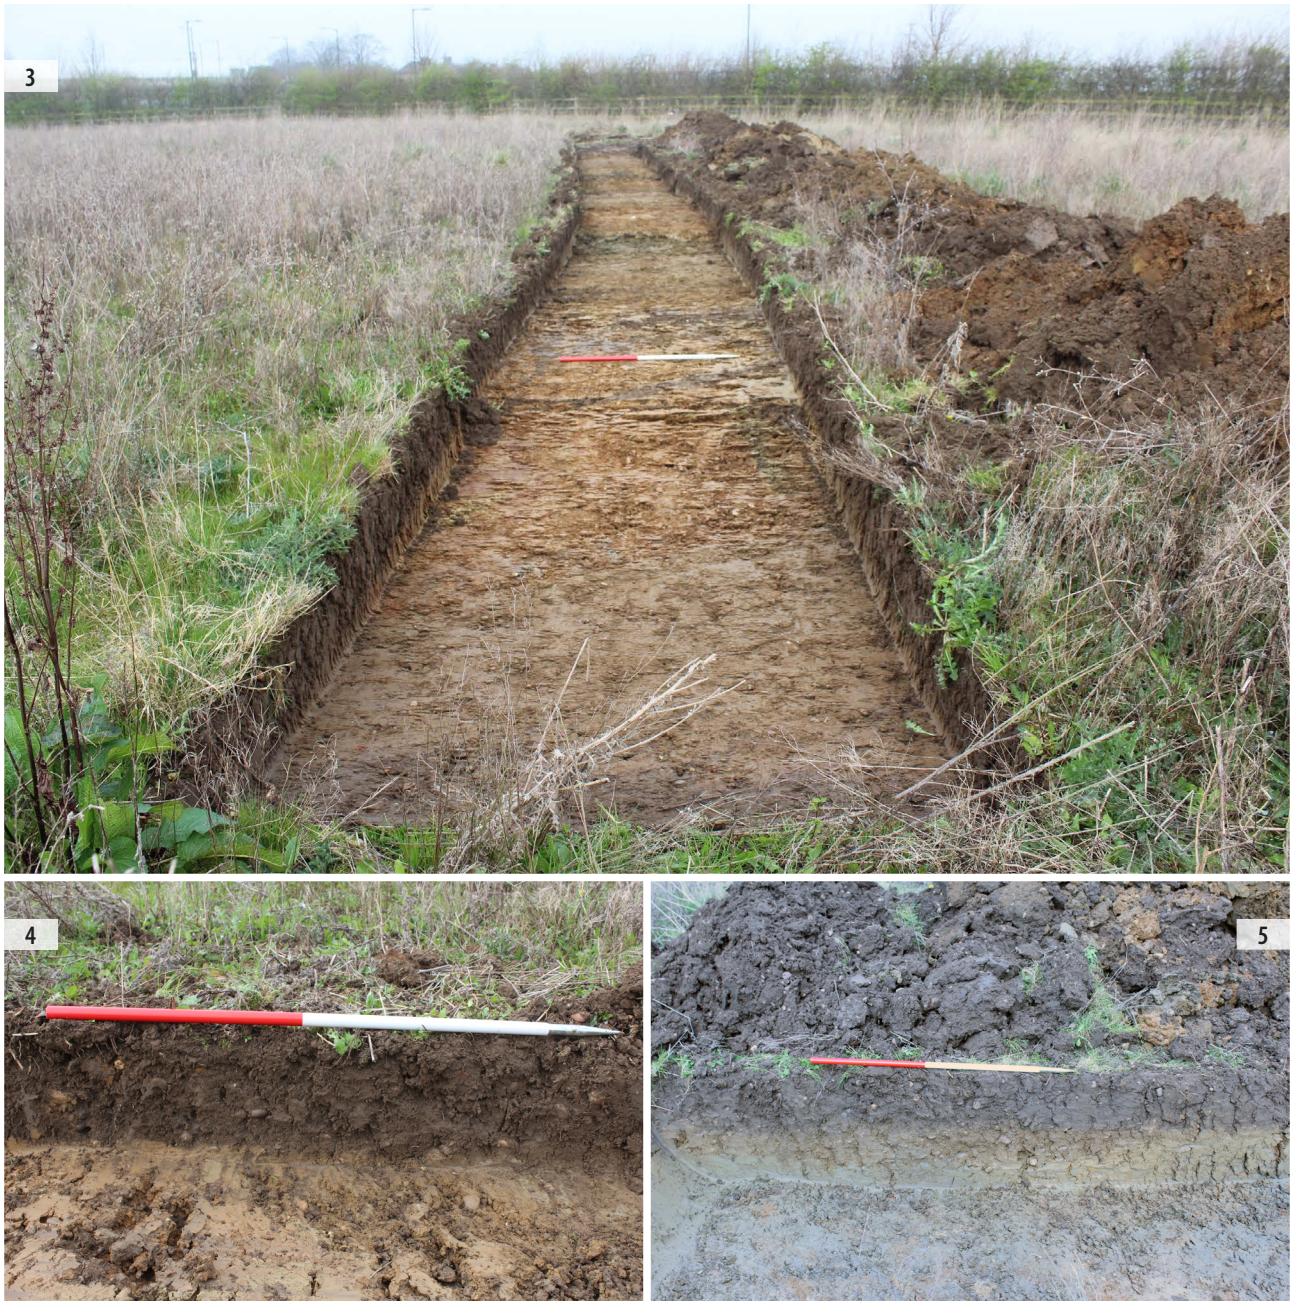
ILLUS 3 Trench 1; looking north-west with furrow in foreground **ILLUS 4** Trench 1; south-west facing section **ILLUS 5** Trench 8; south-east facing section through furrow (08003)

Trench 1 (Illus 3 and 4) measured 30m long and 1.8m wide and was located toward the north-western corner of the site on a northwest-southeast orientation. The natural geology (01002) was represented by mottled orange and buff clay-sands with sporadic

areas of rounded gravels, encountered at a depth of 0.30m below the current ground surface (BGS). The deposit was truncated by the remains of four, north-south aligned, linear features measuring up to 3.0 m wide. The features were interpreted as the remains of furrows (01003). In at least two cases the furrows were truncated by modern land drains on the same alignment. The overlying topsoil (01001) was composed of a 0.30m deep sandy, humic, mid-dark brown material with a moderate number of pebbles throughout its matrix. It had an unusually sharp interface with the underlying natural layer and there was no evidence of a subsoil being present.

Trench 8 (Illus 5) was located to the north-east of Trench 7, at the approximate centre of the site, oriented northwest-southeast. The soil horizons encountered reflected the same pattern as the trenches around the northern portions of the site. The natural (08002) was encountered at a depth of 0.30m BGS and was truncated by four large furrows. The furrow at the western end of the trench (08003) was investigated, revealing a shallow, 0.20m deep, gently sloping concave profile. The surface deposit of topsoil (08001) had the same remarkably sharp interface with the lower stratigraphic unit.

08003 4 furrows, appx 3m wide crossing trench on N-S alignment. 1 at western end investigated. Furrow has gently sloping sides and concave base and contains single light brown silty clay sand deposit with occasional charcoal flecking. Survives to depth of 0.20m

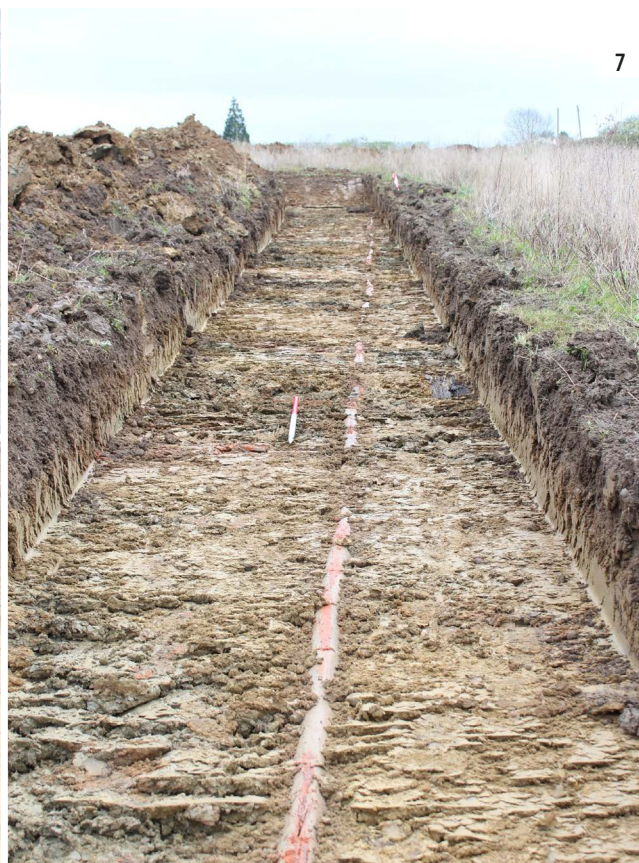
ILLUS 6 Trench 7; north-west facing section showing subsoil (07002) **ILLUS 7** Trench 6; looking south-east showing land drains **ILLUS 8** Trench 11; south facing section of former field boundary [11004]

The same sequence was observed in Trenches 6 and 7 (Illus 6 and 7), which revealed the continuation of the land drainage system observed in Trench 5. Each was 0.60m deep and were positioned on northwest-southeast and northeast-southwest alignments respectively.

Trench 11 was located in the south-western corner of the site, parallel with the southern site boundary. The natural clays (11001) were revealed at a depth of 0.64 BGS and were cut by not only a network of land drains, but also a north-south aligned ditch [11004] (Illus 8) and a small post-hole [11005]. Both the features appeared to be cut through the layer of subsoil (11002) that was encountered across the southern part of the site. The ditch measured 0.53m wide and at its interface with the natural had relatively steeply sloping sides and a narrow, concave base. It was filled by a single deposit of mid-brown sandy clay (11006), with charcoal flecks occurring occasionally throughout its matrix. The sub-rectangular post hole, located 2.20m to its south-east, was filled with a similar deposit (11007), from which a small fragment of modern ceramic building material was recovered. It measured 0.20m long, 0.15m wide and 0.17m deep, with near vertical sides and a flattened base. Numerous land drains could be seen throughout the trench.

TR11	ORIENTATION	L (M)	W (M)	AV. D (M)
	NW-SE	30.0	1.80	0.60
CONTEXT	DESCRIPTION			DBGL (M)
11001	Topsoil – Mid-brown humic clay sand with pebbles			0.00–0.30
11002	Subsoil – orange-brown sand clay with patches of rounded pebbles and flecks of charcoal.			0.30–0.60
11003	Natural – bright yellow with grey mottling and sandy clay with occasional gravel,			0.60 +
11004	Cut of Linear ditch 0.55m wide and 0.24m deep, aligned roughly N-S. Steeply sloping sides and concave base. Cut through subsoil; almost certainly represents former field boundary of modern origin.			0.30–0.84
11005	Cut of small sub-rectangular post hole, 0.15m wide, 0.17m deep and 0.20m long. Locate to south-east of ditch [11004]. Single fill contained modern ceramic. Probably part of fence line associated with ditch [11004]			0.60– 0.77
11006	Mid-brownish grey sandy clay with occasional pebbles and charcoal flecks. Single fill of ditch [11005]			0.30–0.84
