PROPOSED CONSTRUCTION OF NEW UNITS TO REAR OF 16–18 HIGH TOWN, HEREFORD

ARCHAEOLOGICAL FIELD EVALUATION
PLANNING REF. P172824/L

commissioned by Elevate Property Group

August 2017

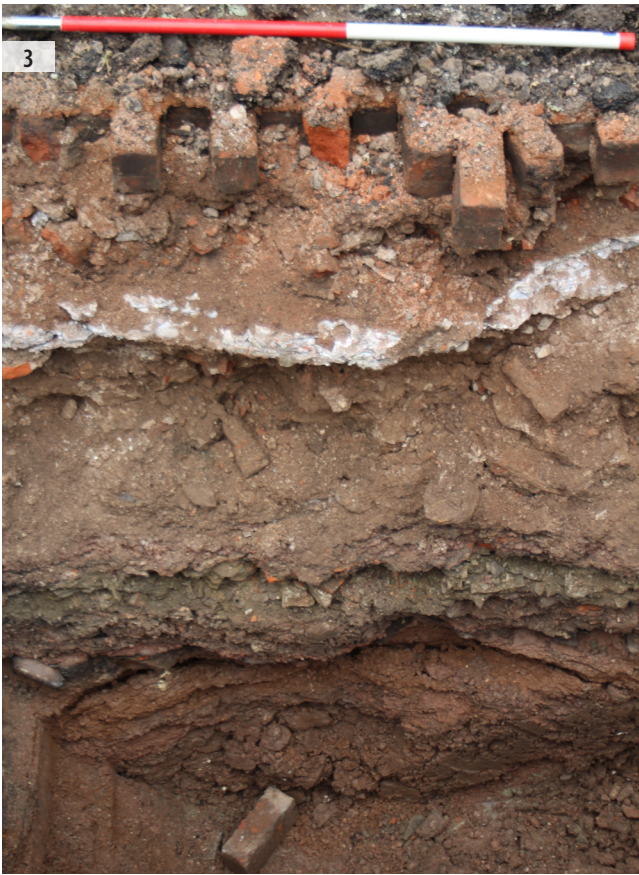
ILLUS 3 West facing section of trench showing site stratigraphy ILLUS 4 South-east facing shot showing remains of probable Saxon ditch (2011) and rampart (2015)
 ILLUS 5 Trench location on 1886 OS mapping showing location of structure (2016)

The trench was excavated to a depth of approximately 2m deep revealing a sequence of stratified modern made ground deposits with evidence for the Saxon rampart and ditch at the base of the trench (Illus 3 and 4).

The infilled ditch was sealed by deposit (2009), a mid-reddish grey silty clay between 0.95–1.80m BGL which in turn was sealed by two separate demolition deposits (2012) and (2014). These two separate deposits had a disused modern metal water pipe, running approximately north-south, between them through the centre of the trench and a ceramic service pipe running approximately northwest-southeast through the southern third of the trench.

A further layer of made ground, comprising demolition debris and gravels (2006), was sealed by a brick surface (2003) and make up layers (2005), (2004). The final deposits were represented by the present tarmac and make up layer (2001) and (2002) respectively.
