GEOTECHNICAL SITE INVESTIGATIONS TO THE WEST OF HEREFORD

ARCHAEOLOGICAL WATCHING BRIEF
HER REF. EHE 80306

commissioned by WSP

ARCHAEOLOGICAL WATCHING BRIEF

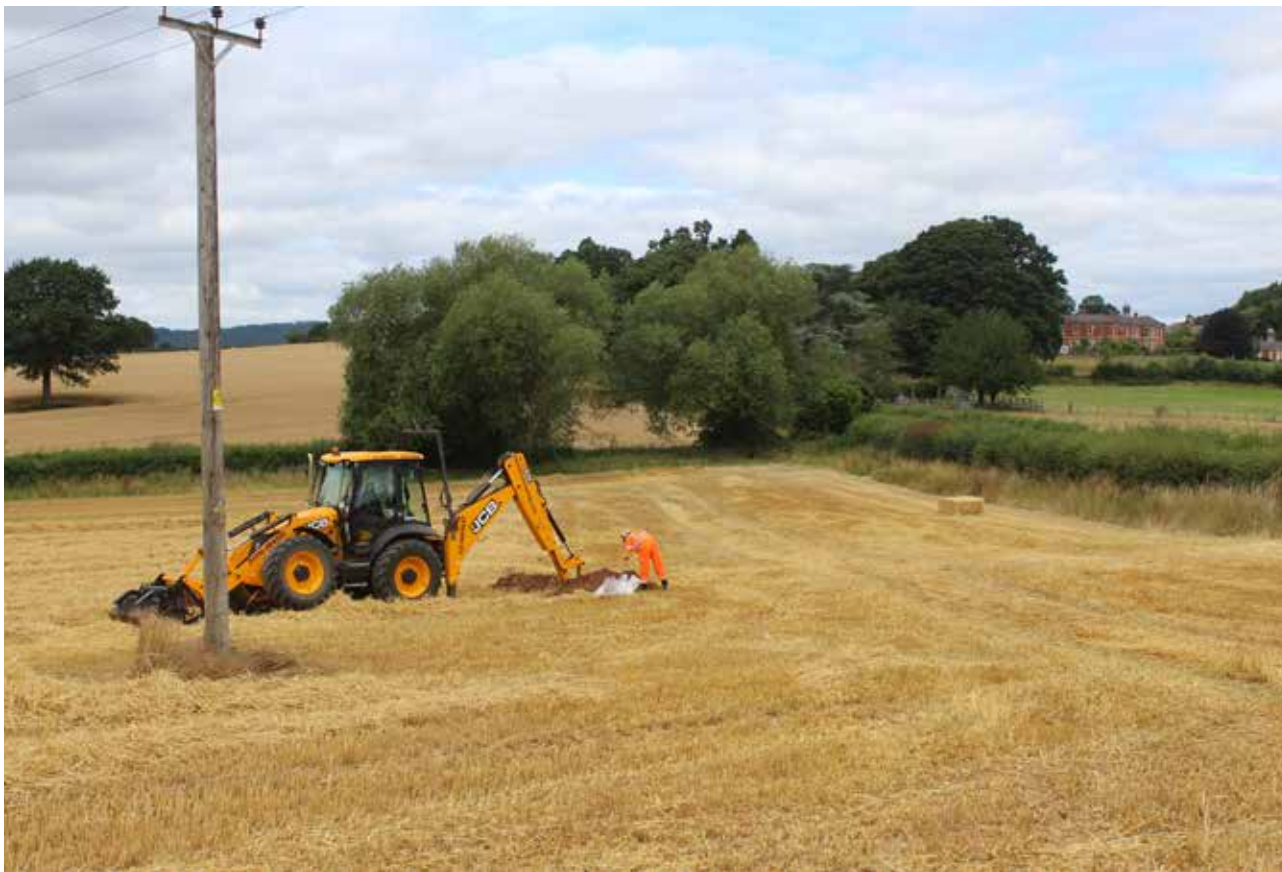
ILLUS 2 Working shot showing topography

The proposed road corridor runs west from the A49, just north of Hereford (NGR SO 50564 42971), turning south at the village of Burghill and the area around the Hereford livestock centre on the Roman Road (NGR SO 47666 42253). The course of the road then heads in the direction of Breinton village, crossing Kings Acre road before traversing the major topographic feature of the route, the River Wye (NGR SO 48153 38885). On the south side of the river it runs through the former site of Belmont golf course, and south west around Belmont Abbey, before joining the Abergavenny Road, south of Hereford (NGR SO 47753 37487). North and south of the river the topography is gently undulating agricultural land (Illus 2), apart from the river channel of the Wye.

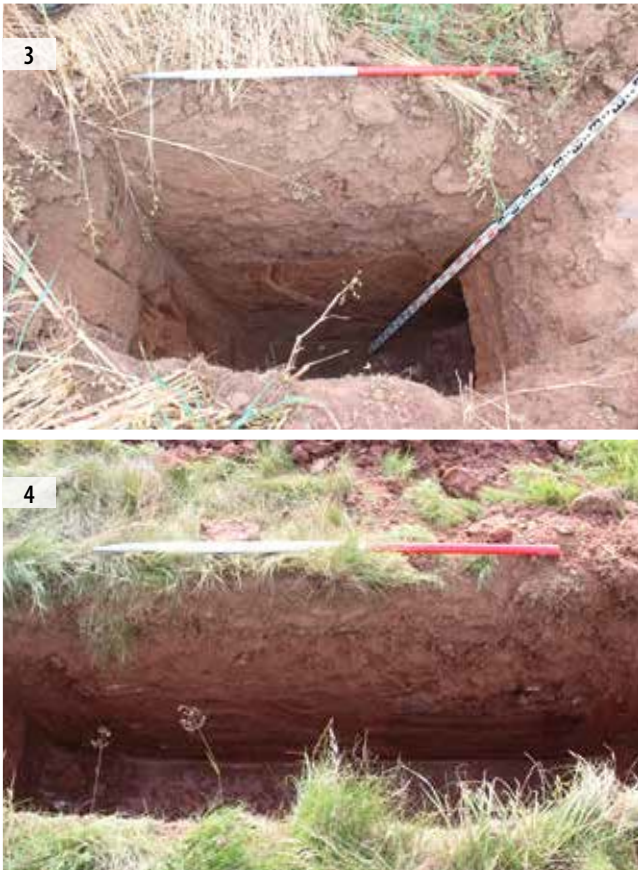
ILLUS 3 East facing section of TP116, showing below ground deposits

The soil profiles showed a marked similarity across the whole of the route. On low lying grass and pasture fields, there was generally a shallow topsoil measuring 0.10m thick composed of a friable silty loam, overlying a friable silty clay subsoil, measuring on average 0.3–0.6m thick, overlying a firm reddish clay substrate (eg TP116 – Illus 4).

The natural geology varied slightly, with mudstone predominant over the majority of the route. Deposits of gravel were identified in the vicinity of Kings Acre Road (TP116 (Illus 3), 118, 121 and 124), and alluvial silts were identified adjacent to the River Wye (TP105 and 108).

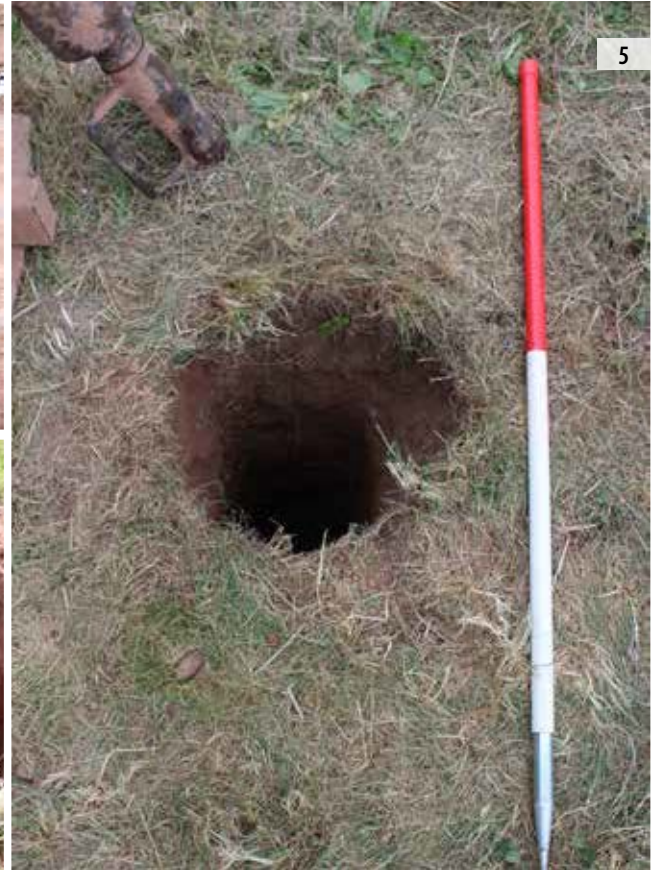
ILLUS 4 Section of TP106 on grassland **ILLUS 5** Plan view of excavated BH212

the route, four were observed (BH211, BH212 (Illus 5), BH213 and BH215).

The soil profile of the bore-holes corresponded to the adjacent test pits. In the four bore-holes observed, the natural comprised mudstone.

CONTEXT	DESCRIPTION	DBGL (M)
0212-01	Silty loam	0–0.10
0212-02	Sandy clay	0.10–0.40
0212-03	Silty clay	0.40–1.70
0212-04	Silty clay	1.70–2.15
0212-05	Clay gravel	2.15–5.60
0212-06	Sandy clay	5.60–6.10
0212-07	Clay/gravel	6.10–7.50
0212-08	Weathered bedrock/mudstone	7.50 +

TP106		
DIMENSIONS L X W X D (M)		
2.00 X 0.50 X 3.50		
CONTEXT	DESCRIPTION	DBGL (M)
0106-01	Topsoil: brown, loamy sand	0–0.20
0106-02	Subsoil: brown, friable, silty loam	0.20–0.70

0106-03 Reddish brown silty clay, firm, occasional fragments of sandstone 0.70–3.50
