THE LODGE, CAMP LANE, LUDLOW, SHROPSHIRE

ARCHAEOLOGICAL WATCHING BRIEF
PLANNING REF. PREAPP/13/00097

November 2017

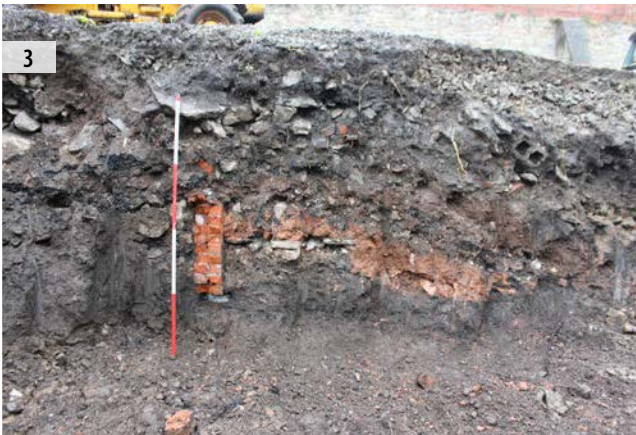
A small section of red brick wall [111] was observed within the bank. This was photographed and drawn however, due to the collapse of the bank prior to completion of recording, it was not possible to spatially locate the drawing points.

ILLUS 3 South-west facing elevation of septic tank wall [111] ILLUS 4 Plan of well [302]

The terraced bank immediately to the south of the northern entrance to the site comprised a sequence of heavily mixed modern (19th and 20th century) make up layers (100–110, 112 and 113) (see Appendix 1). A single section of red brick wall [111], most likely a disused septic tank, was observed and recorded within the bank. No archaeological finds were retained from the deposit sequence due to its heavily mixed nature.

A fragment of red brick wall was identified in the existing terraced bank. This is most likely the remnant of a septic tank that was partially destroyed during an episode of landscaping.

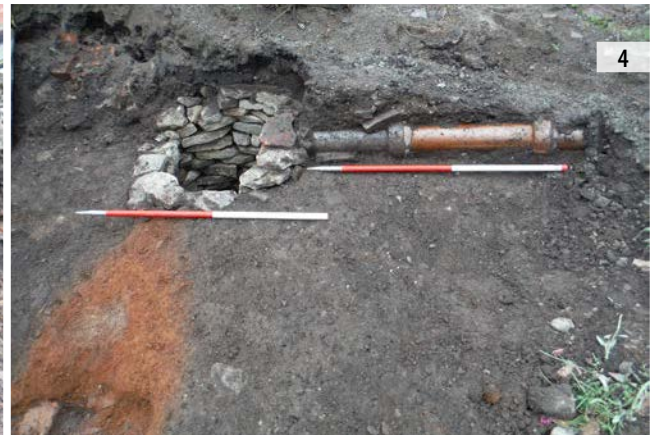
Following demolition of the existing building, the existing foundation and house platform were grubbed out using a 10 ton 360 degree, tracked machine fitted with a toothed bucket. This operation exposed a 19th century, dry stone built well [302]. The well had been capped with a slab of concrete, presumably as part of the levelling of this area. The deposits within the well were not excavated, however, when probed they were found to extend to over 1m in depth. The upper 0.65m of the well remained empty.

A 19th century well [302] was observed and recorded following partial demolition of the existing building (Area 3). The well was of dry stone construction and had been capped with a modern concrete slab. A ceramic drainage pipe had been inserted into the well from the north but this is likely to have been a later addition. The well sat within a deposit of made ground (301) comprising dark brown, loamy clay with rubble inclusions. This was overlain by a further deposit of made ground (300) comprising very dark brown loamy clay with frequent inclusions of rubble, hard core material and brick.

A dry stone well was observed and recorded at the western edge of the site. This had been backfilled and capped, prior to being buried during an event of modern landscaping. The backfill within the well was highly mixed and mostly modern and offered no insight into the date of the well itself. However, given the way in which the well was constructed, it is possible that it dates to the 19th century.

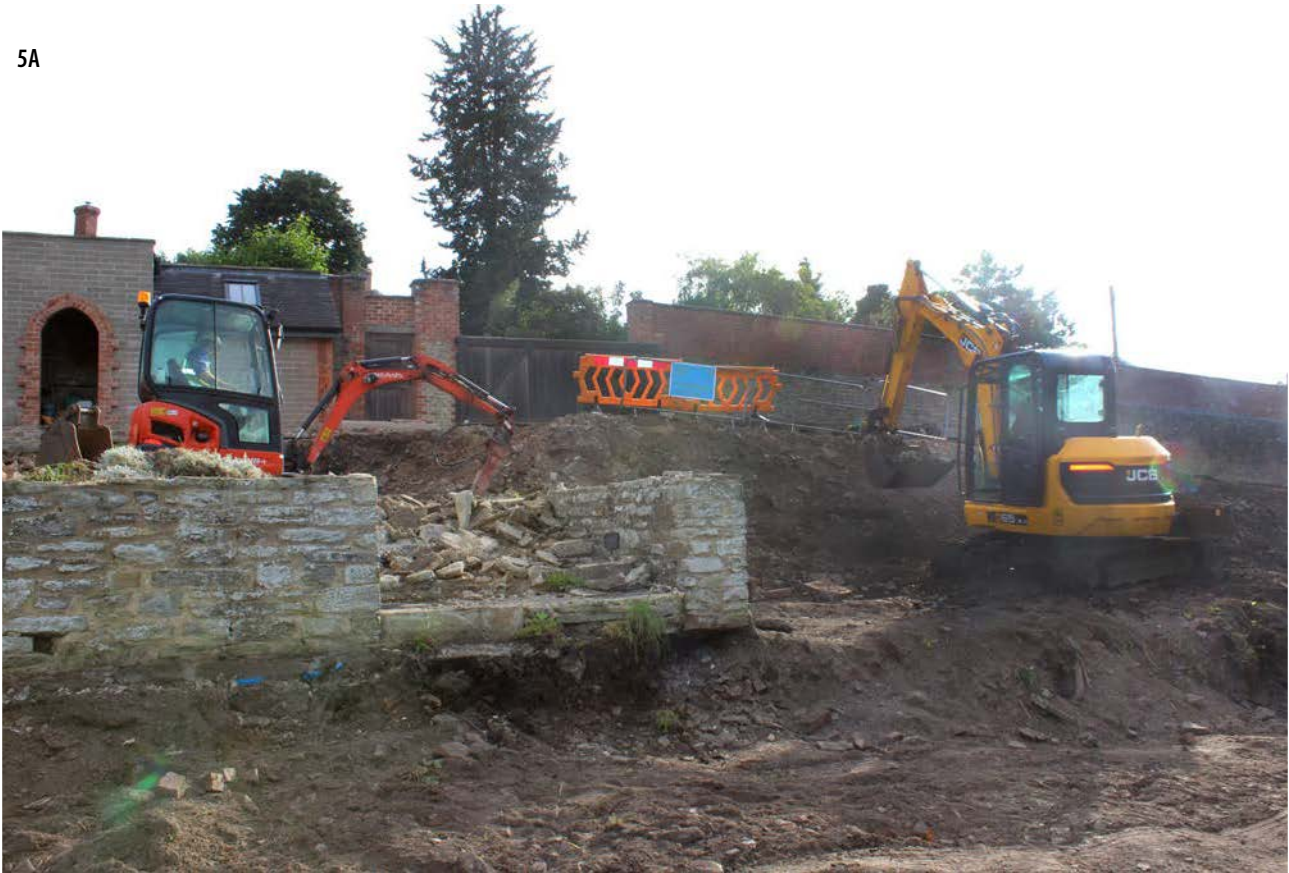
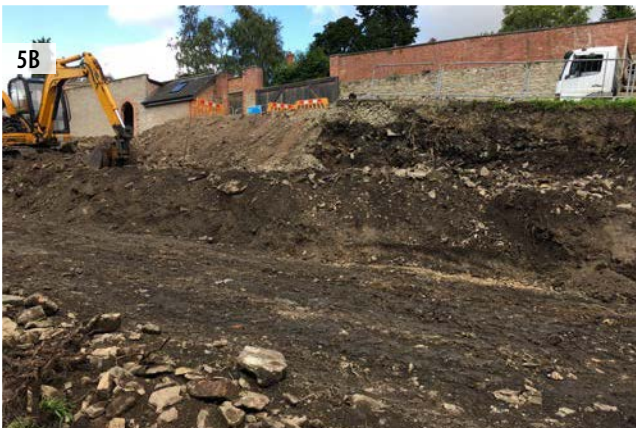
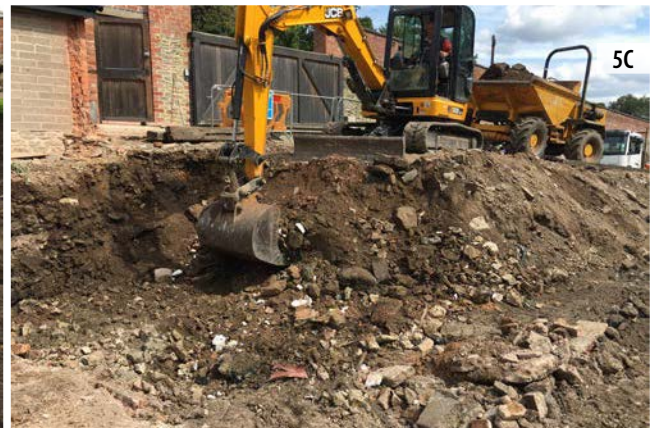
5A

ILLUS 5A–C General shots showing scale of groundworks
