CUSTOS LODGE, VICARS CHORAL HEREFORD CATHEDRAL

ARCHAEOLOGICAL EXCAVATION
HER EVENT NO. EHE 80305

commissioned by Robert Kilgour Architects Ltd
on behalf of Dean and Chapter, Hereford Cathedral

March 2018

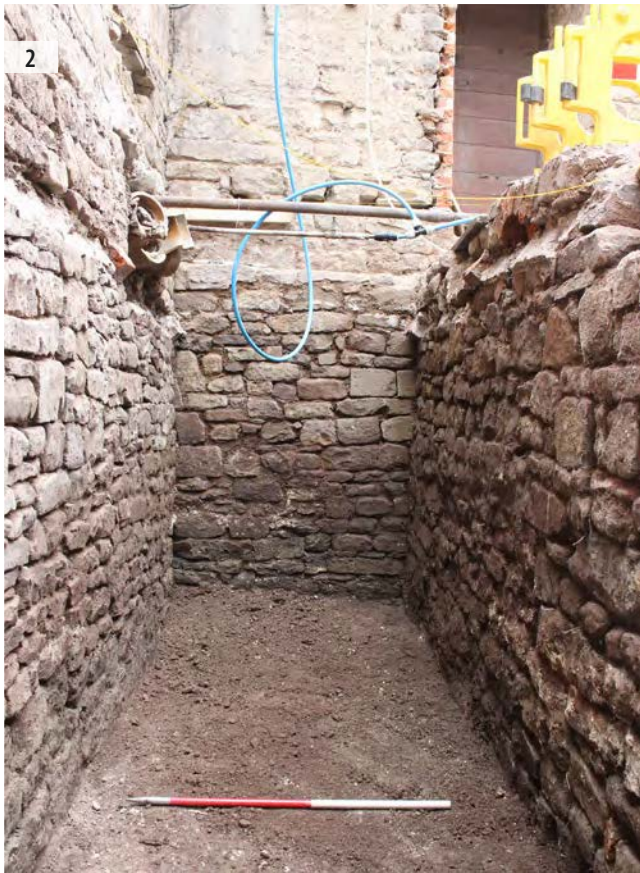
ILLUS 2 East facing view of the 'Cellar' **ILLUS 3** East facing view of drain in east end of 'Cellar' **ILLUS 4** Enhanced view of photograph from backfill of 'Cellar'

During the evaluation stage of the project, a large underground vault, interpreted as a cellar was discovered to the north of site (Illus 2). This vault measured roughly 6m x 1.8m and extended to just over 2.00m below the existing ground level. This vault had stone walls on all sides, each belonging to different phases of construction (Archer & Craddock-Bennett 2017).

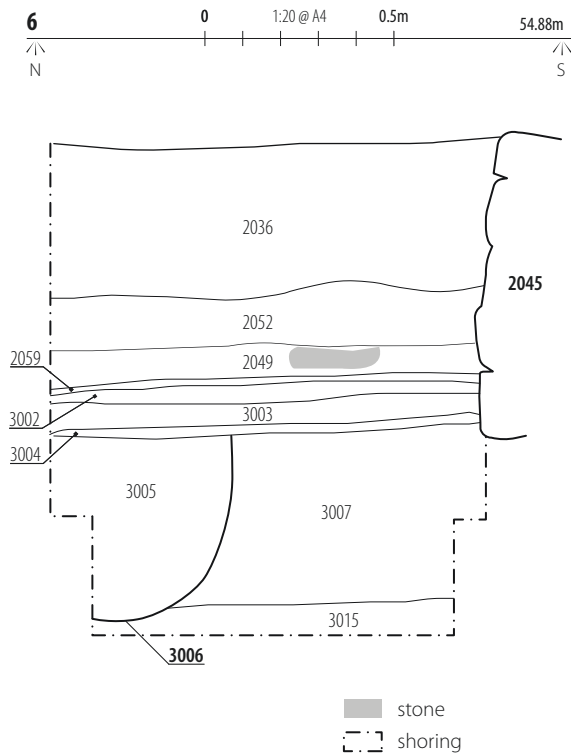
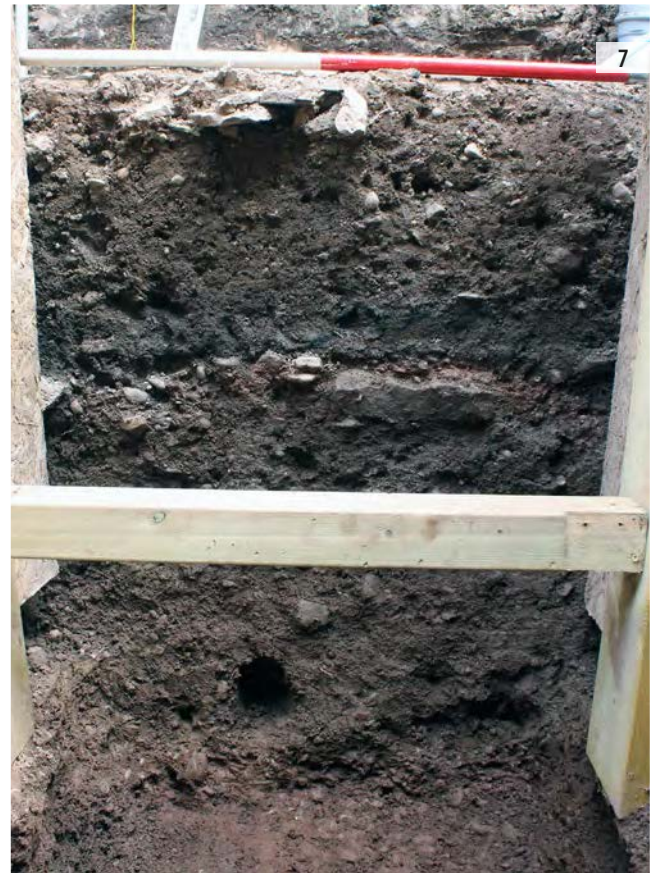
ILLUS 6 West facing section of Trench 1 **ILLUS 7** West facing section of Trench 1

was first encountered at 1.22m below the existing ground level, or 54.87m AOD, was a compact slightly clayey sand, intermixed with poorly sorted coarse gravels. A drawing of the west facing section of the completed trench can be seen in Illus. 6, and a corresponding photograph in Illus 7.

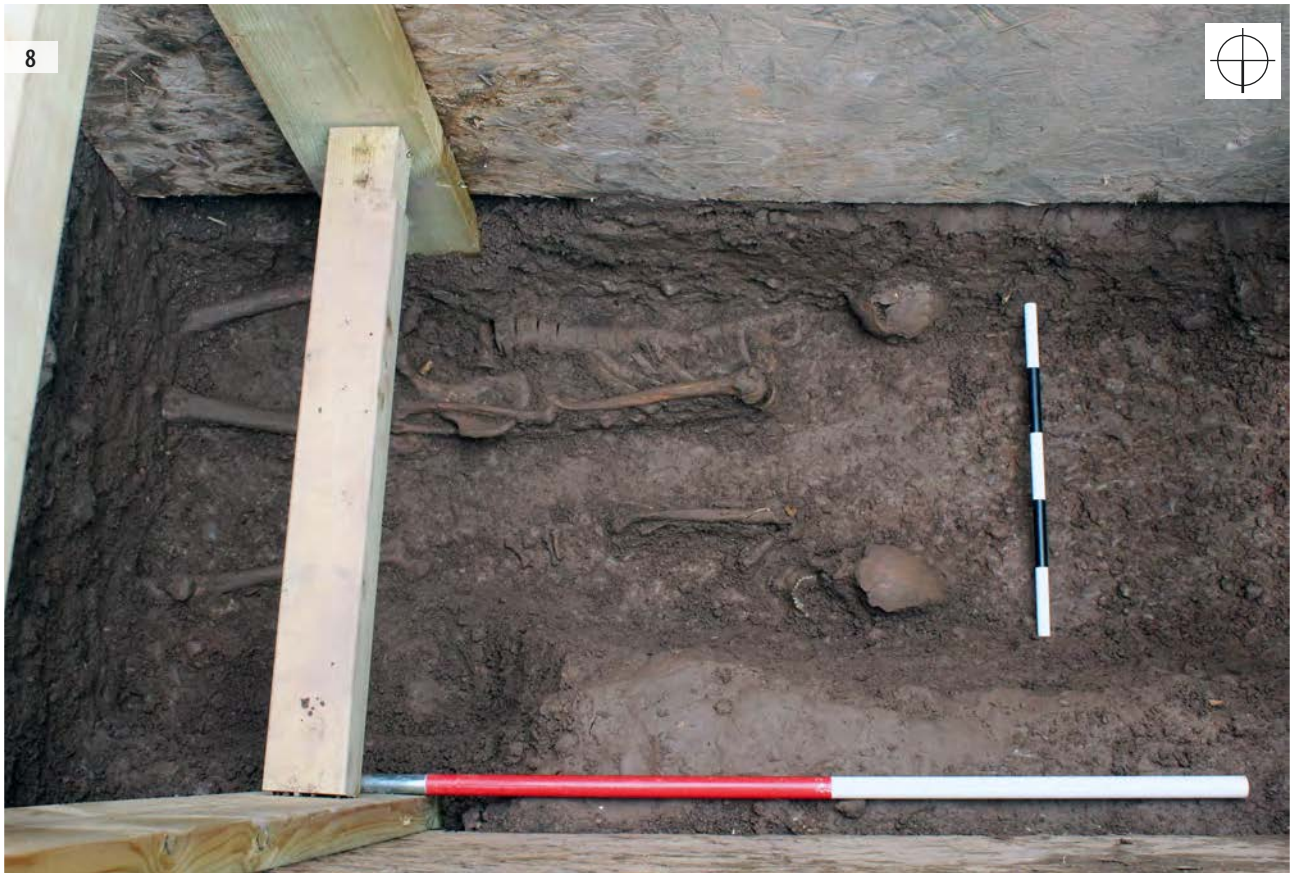
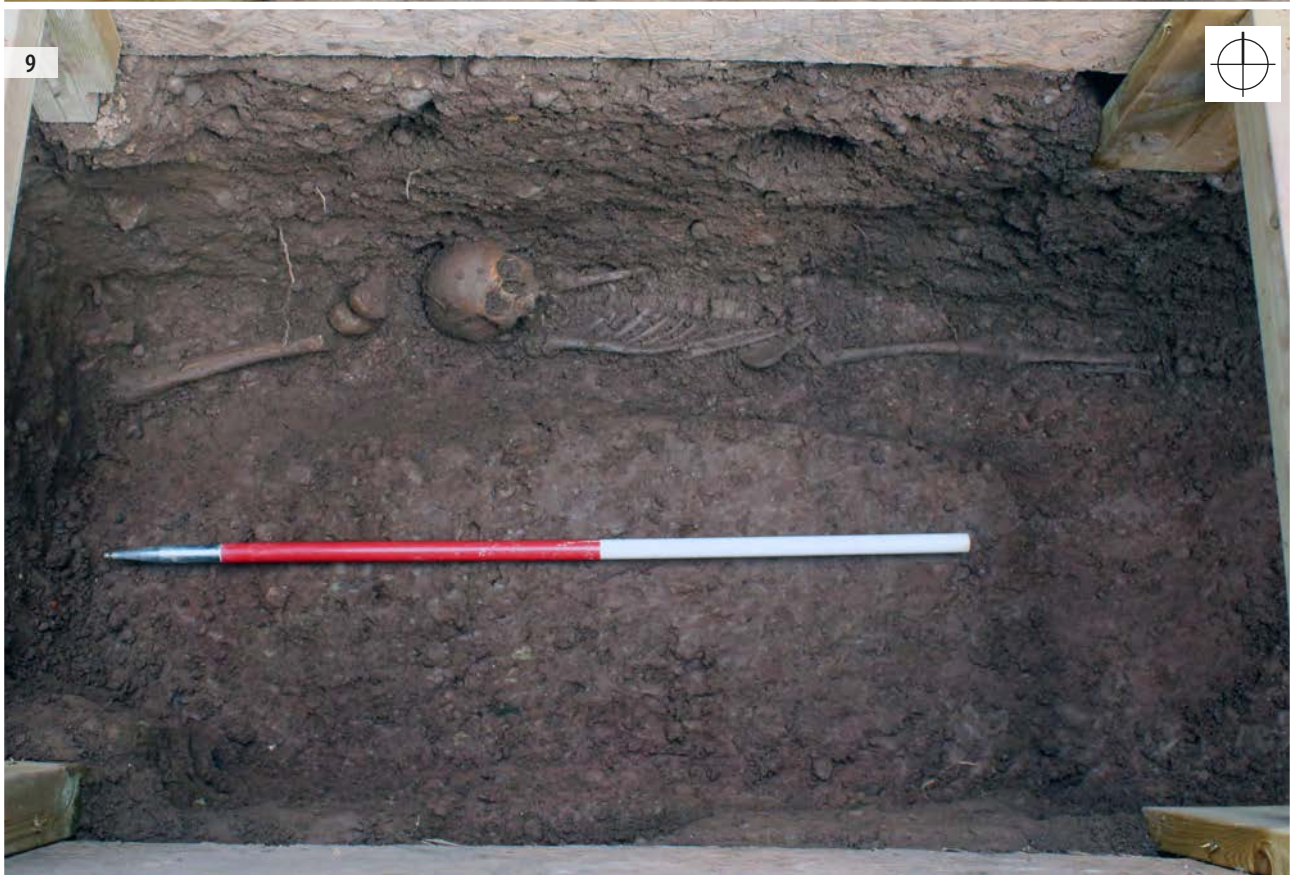
ILLUS 8 Skeletons SK3008 and SK3009 in situ **ILLUS 9** Skeletons SK3010 and SK3011 in situ

Overlying this geology was (3007), a layer of mid greyish brown silty clay, which contained occasional small charcoal and stone inclusions. This was observed to have a maximum depth of 0.44m. Contained in this deposit were the skeletal remains of two individuals, (SK3008) and (SK3009) (Illus. 8). These individuals were both aligned east to west with their feet at the west end and were both lying in a supine position. Individual (SK3008) appeared to be positioned with arms at its sides, however, individual (SK3009) was too badly truncated to ascertain the arm position. No grave cuts were visible within the surrounding deposit for these two burials, possibly due repeated re-use of burial ground causing homogenisation of the soil. The heads of these skeletons aligned with each other on a north to south axis, with only roughly 0.10m between their shoulders. This may suggest that they represent a double burial, although the invisibility of any grave cuts makes this difficult to verify. Another, possibly more likely explanation may be that the graves were marked with some form of grave marker, which made it possible to dig new graves in line and without disturbing older ones, although no trace of any sort of marker was observed. A third possibility may be that these graves were dug at the same time, or in relatively short succession, again making it possible to line up the graves.

Cut through deposit (3007) and into the underlying geological deposits (3015), in the north-west corner of the trench, was grave [3013], which contained individual (SK3011). This grave was only partially exposed in the trench, as it extended past the western and northern limit of excavation. This meant that only the right side of the individual, from the pelvis downwards was exposed. This grave was cut by another grave [3006], cutting through just above the knee, and meaning that the lower legs were lost. The broken lower end of the femur of (SK3011) was found in the fill of [3006]. Both parts of the femur showed cut marks around the break, seemingly from when this bone was broken during the interment of [3006]. The fill of this grave (3014) was a mid-reddish brown silty, clayey sand with poorly sorted gravel, possibly representing backfill formed of a mix of the natural geological material and overlying deposits cut through by the grave. Only parts of the pelvis, right leg, right forearm and right hand were recovered from (SK3011), due to its partial exposure and truncation. This individual was not subject to osteological assessment due to this limited recovery.

Grave [3006], located on the northern side of the trench, cut through the eastern end of [3013], and also through (3007) and into the natural geological deposits, heavily truncating the left-hand side of (SK3009). This contained individual (SK3010) (Illus 9). Grave [3006] appears to be the latest grave in the sequence of burials in the trench. The fill of this grave, (3005), was again a mid-reddish brown silty, clayey sand with poorly sorted gravel. This was probably representative of a mixed backfill to this grave. There was no definable interface between (3005) and (3014), possibly due to the similar nature of deposition. The relationship between these two graves could only be identified from the disturbance of skeleton (SK3011). Several large pieces of charnel were present in (3005), possibly deriving from graves disturbed during the digging of grave [3006]. One piece of brick, or possibly unglazed floor tile, was recovered from (3005). Although this could not be accurately dated it was thought to be probably medieval or early post-medieval.

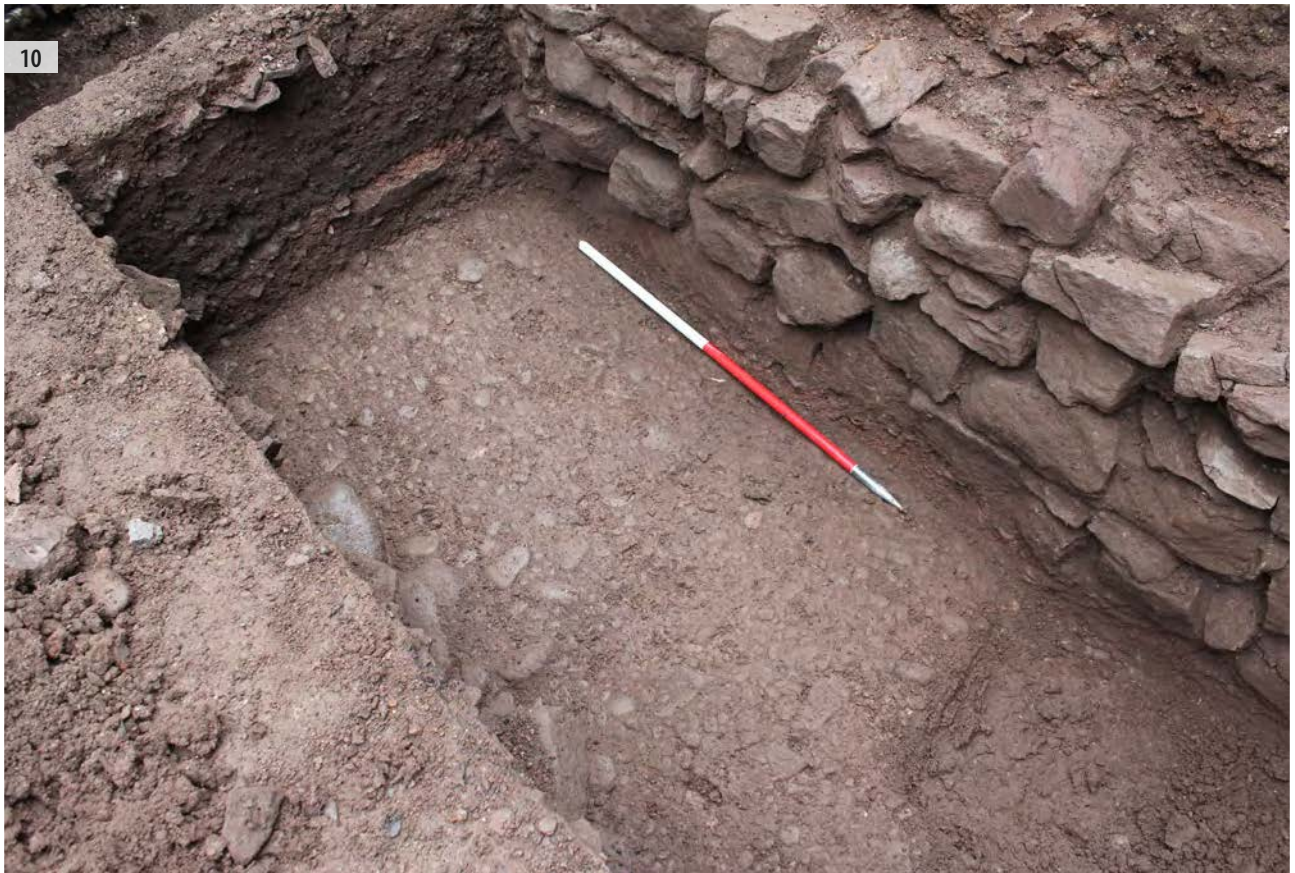
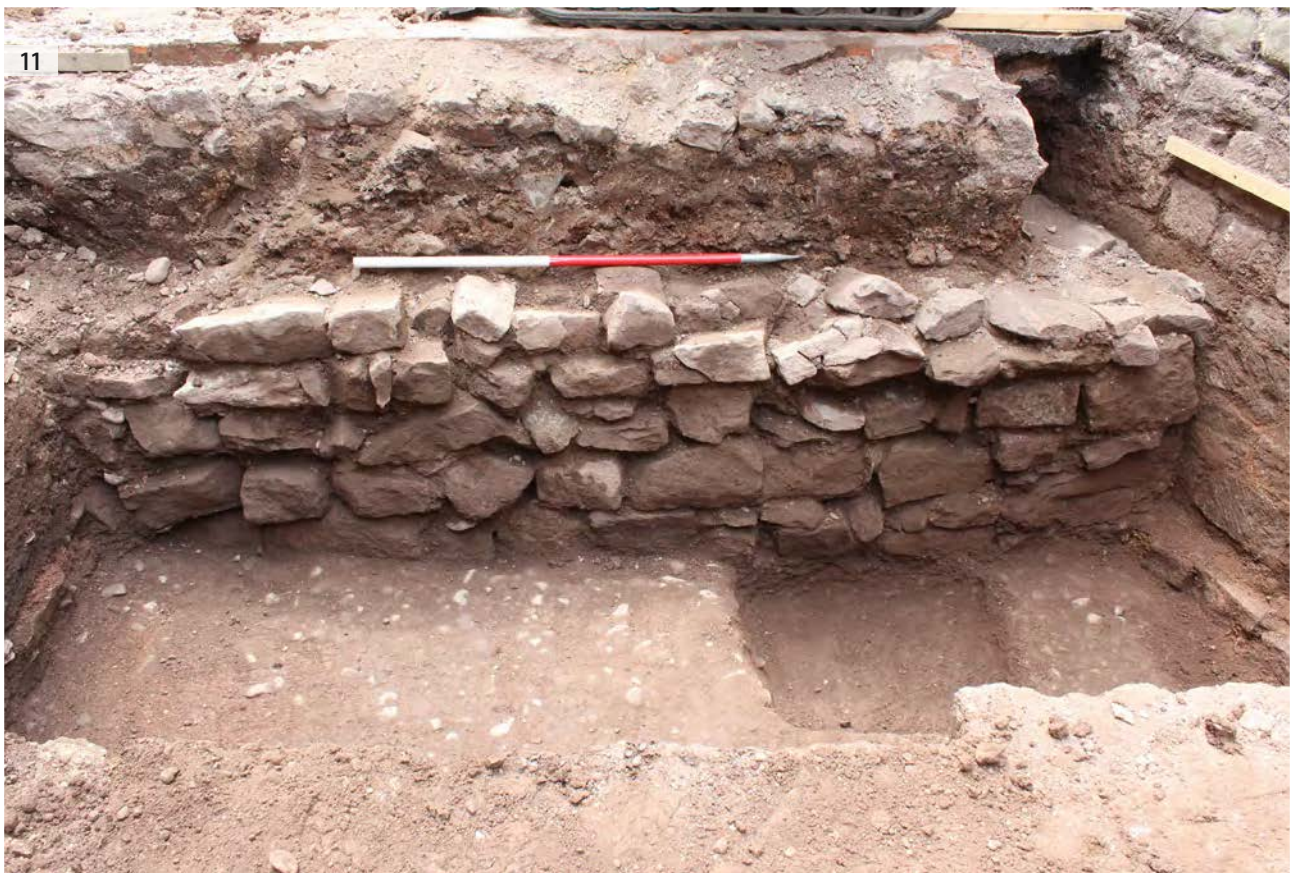
ILLUS 10 Metallurgical surface (3004) with wall [2095] to rear **ILLUS 11** North face of wall [2045]

These deposits were sealed by context (3004). This appeared to a rough metallised surface formed of compacted pebbles that covered the entire area of the trench (Illus 10). The pebbles forming it varied in size, but most appeared to be roughly 0.05m in diameter, although the largest was measured to be roughly 0.26m in diameter. There was no visible pattern to the deposition of these stones. The layer itself was measured to be 0.04m in depth.

(2045) was an east-west running wall, located in the southern section of the trench (Illus 11) and cut through surface (2059) and the underlying deposits. This appeared to be the former southern wall of the Custos Lodge. To the west it could be seen that this wall butted up against the wall of the bishop's garden. The top of it was truncated by a modern brick wall on the same alignment. It was constructed of very roughly faced stone blocks in random courses. Five courses remained to an average height of 0.73m. The southern face of the wall was observed through the excavation of a trial pit to the west of the trench, along the Bishops' garden wall, and showed it to be approximately 0.86m in width. There was no evidence of mortar, but the wall appeared to have a soft earth bonding material between the stones. This trial pit also revealed fragments of a piece of worked stone, which appeared to be some form of grave marker, re-used in the fabric of the wall (Illus 12–13). This piece of stone was recovered from the wall, however it could be seen that more of it was present in the wall, visible in the section of the trial hole.

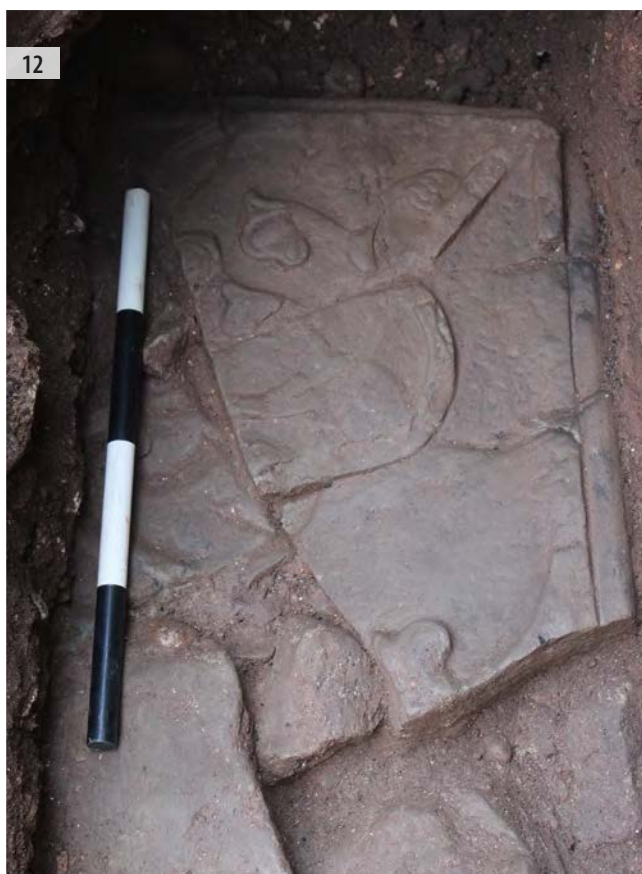
ILLUS 12 View of (3012) in situ in wall [2045]

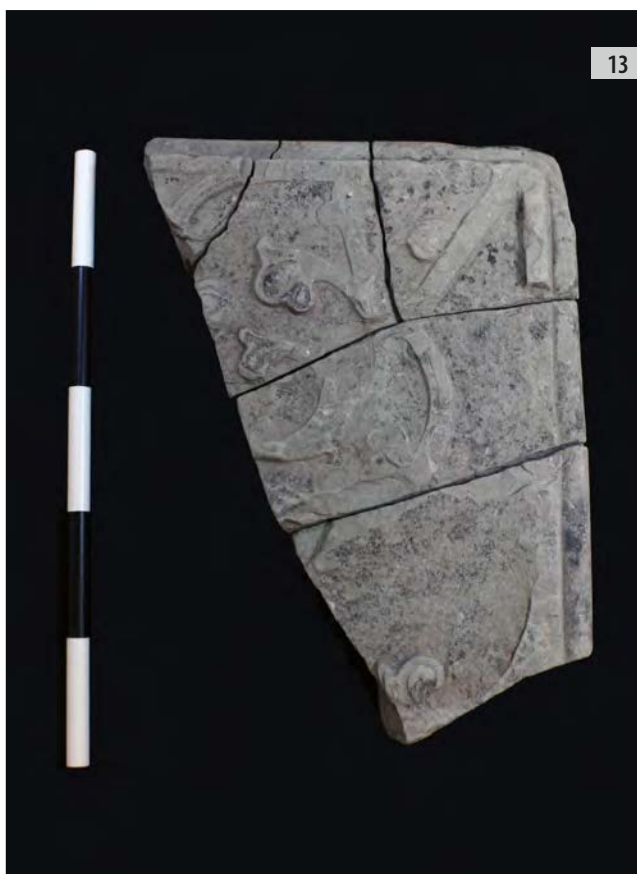
ILLUS 13 (3012) after retrieval

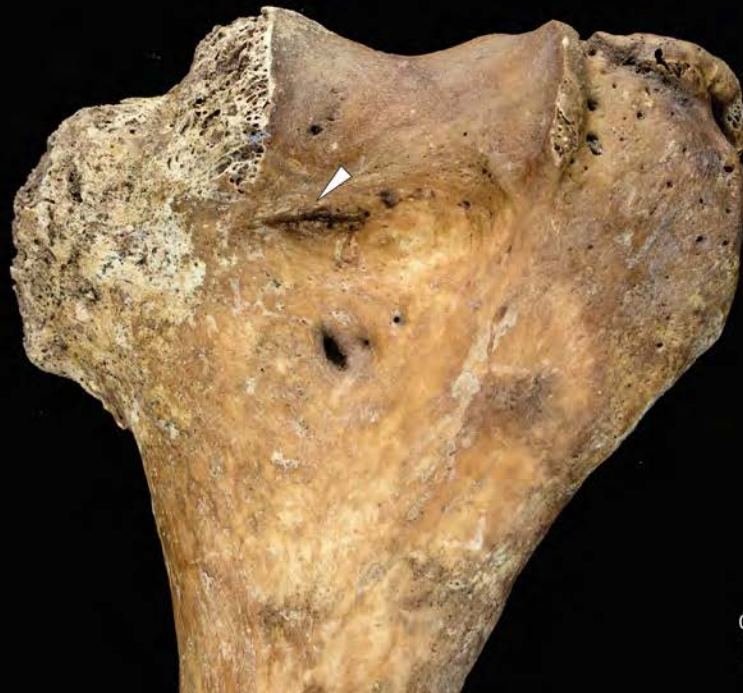
ILLUS A4.1 SK3008, wound to left humerus **ILLUS A4.2** SK3008, right proximal phalanx (thumb) with cut mark

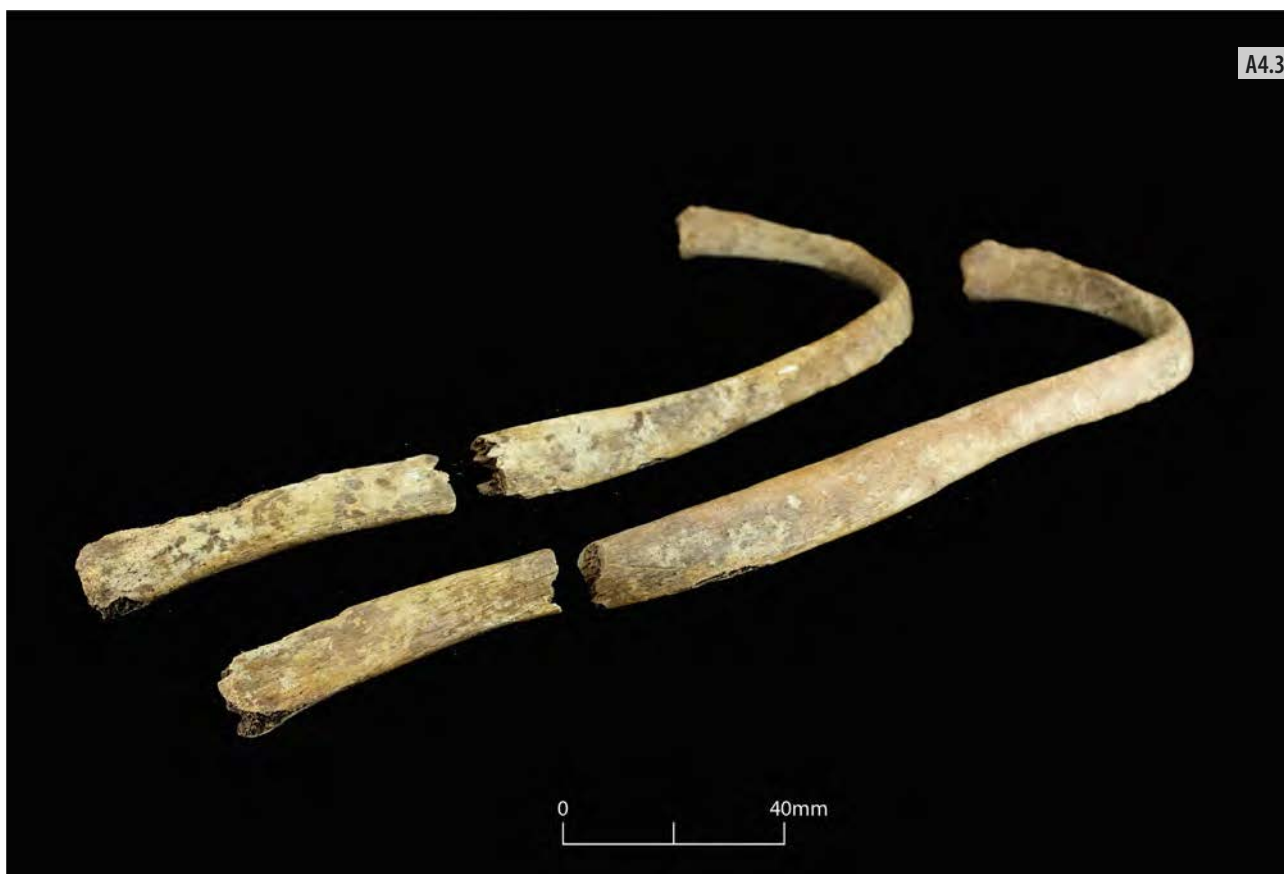
ILLUS A4.3 SK3008, stab wound to left ribs **ILLUS A4.4** SK3008, stab wound cutting the left scapula, 7th and 8th vertebrae, finishing in the 9th vertebra

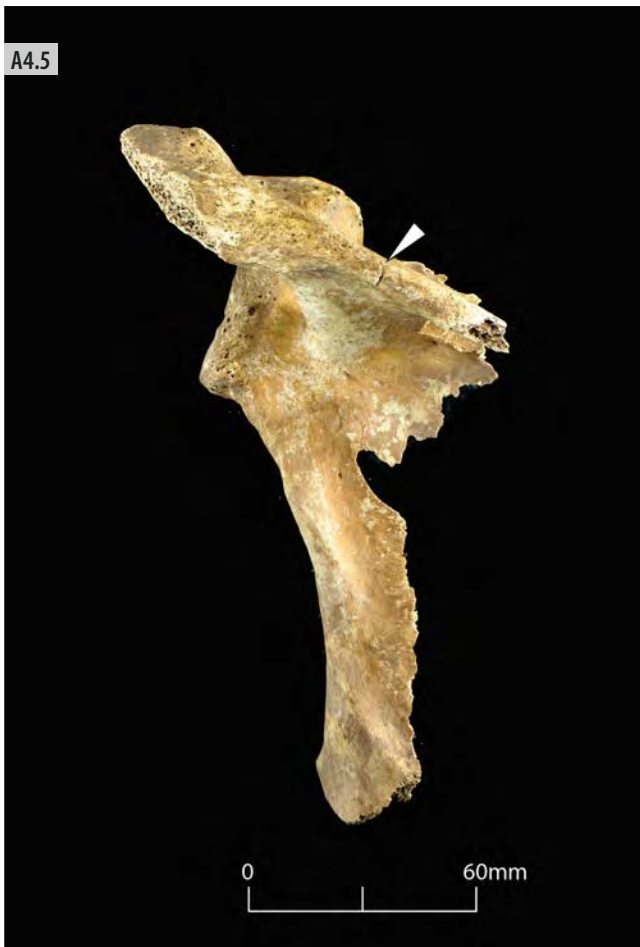
ILLUS A4.5 SK3008, wound to left scapula

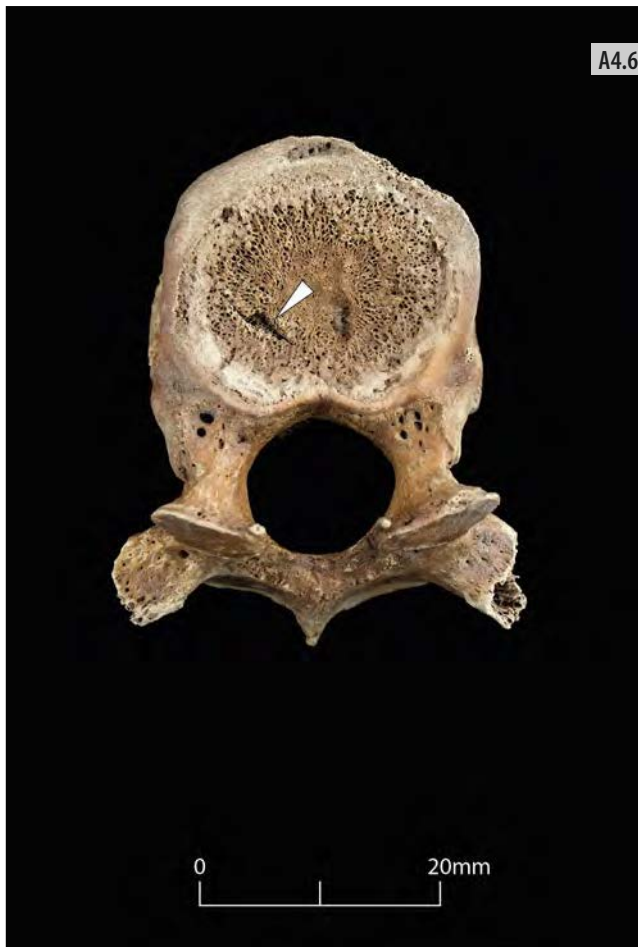
ILLUS A4.6 SK3008, blade wound in 9th vertebra

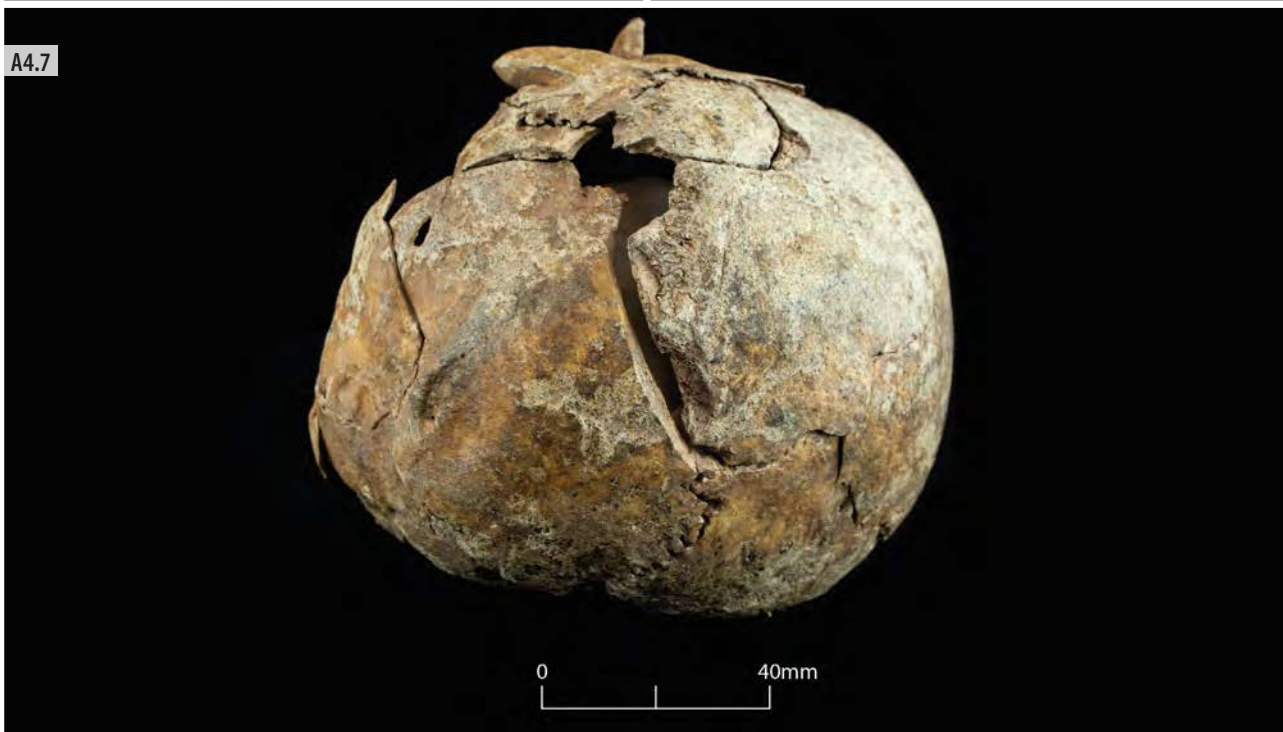
The fourth injury was inflicted with an edged weapon, again from behind, a very powerful blow administered to the skull (Illus A4.7). The weapon was at about a 60° angle when the blow struck, swung from directly behind the head and penetrating the occipital bone from 20 mm left of lambda, the highest point of the bone in the midline, through to a point at asterion, just behind the left ear, a length of some 62mm. The blade cut through the entire thickness of the skull and into the brain and the injury must have been fatal very quickly. The force of the blow also caused a large 'S'-shaped

fracture in the occipital bone, running from the midpoint of the lambdoid suture on the right, curving under the external occipital protuberance at the thickest part of the skull, and ending at the left edge of the foramen magnum. Other, smaller fractures radiate away from this main fracture, adding to the evidence of massive trauma to the skull.

It seems probable that these are battlefield injuries, although the victim may not have had full use of his left arm and may not have been wearing armour. That the blows were mostly from behind and above may indicate an assailant on horseback.

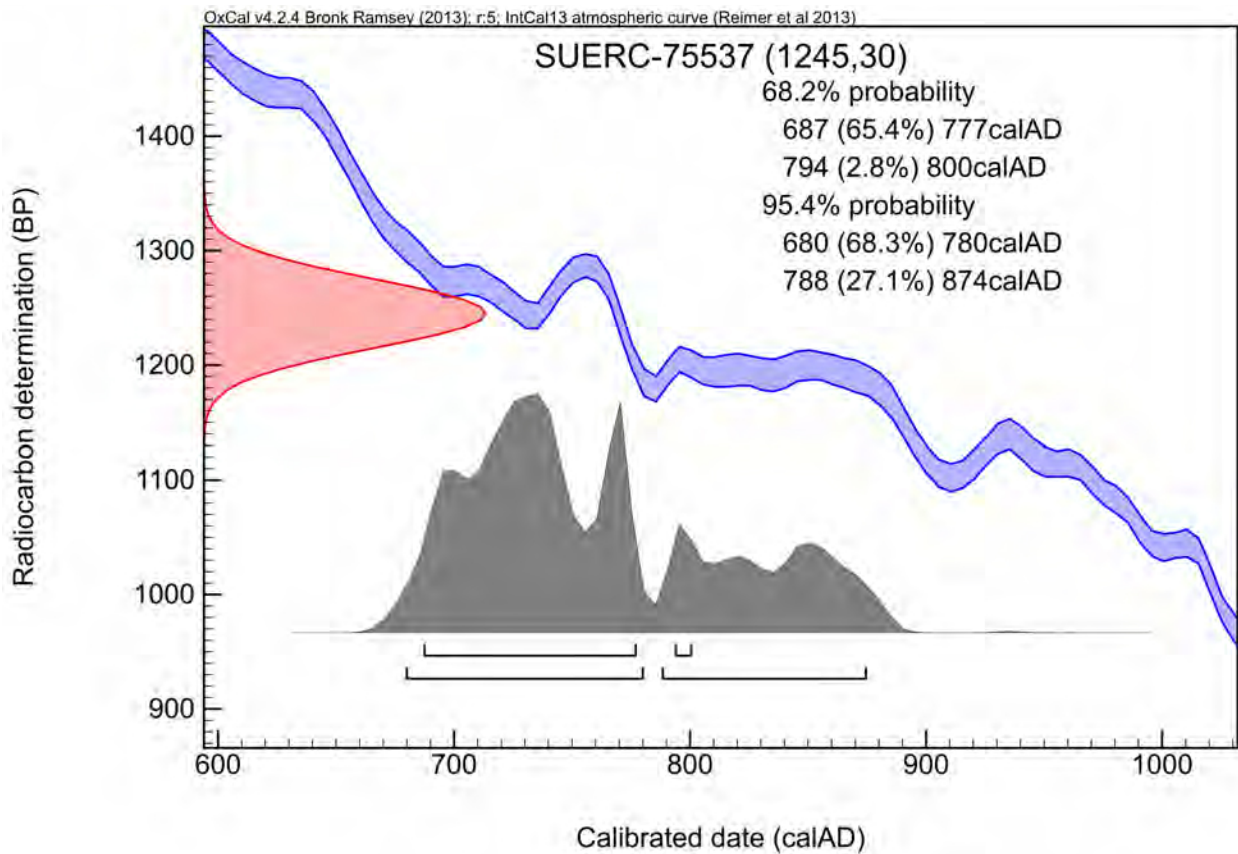
The radiocarbon age given overleaf is calibrated to the calendar timescale using the Oxford Radiocarbon Accelerator Unit calibration program OxCal 4.*

The above date ranges have been calibrated using the IntCal13 atmospheric calibration curve†
