LAND OFF DOWNFIELD LANE, TWYNING, GLOUCESTERSHIRE

ARCHAEOLOGICAL EVALUATION

commissioned by Novus Sustainable Developments

March 2018

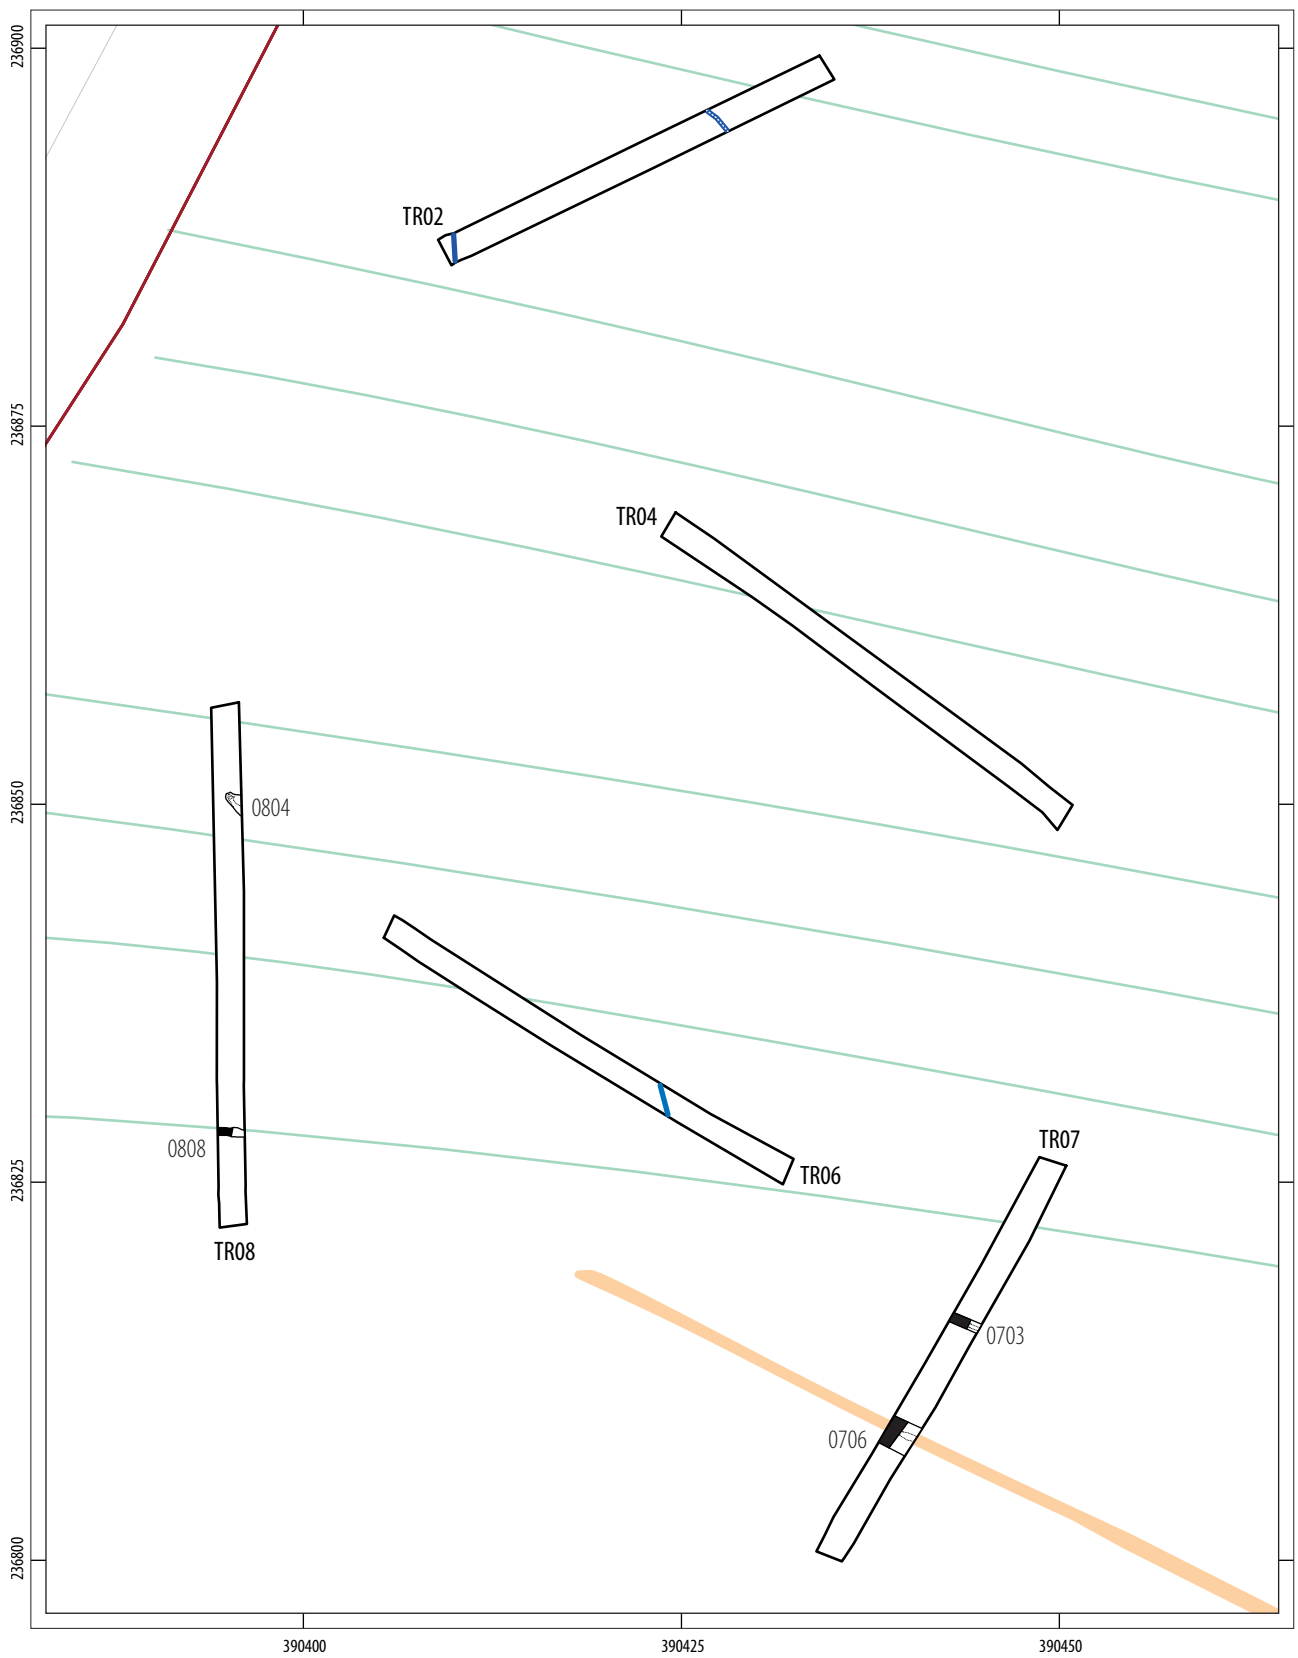
ILLUS 2 Site plan showing Trenches 2, 4, 6, 7 and 8

Three probable linear features were recorded across the site; ditch [0703], ditch [0706] and ditch [0808].

Ditches [0703] in Trench 07 (0.70m wide x 0.30m deep) and [0808] in Trench 08 (appx.1.00m wide x 0.50m deep) both had a similar, roughly north-west to south-east alignment and form and were most likely the same feature (Illus 3). The alignment of the feature, leading to the adjacent pond, to the south-east, strongly suggested that it represented a field drainage ditch.

The larger ditch, [0706] in Trench 7 (2.20m wide x 1.33m deep), was in the approximate location of a possible archaeological anomaly identified on the geophysical survey. This ditch was roughly coincident with the position of a field division noted on the Twyning Tithe map (Richards 2018), and thus likely represented a ditch defining this field boundary (Illus 4). The continuation of this ditch was not, however, visible in Trench 08 to the west

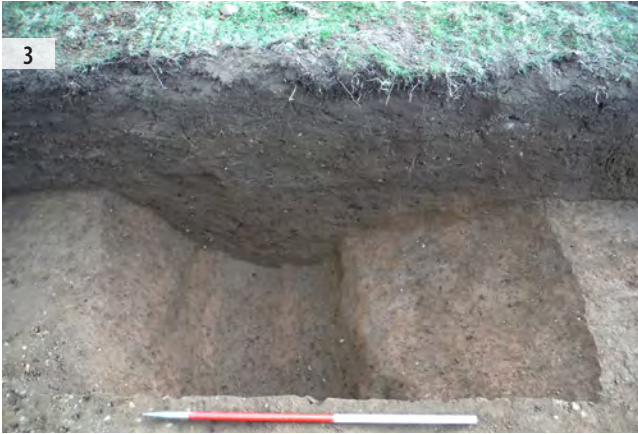
ILLUS 3 Linear feature [0703], looking south-east **ILLUS 4** Linear feature [0706], looking south-east **ILLUS 5** Probable natural feature [0804], looking east

TR07	L (m)	W (m)	Min. D (m)	Max. D (m)
	30	1.80	0.65	0.75
Context	Description			DBGL (m)
0700	Plough/topsoil – mid greyish brown silty sand			0 – 0.30
0701	Subsoil – dark reddish brown silty sand			0.30–0.60
0702	Natural- Dark red Sandy-Clay			0.60+
0703	Small ditch running NE-SW across trench 07			0.60–0.90
0704	Secondary fill of 0703 – mid greyish brown silty-clay			0.60–0.90
0705	Primary fill of 0703 – Dark reddish-brown clay-silt			0.60–0.85

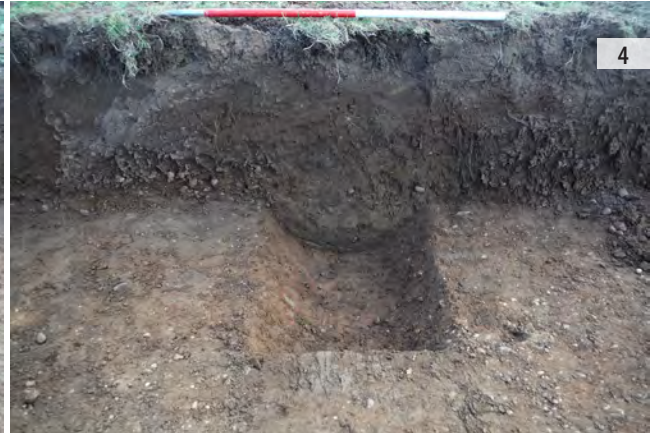
0706 Large ditch running NE-SW across trench 07 0.60–1.33

0707 Fill of ditch 0706 0.60–1.33

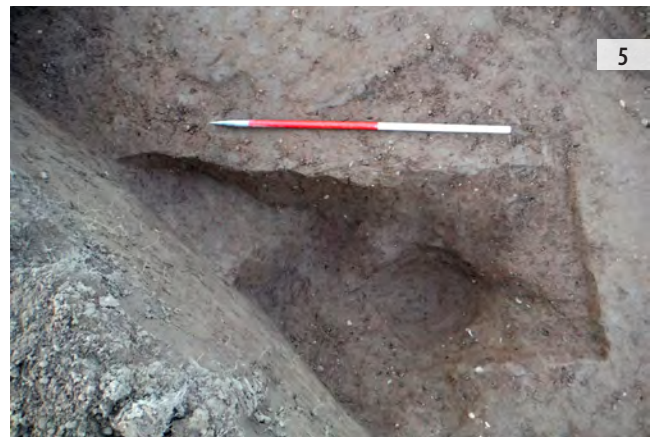
A fourth feature, [0804] (0.74m wide x 0.55+ deep), was recorded as a possible ditch, terminating at the centre of Trench 08, with very high levels of bioturbation and surrounding disturbance (Illus 5). Though its form was roughly linear, the feature was highly irregular, with an undulating base and sides. It is likely that this feature is of natural

origin, due to its ill-defined shape and the similarity of associated deposits to patches of natural geology elsewhere across the site.

0804 Cut of natural feature/possible disturbed terminus 1.00–1.35

0805 Fill of 0804 – mid greyish brown/reddish brown – diffuse with subsoil. 1.00–1.35

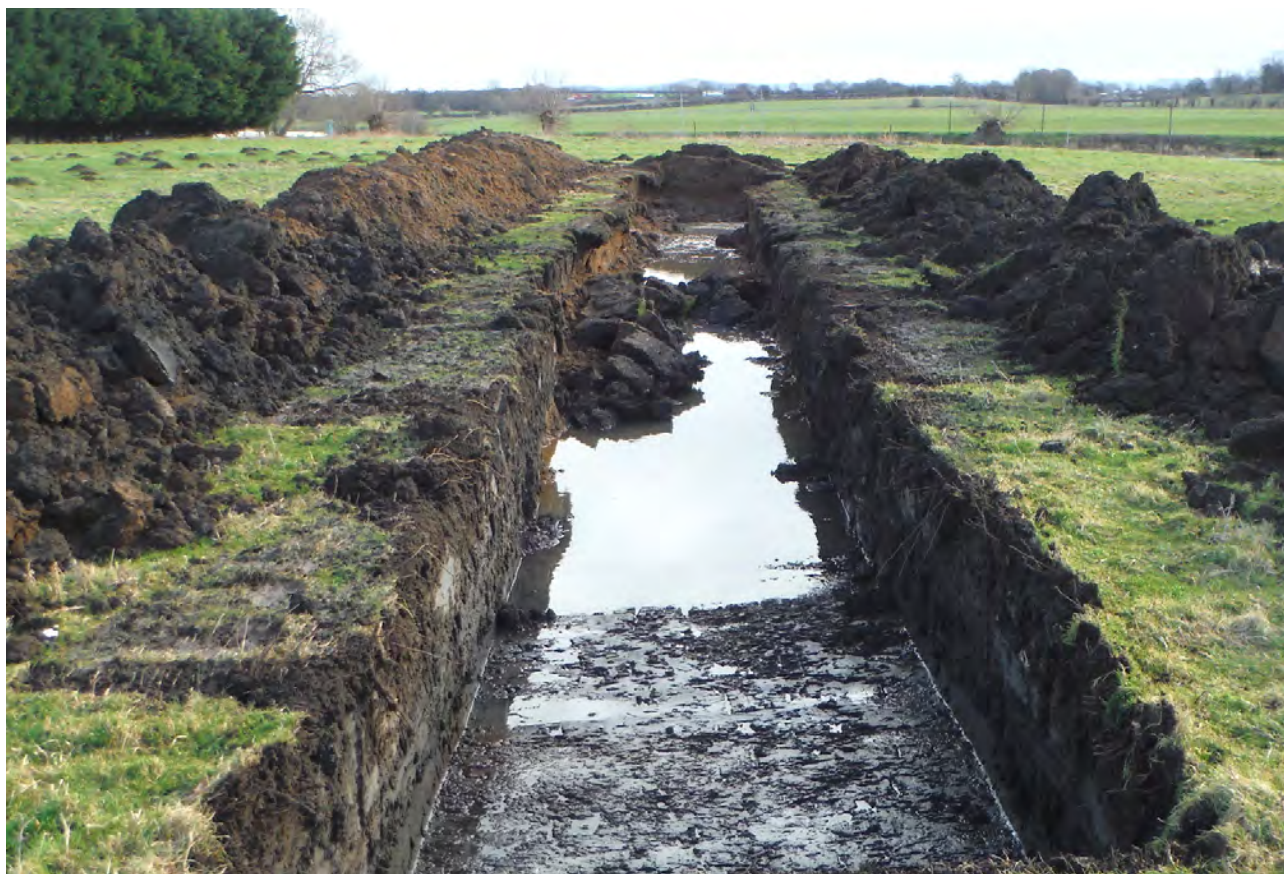
ILLUS 6 Trench 12 showing trench conditions to the east of the site

The remaining trenches were void of archaeological features, but the large amount of redeposited alluvial material in Trenches 12 and 13, to the east of the site, is worth noting and is likely the result of dredging practices in the adjacent River Avon. The waterlogging of these deposits caused instability during the excavation of these trenches, with groundwater flooding and trench edge collapse (Illus 6). It was deemed unsafe to enter these trenches, but a sondage to the north-eastern end of Trench 12 was attempted and revealed underlying Charmouth Mudstone at approximately 1.40m BGL.

TR12	L (m)	W (m)	Min. D (m)	Max. D (m)
	30	1.80	1.00	1.45
Context	Description			DBGL (m)
1201	Plough/topsoil – mid-dark greyish brown clayey-silt – diffuse borders			0 – 0.30
1202	Dark grey-blue clay – diffuse borders (westernmost end of trench)			0.30–1.10
1203	Alluvial mid-orange gravel material – possibly redeposited/ levelled. Very waterlogged. Middle – eastern end of trench.			0.30–1.40
1204	Mid blue-grey clay – Charmouth mudstone formation natural geology			1.40+
Summary	East of site, aligned NW-SE. No archaeology visible, though darker grey material at western end could be a sign that pond was either dredged or used to be larger. Gravels and clays are likely redeposited alluvial material from adjacent River Avon, overlaying Charmouth mudstone formation geology. Very unstable trench edges during excavation, and immediate trench flooding – it was deemed unsafe to enter the trench for recording.
