CASTLE HILL WALK, BRIDGNORTH

ARCHAEOLOGICAL WATCHING BRIEF ON CABLE INSTALLATION

commissioned by Western Power Distribution

April 2018

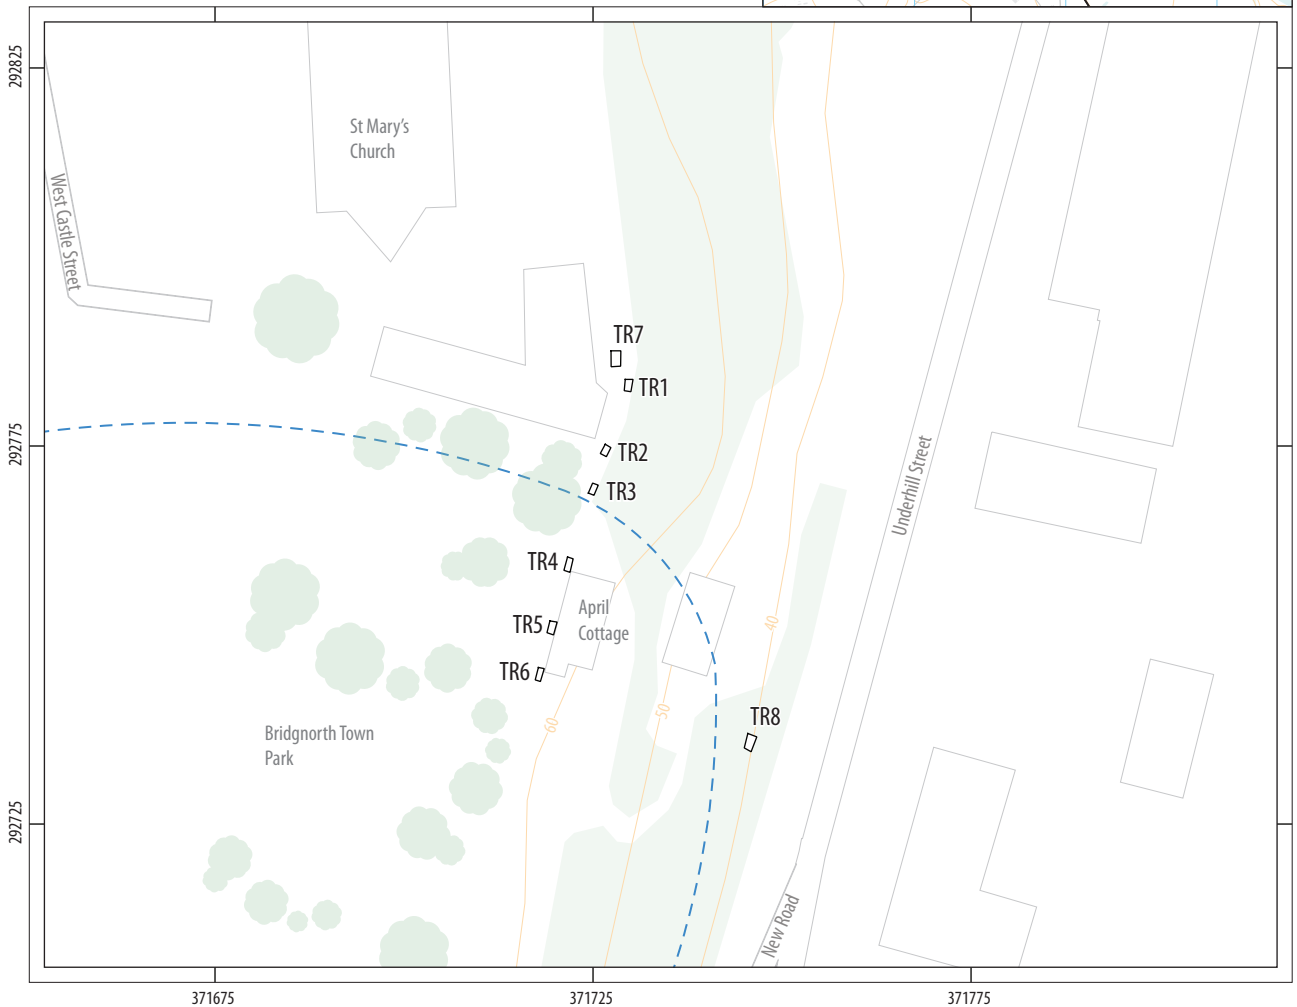
□ trench location
 - - - scheduled monument area

A full description of the sequence of deposits is provided in Appendix 1. The locations of the excavated trenches are recorded in Illus 1.

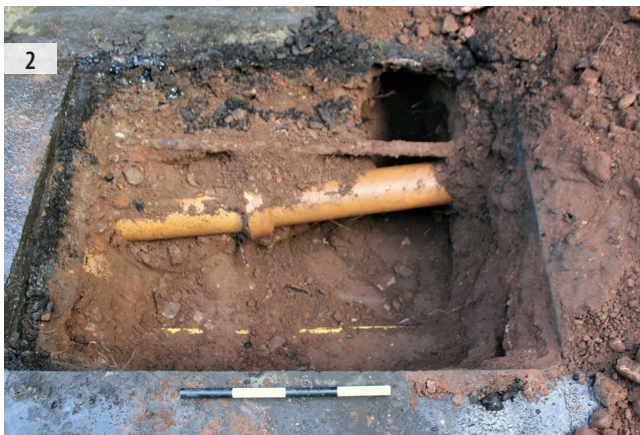
ILLUS 2 Trench 6, looking south-east **ILLUS 3** Trench 8, looking south-west

south. Trenches 1-6 were rectangular trenches aligned northeast-southwest, and ranged from 1.10m–1.20m long, between 0.65–1.10m wide and were approximately 0.50m deep (Illus 2). Trenches 4-6 were within the scheduled area. Trench 7, the northernmost trench, was excavated to connect the new cable with the existing mains electricity supply. This trench was square in plan, with 1.20m sides and a depth of 0.60m.

The profile was regular throughout the trenches, and stratigraphy uniformly consisted of a thin tarmac path layer (c.0.10m thick), above a redeposited red-brown silty sand with frequent red-brick rubble inclusions (c. 0.50m+ thick). Trenches 3 and 5 each contained a single small fragment of clay tobacco pipe, which was recorded and discarded.

The trenches were excavated where it was apparent recent moling had already been conducted along the path, and trenches 1-6 all contained a modern yellow gas pipe, which was carefully excavated around by hand. Trenches 1, 5 and 6 also contained an old electricity supply for the lampposts along the walkway, whilst Trenches 5 and 6 contained an additional post-medieval ceramic land drain. All cables and drains were aligned northeast-southwest across the trenches.

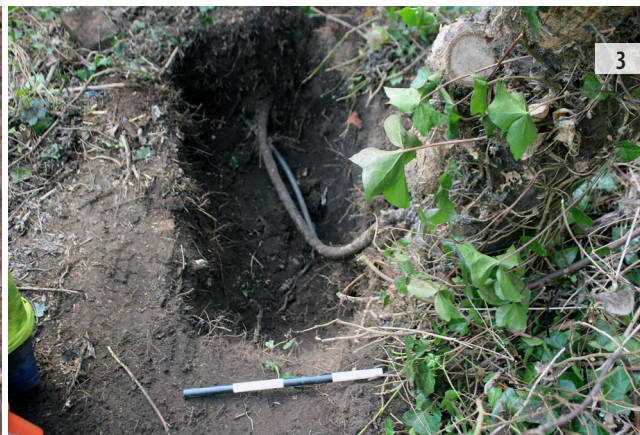
A single trench (1.10mL x 0.60mW x 0.60mD) was excavated near the base of Castle Hill, to the east of castle walk, and near to the western edge of Underhill Street, outside of the scheduled area (Illus 3). This trench was excavated in front of a utility pole, to disconnect the old electricity cables ready for the new electricity supply. The trench contained organic material and topsoil to its full depth, and the area was heavily overgrown with vegetation, with frequent rooting apparent. No deposits of archaeological significance were identified, though one small fragment of animal vertebrae (likely Bovine) was recovered and discarded.
