# NEW WARDS GI WORKS, HEREFORD HOSPITAL

ARCHAEOLOGICAL WATCHING BRIEF  
EHE 80325

commissioned by Kier Construction

July 2018

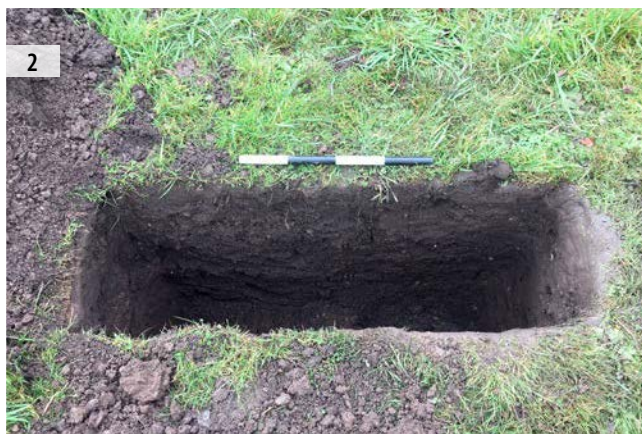
**ILLUS 2** Percolation pit 1 view from north-east    **ILLUS 3** Percolation pit 2 view from north-west

Both percolation pits and the trial trench were located to the south-west of the main hospital at the Macmillan Renton Unit. The deposit sequence in each percolation pit was similar and comprised a firm greenish brown fluvial gravel (1002), (2002), overlain by a soft mid-reddish brown silty, sandy clay subsoil (1001), (2001). This was sealed by a soft brown clayey silt topsoil (1000), (2000). All deposits observed within the trial trench related to modern backfilling of a gas main. Deposit (3002) was a reddish yellow builder's sand, which contained hazard tape indicating the presence of the existing gas main. This was sealed beneath highly mixed greyish brown modern made ground (3001), which itself was below a soft brown topsoil (3000).

PP1			
L (m)	W (m)	Min. D (m)	Max. D (m)
1.00	0.30	0.80	0.80
Context	Description	DBGL (m)	
(1000)	Soft brown clayey, silty topsoil	0.00–0.50	
(1001)	Soft mid-reddish brown subsoil with occasional (<10%) pebble sized flint nodules	0.50–0.75	
(1002)	Firm greenish brown fluvial gravel	>0.75
