# LAND OFF NEWPORT STREET, CUSOP, HAY-ON-WYE

ARCHAEOLOGICAL WATCHING BRIEF  
PLANNING REF. DCSW/2008/0118  
CONDITION 12

July 2018

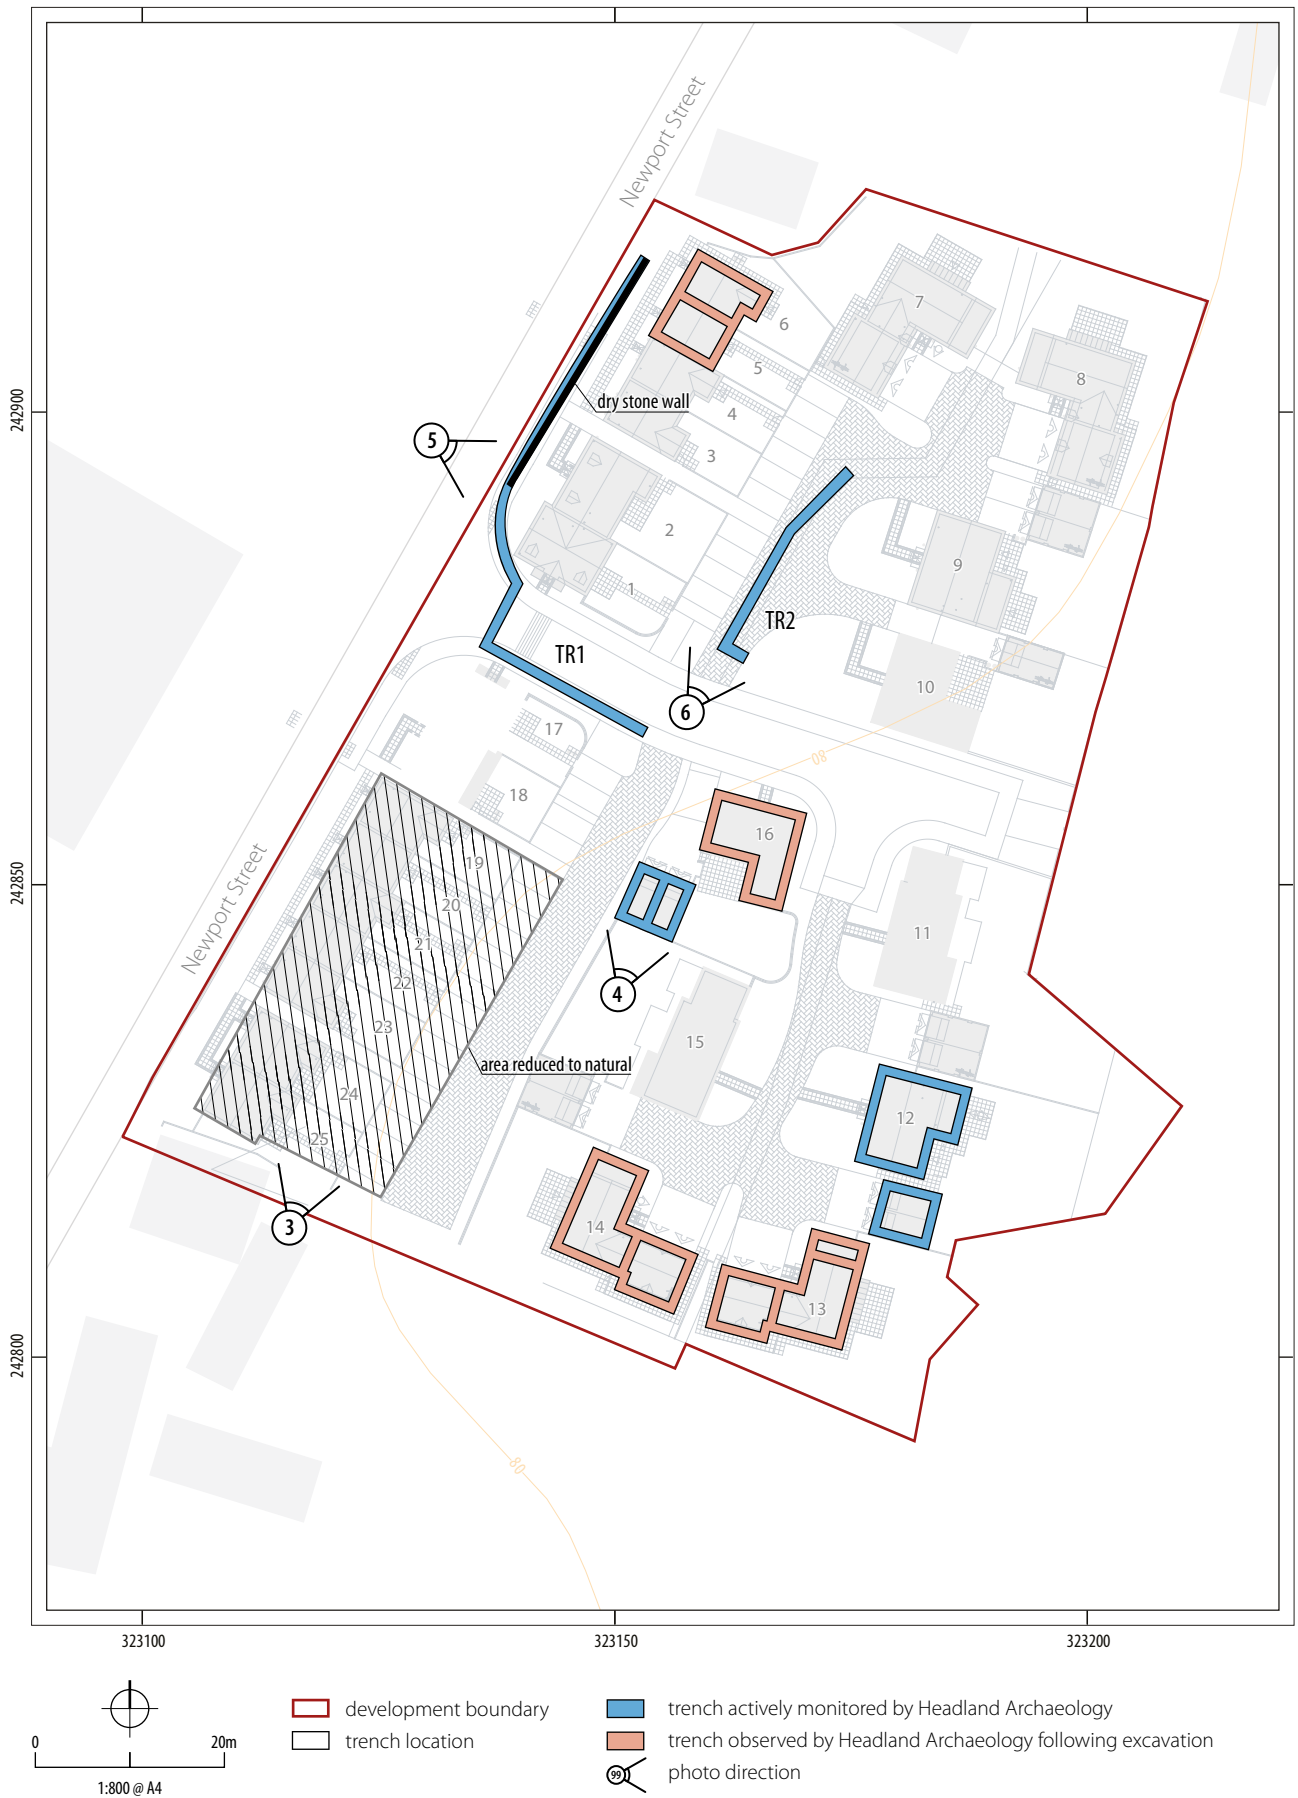
ILLUS 2 Site plan showing excavations monitored

In the northern part of site, the central space between Plots 1 to 7 and Plots 8 to 10 (see Illus 2) had hitherto remained unexcavated making this the most suitable location.

Trench 1 was a service trench cut parallel to the road in the north-west of the site. It was L-shaped in plan and its main body was orientated NE-SW. It was c 70m long by 0.8m wide and was excavated to a depth of 1m below formation level (see Illus 2).

Plot 12, foundation trenches for a house and garage were dug according to the architect's design to a depth of 0.9 to 2.3m below formation level (see Illus 2).

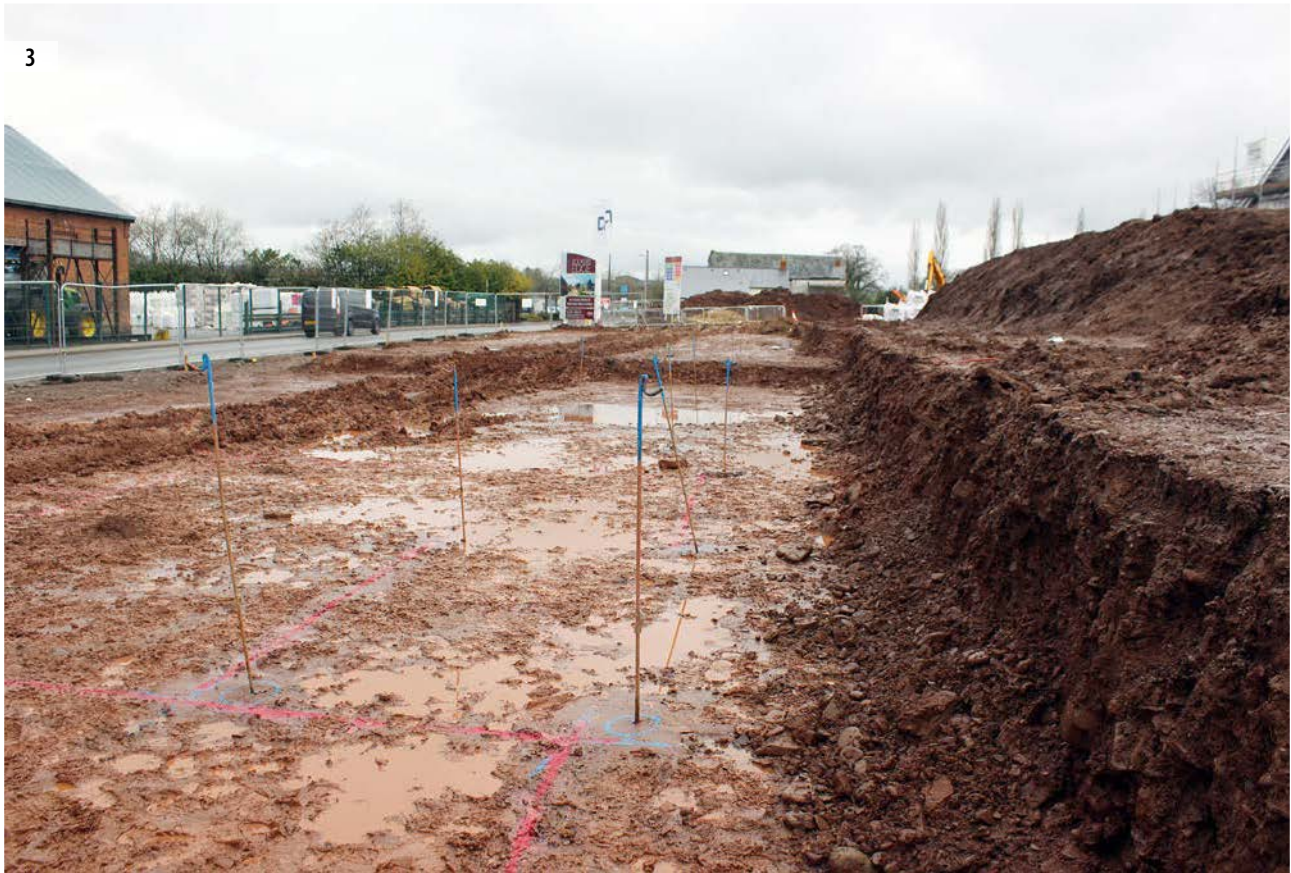
**ILLUS 3** Plots 19–25 reduced to natural substrat **ILLUS 4** Plot 16 foundation trench looking north **ILLUS 5** Trench 1 showing wall remnant looking east

Within the footprint of Plots 19-25, the area was reduced to a level of 1-1.4m below pre-development ground level (BGL) (see Illus 3).

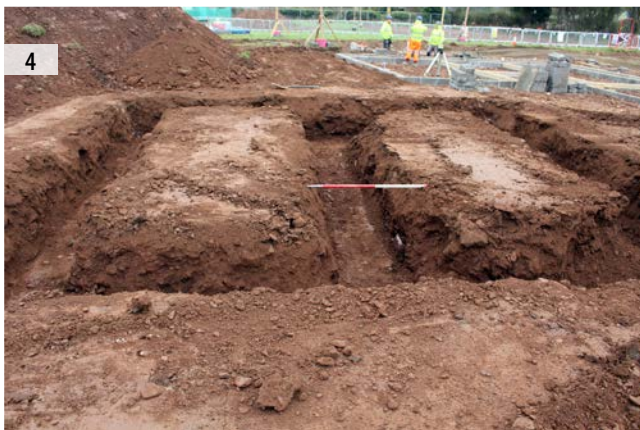
Plot 16, foundation trench for a double garage was dug according to the architect's design to a depth of 0.8m below formation level (see Illus 4).

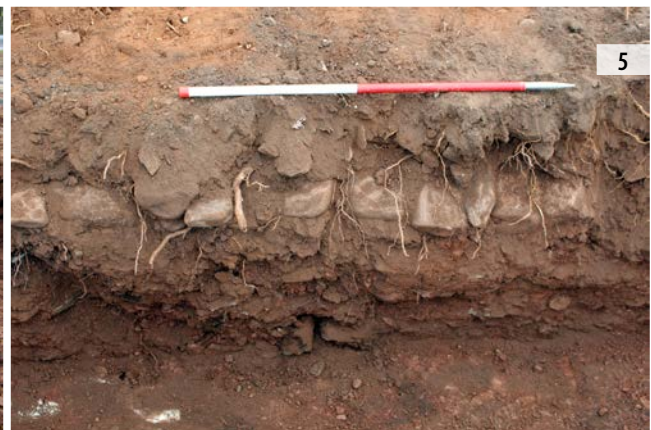
The watching brief identified a remnant of a drystone wall foundation (009) in the west facing section of Trench 1 at a depth of c 0.4m BGL (see Illus 5).

The wall was aligned NE-SW extending NE beyond the limit of excavation. It was >30m long by 0.4m high by 0.6m wide.

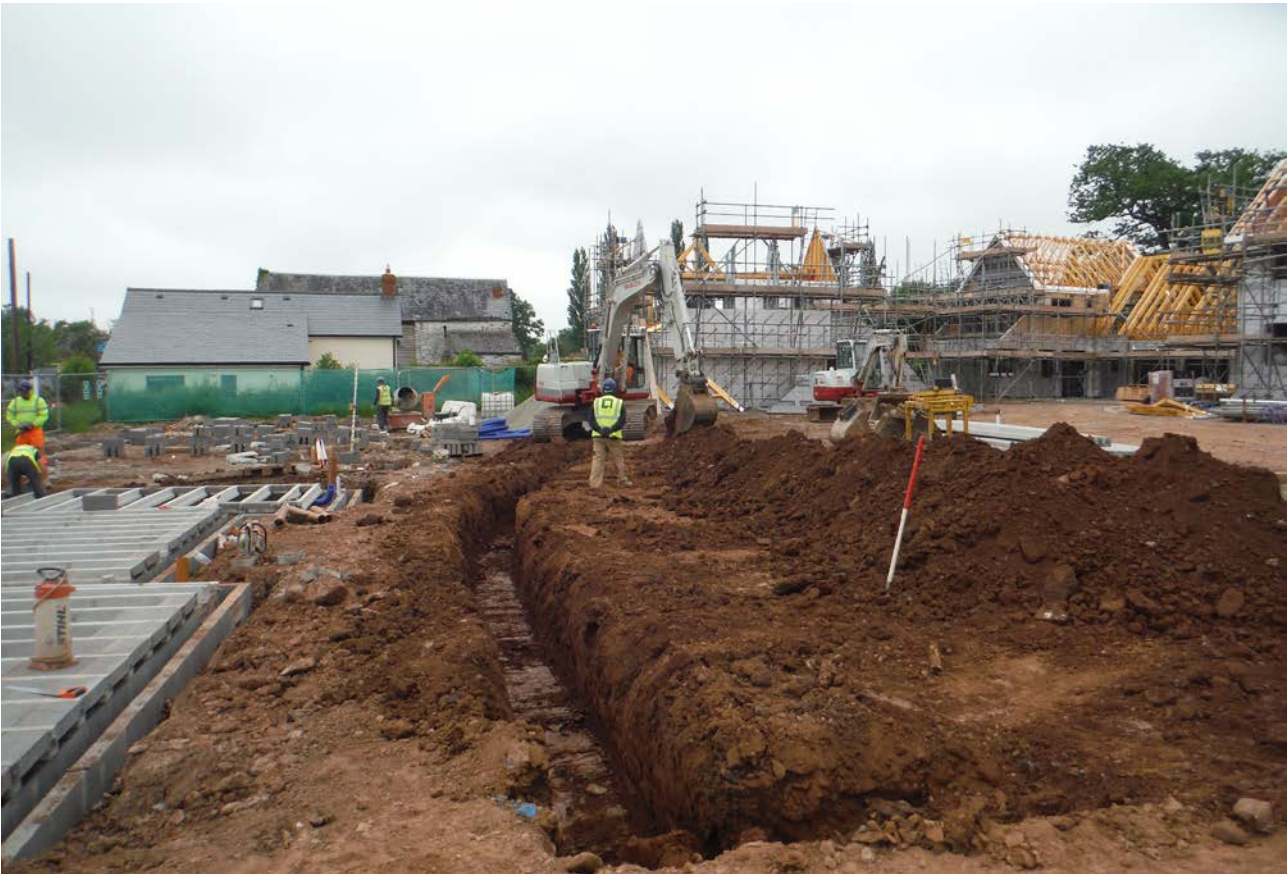
ILLUS 6 Trench 2 overview looking north-east

Trench 2 was an archaeological evaluation trench. It was L-shaped in plan and its main body was orientated NE-SW. It measured 36m long by 0.8m wide and was excavated to the depth of the geological horizon (0.7m below formation level) (see Illus 6).
