16–18 HIGH TOWN, HEREFORD

WATCHING BRIEF
PLANNING REF. P172823/F

commissioned by Alban House (Hereford) Ltd

WATCHING BRIEF

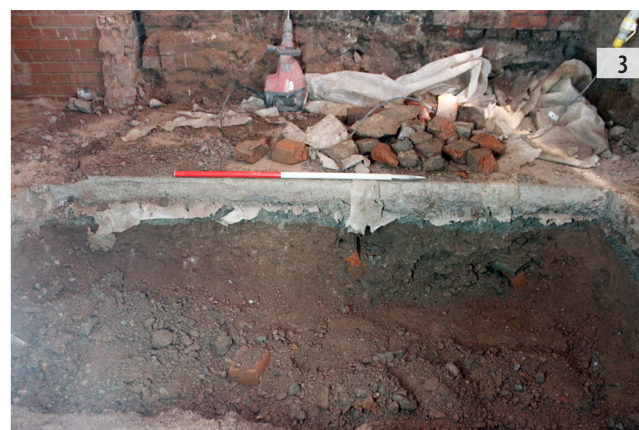
ILLUS 3 North facing section of Trench 1, showing feature [1002]

Context [1002] was a cut which was visible in the north facing section of the trench. It measured 0.92m wide and 0.60m deep and did not extend more than 0.15m into the trench. It had steep, almost vertical sides and flat base. It contained a single fill, (1003); a mid greyish brown sandy clay. This fill was very loose with voids throughout and contained frequent broken brick inclusions, as well as occasional stones.

Features [1002] and [1010] and their fills appeared to be very similar to each other and probably held a similar use or purpose. The amount of building material present within the fills of these features suggests that they were both associated with renovations to the buildings above. Although their exact nature is difficult to determine, it is possible that they are former foundation cuts for walls within the basement of the building.
