NORTH-WEST CREWE PACKAGE

ARCHAEOLOGICAL EVALUATION OF LAND SOUTH OF SMITHY LANE, CREWE

PLANNING REF. 18/15195

October 2018

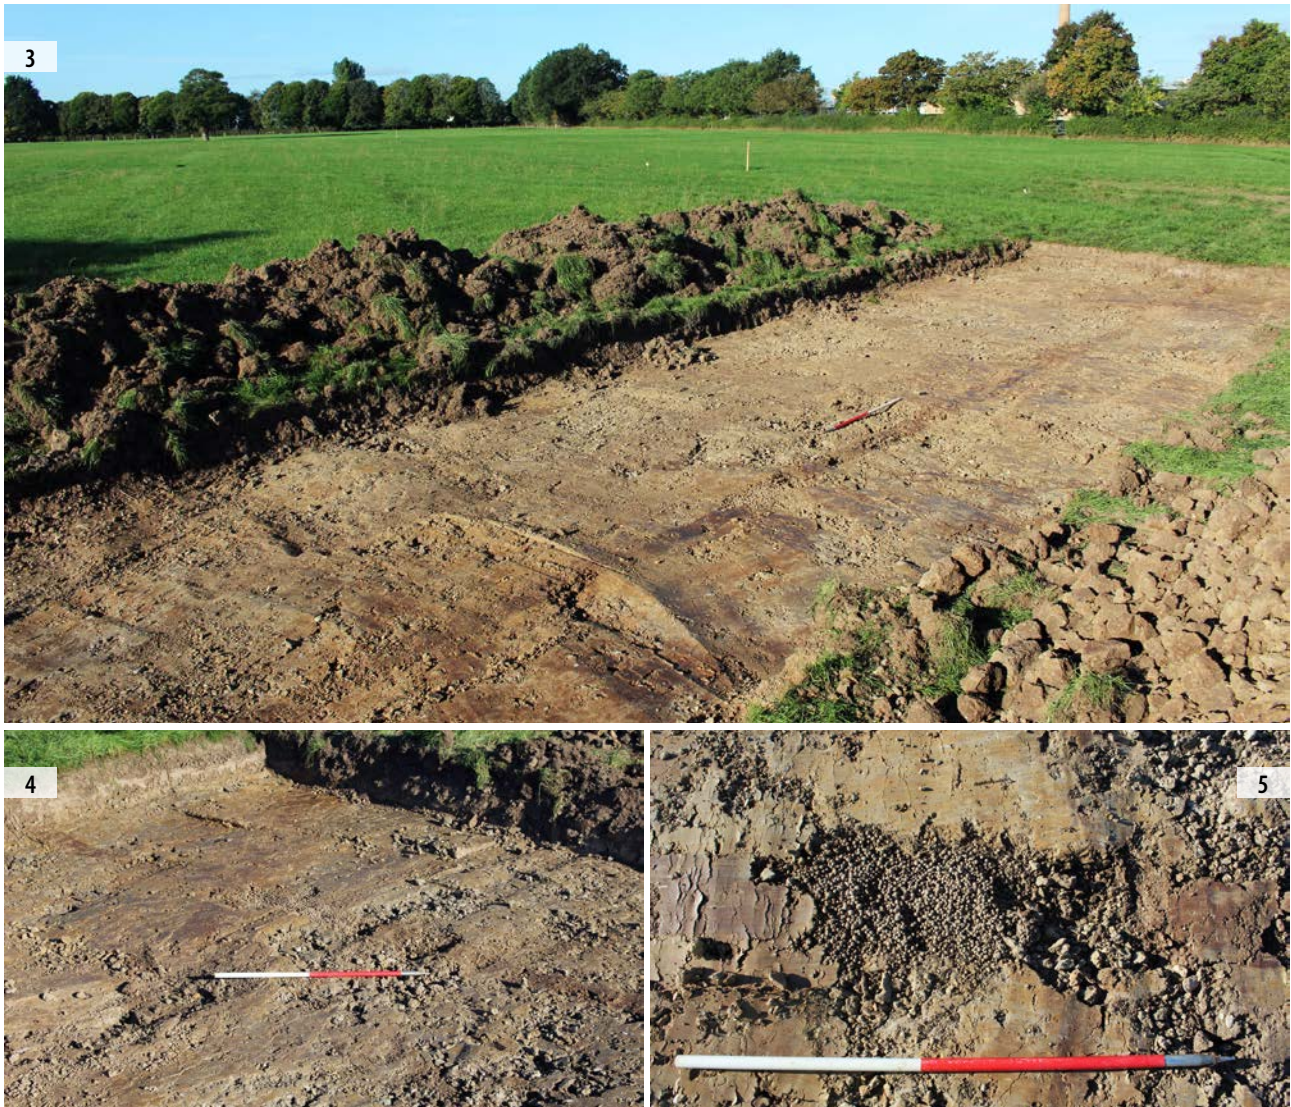
ILLUS 3 Modern service/land-drain in Trench 3, looking west **ILLUS 4** Trench 3, looking north-west showing deposit (306), the source of the geophysical anomalies **ILLUS 5** Trench 3, looking south-west showing intersection between service (304) crossing land drain with gravel (306) to east side of intersection

linear feature; probably a land drain (Illus 4). The granules were approximately 8mm in diameter and are likely to be some form of industrial waste product, quite possibly from a very high heat process which resulted in them producing higher magnetic field responses than the surrounding deposits. Each of the deposits (306) was situated immediately east of a land drain crossing / crossed by the linear feature containing them (Illus 5). This deposit was probably used to separate and protect the pipes from each other.

Archaeological evaluation of geophysical anomalies on land south of Smithy Lane, Crewe, has established that no archaeological remains were present. The evaluation corroborated the results of the geophysical survey, clearly demonstrating that the anomalies corresponded to magnetically enhanced sub-surface deposits. The deposits identified were modern in origin and were the result of modern pipe laying activity.
