16–18 HIGH TOWN AND 12 EAST STREET, HEREFORD

ARCHAEOLOGICAL EXCAVATION

PLANNING REF. P172824
EHE NO. 80356

January 2019

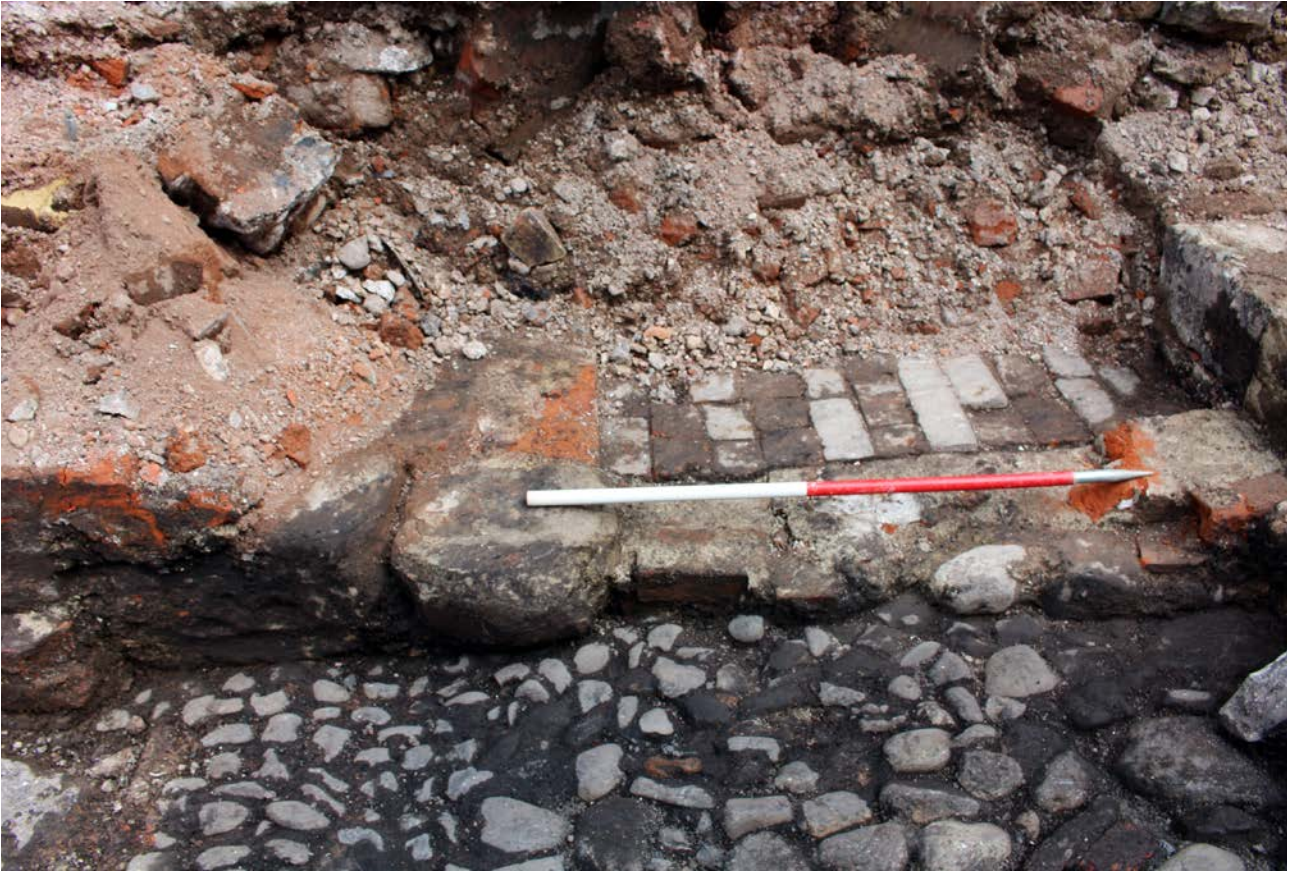
ILLUS 15 General view of foundation (2039), surface (2034) Group 2116 and foundation (2005), Group 2114, showing re-used masonry and relationship with earlier metaling (2032)

Group 2116 (Table 5) comprised fragmentary brick wall foundations and surfaces encountered between 56.12 and 56.64m AOD, defining the remains of a heavily truncated structure (Illus 15). A mid-grey sandy clay (2049) was identified below brick surface (2034) and interpreted as probable made ground for setting of the surface. Modern ceramics were recovered from the deposit. The full extent of the structure was not evidenced and the high level of disturbance and demolition on the site rendered complete understanding difficult. However, spatially and stratigraphically, it appeared to

The remains of Group 2114 suggested a rectangular building fronting onto East Street, with a small rectangular room projecting from the northern end; likely functioning as an outhouse, with modern drains and pipes associated with the foundations. Surfaces were of cement construction, with no indication of tiling or brickwork. Foundations (2001), (2005) and (2008) abutted the earlier stone foundation (2004) and brickwork (2069) built into it suggested re-use of the stone foundation. Foundation (2005), to the north of (2004), also incorporated large sandstone blocks (Illus 15).
