CASTLE HOUSE HOTEL, HEREFORD

ARCHAEOLOGICAL WATCHING BRIEF

PLANNING REF. P151867
EHE NO. EHE80379

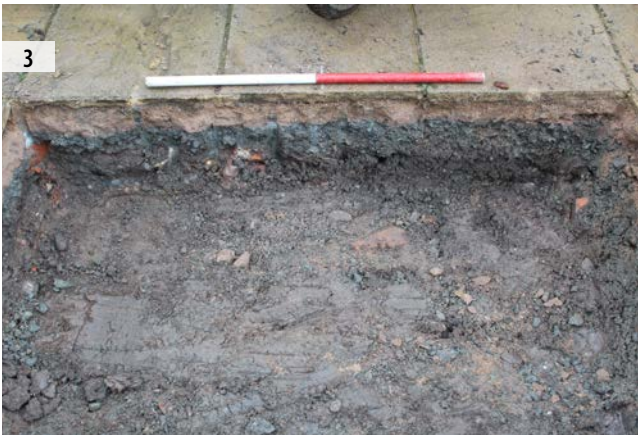
ILLUS 3 General View Pad 2, looking south **ILLUS 4** General view of Pad 5, looking west

Across the patio area (Illus 3), the present ground surface generally comprised stone slabs and sand cement setting deposit (001) which overlay a blue-grey layer of gravels (002) up to 0.15m thick. This in turn sealed a further layer of clayey sand and gravels (007) in which brick fragments were observed. This overlay a dark greyish brown clayey silt (004) containing construction and/or demolition debris. Variable made ground layers were noted in Pit 6, with a deposit containing a greater density of building debris (010) identified at the limit of excavation.

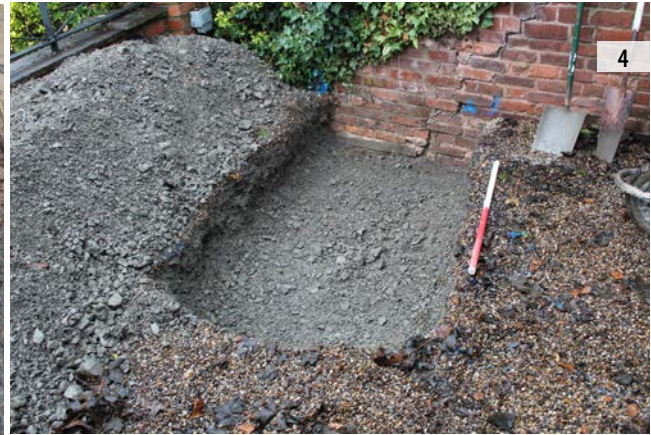
Within Pits 4 and 5 (Illus 4), a thin layer of decorative pea gravel (007) overlay a deep layer of grey gravel (008) extending beyond formation level. Made ground (012) containing brick and tarmac fragments was recorded below the pea gravels in Pit 8. The bulk of the excavated area in Pit 8 contained a large concrete slab which was not removed, with a similar concrete slab also identified in Pit 7. The concrete is likely to have related to a former 'smoking room' associated with the hotel (S Morgan pers com).

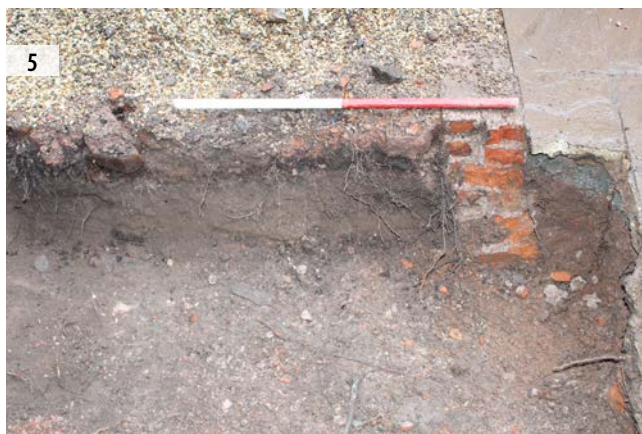
ILLUS 5 View of south facing section, Pad 3, showing wall foundation [011] **ILLUS 6** View of scar of former structure associated with foundations [005] and [011]

Remains of red brick wall foundations (005) and (011) (Illus 5) were observed in Pits 1 and 3. The foundations appeared associated and related to a former, rectangular brick structure measuring 4.30 x 1.80m, the scar of which was visible in the extant boundary wall of the site (Illus 6).
