# GLOUCESTER SEWERAGE GROWTH PIPELINE, HARDWICKE, GLOUCESTERSHIRE

## ARCHAEOLOGICAL MITIGATION

commissioned by North Midland Construction PLC  
on behalf of Severn Trent Water

March 2019

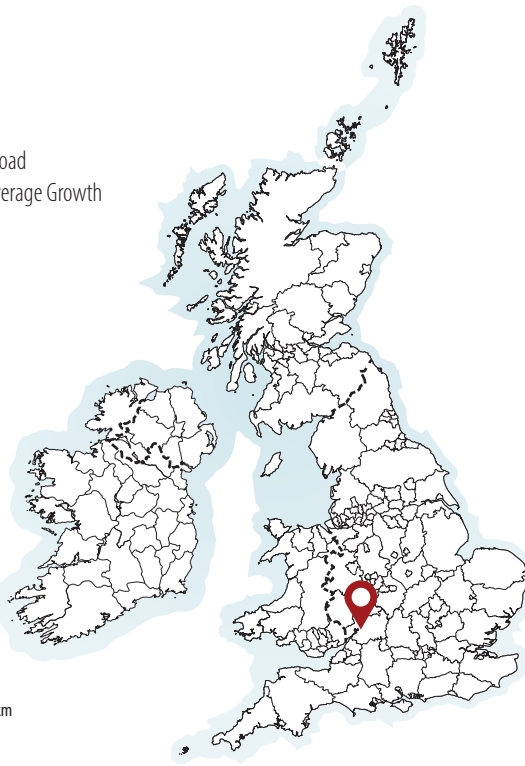
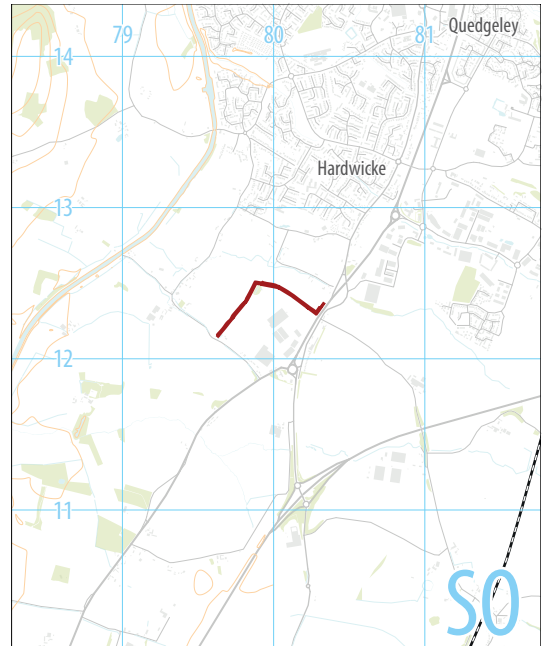
ILLUS 1 Site location

The proposed pipeline is located north and west of Quedgeley Trading Estate West, Hardwicke and extends north-eastwards from the pumping station on Pound Lane (SO 7964 1215) for 450m before turning south-eastwards and terminating at the site of a proposed flushing chamber on the east side of the A38 (SO 8043 1233). The route crosses six arable fields (Illus 2).

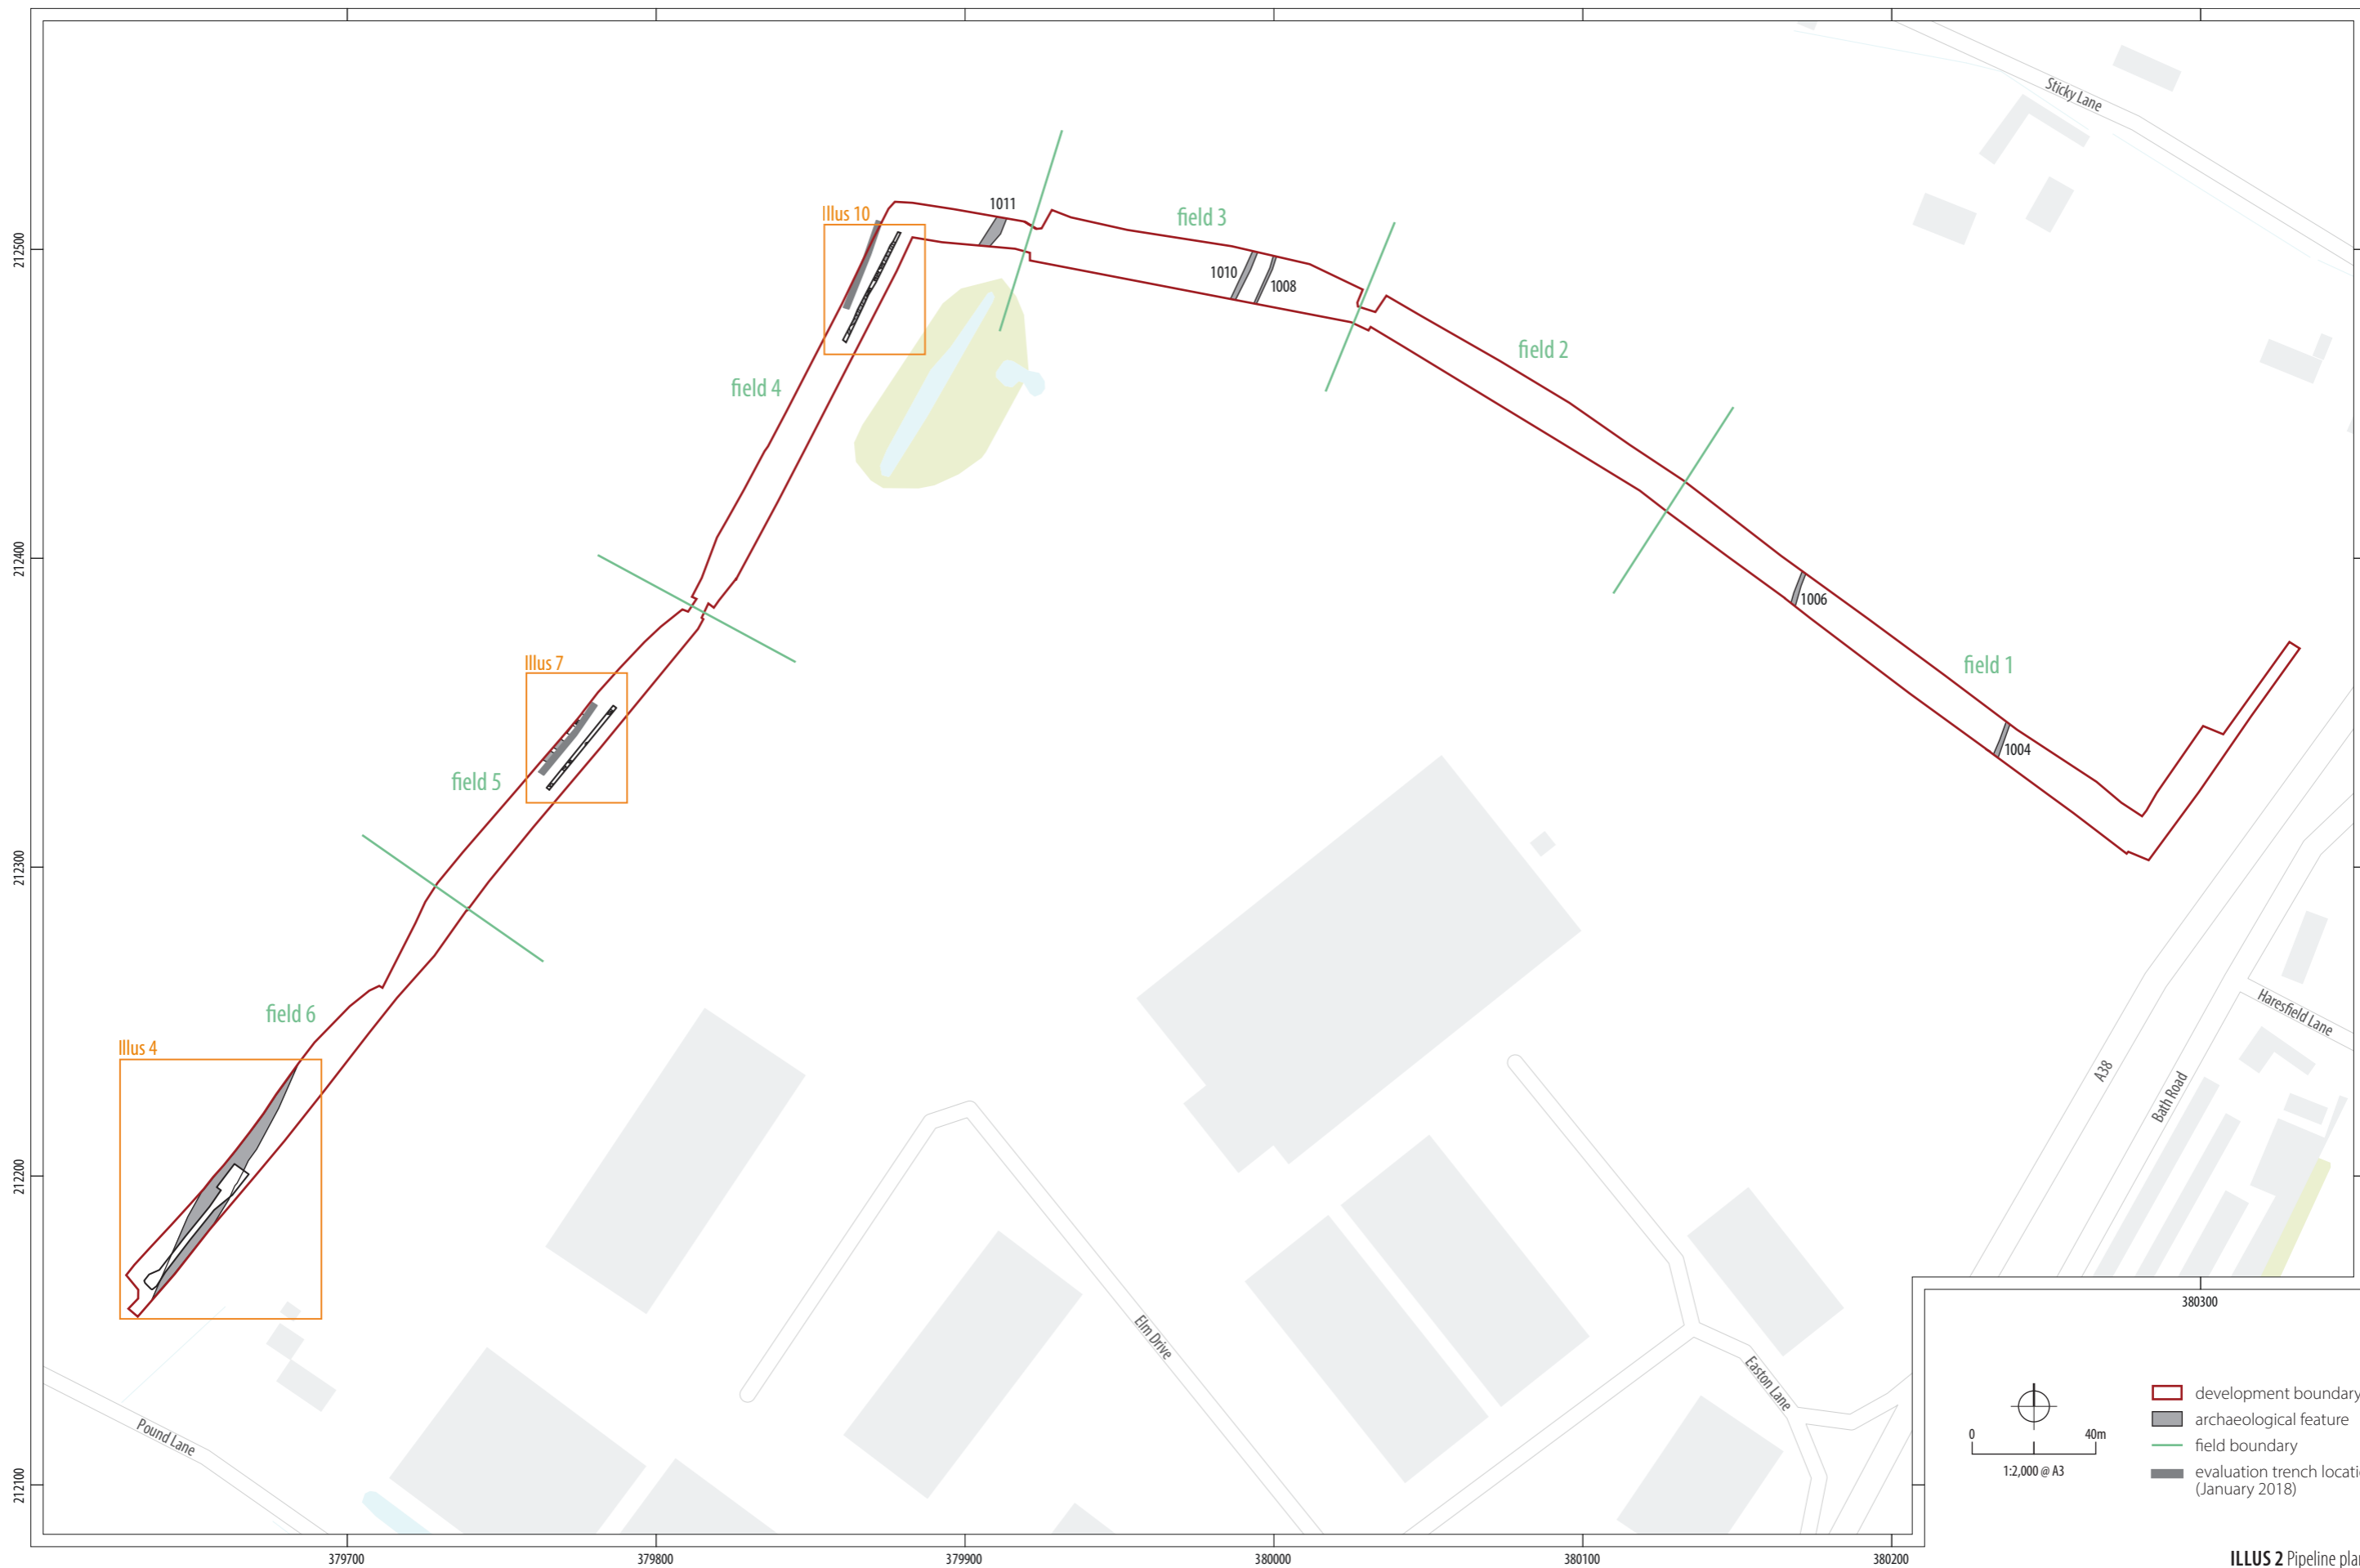
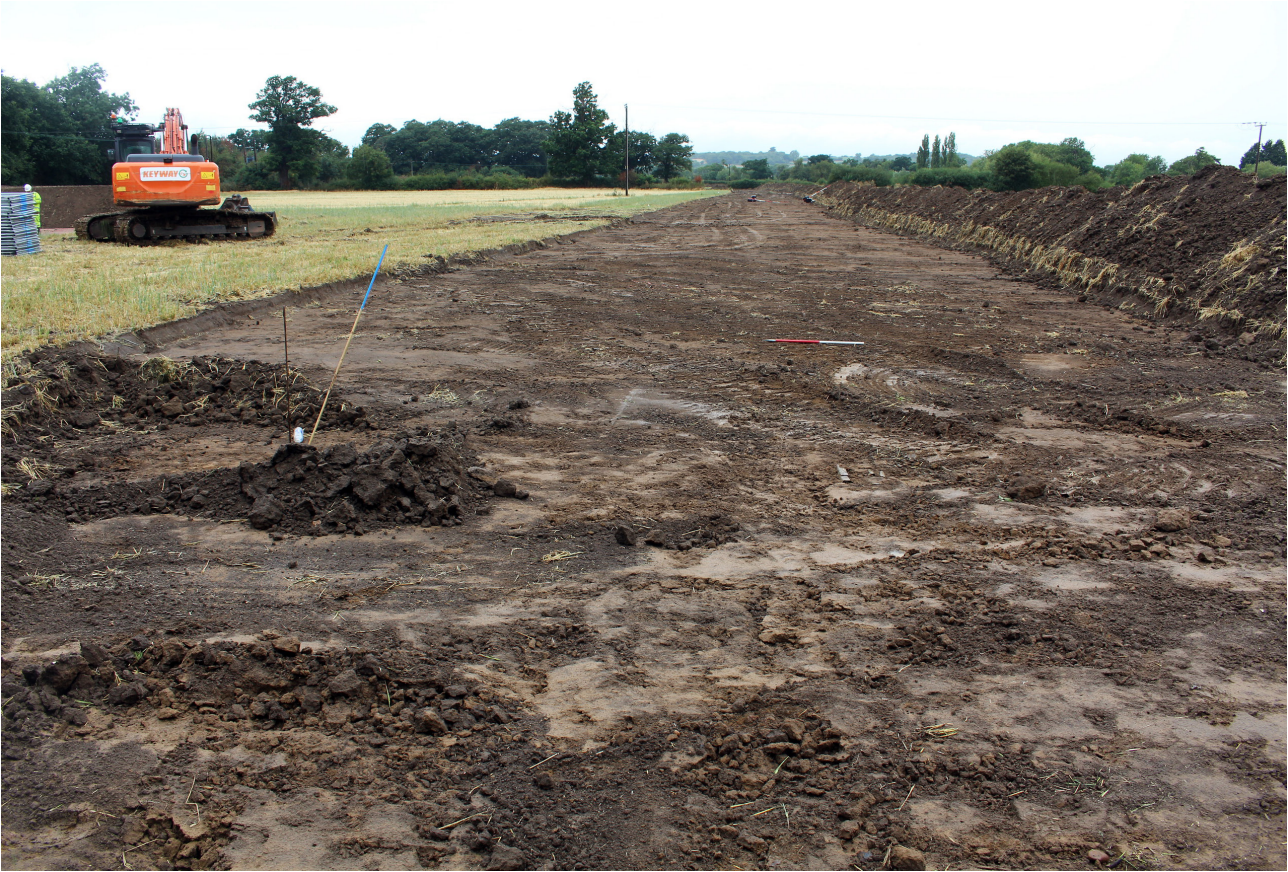
**ILLUS 3** General view of pipeline easement, Field 1, looking west

The site works were undertaken in two phases between the 10th August and 21st November 2018. Phase 1 involved the stripping of topsoil within a 10–15m wide easement running the full length of the site (Illus 3). Phase 2 involved the excavation of manhole pits and an approximately 1.20m wide service trench within the easement, between 3.5 and 5m below ground level, to receive the replacement sewer pipe.

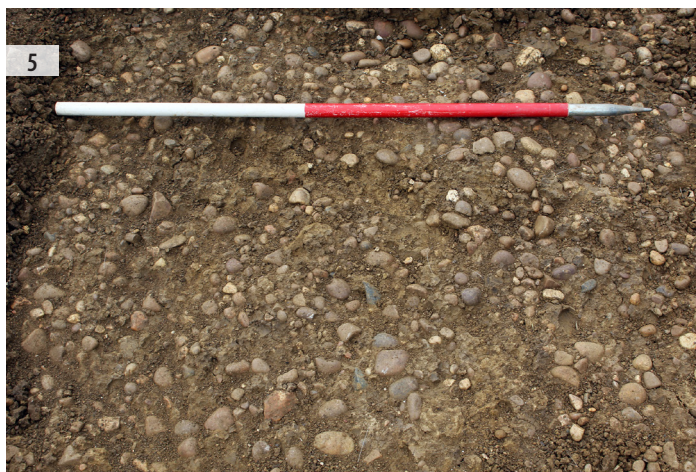
sequence of construction layers was observed. A make-up layer of light reddish-brown sandy clay and pea gravel (1091), a maximum of 0.15m thick, appeared to form the base or primary deposit for the road. Overlying this, a 0.10 to 0.15m thick, compact make-up layer of sub-rounded pebbles and gravel (1031) was identified (Illus 5). This was in turn overlain by a further setting deposit, 0.05m thick, of a brownish-yellow sandy clay containing frequent pea gravel (1033). Within Sondage 2, remnants of limestone paving (1032) appeared to be set into deposit (1033) creating the final road surface (Illus 6).

**ILLUS 5** Plan view of gravel make up (1031) for road (1030) in sondage 1 **ILLUS 6** View of remnants of road paving (1032) and make up (1031) in sondage 2, looking south

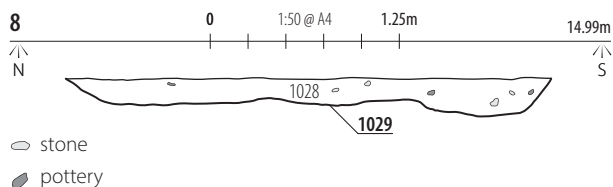
Located to the south-west of post-hole [1023] a partially exposed cut [1029] was test excavated and revealed a feature measuring 3.19m in width and greater than 1.00m in length, continuing beyond the LOE to the west. The cut had a steep northern edge, slightly uneven base and stepped down at its southern extent, varying between 0.12 and 0.25m deep (Illus 8). The cut contained a single fill (1028) from which a large amount of pottery of 12th–15th century date was retrieved along with a number of animal bone fragments (the latter not retained). Due to the limited exposure of the feature full interpretation was speculative but it may have represented the remains of a sunken floored structure.

**ILLUS 8** West facing section through [1029] **ILLUS 9** South-west facing section through [1036]

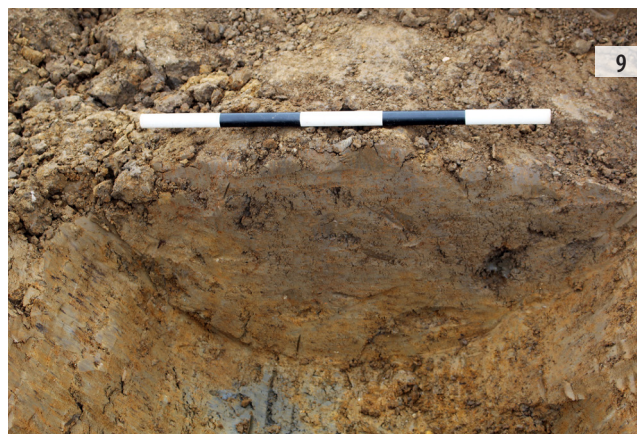
Towards the south end of the pipe trench, three linear features were identified. The most northerly of these was an east to west oriented ditch [1036] measuring 0.79m wide and 0.34m deep (Illus 9). The ditch contained a primary fill (1035) similar in character to surrounding geological deposits and a secondary fill (1034) likely deriving from gradual sedimentation and from which pottery of 12th to 15th century date was retrieved.

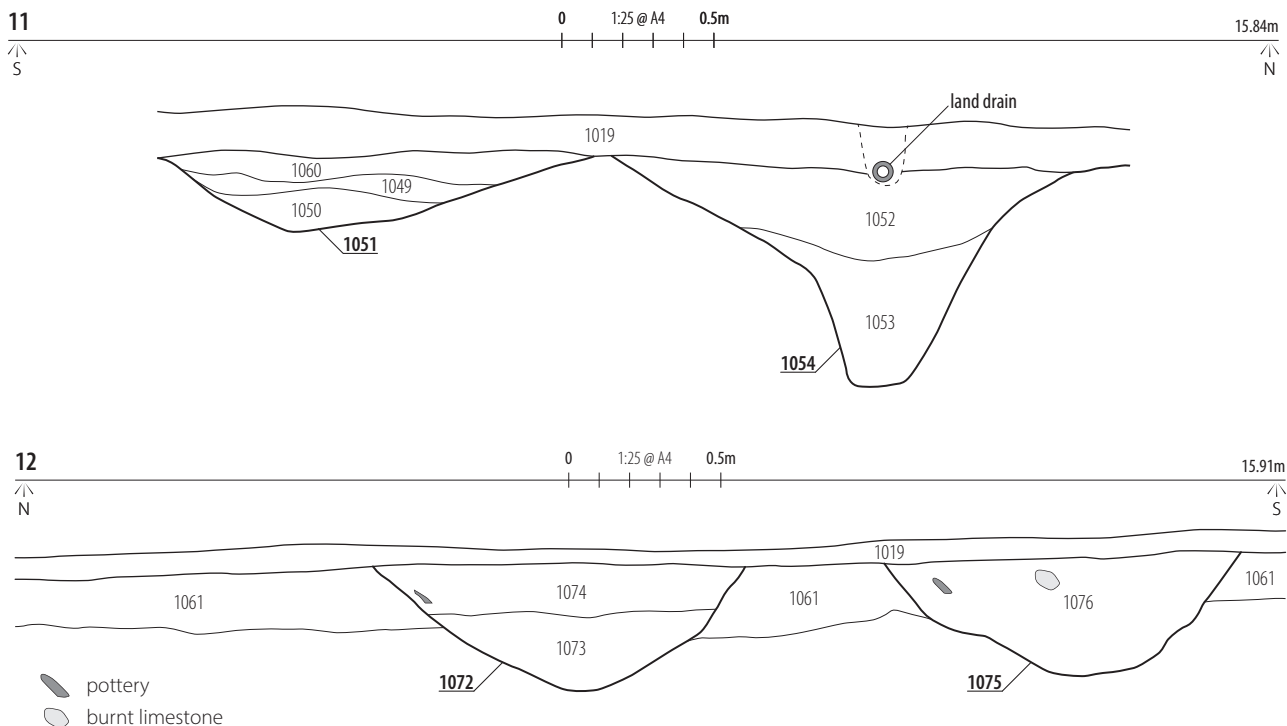
Identified as cutting (1061) an east to west oriented ditch [1054] measured 1.49m wide and 0.73m deep. The ditch was steep sided with a narrow, 0.25m wide base. Two fills were identified (Illus 11).

Located immediately south of [1054] and also oriented east-west, a 1.38m wide and 0.19m deep, shallow ditch [1051] (Illus 11) was recorded. Three fills were identified, the primary fill (1050) resembling the surrounding geology, probably indicating erosion of upcast or sides of the cut into the ditch. Pottery of 12th–15th century date was recovered. The second deposit (1049) measured 0.08m thick and contained a density of charcoal fragments, heat affected stone, degraded animal bone and pottery dating between the 12th and 15th centuries. The deposit was interpreted as representing the deliberate dumping of material likely to be associated with occupation in the vicinity. A final, homogeneous sandy clay (1060) filled the ditch, suggesting a final gradual sedimentation of the feature. No dateable material was recovered with only charcoal flecks rarely observed.

**ILLUS 11** East facing section through ditches [1051] and [1054] **ILLUS 12** West facing section through ditches [1072] and [1075]

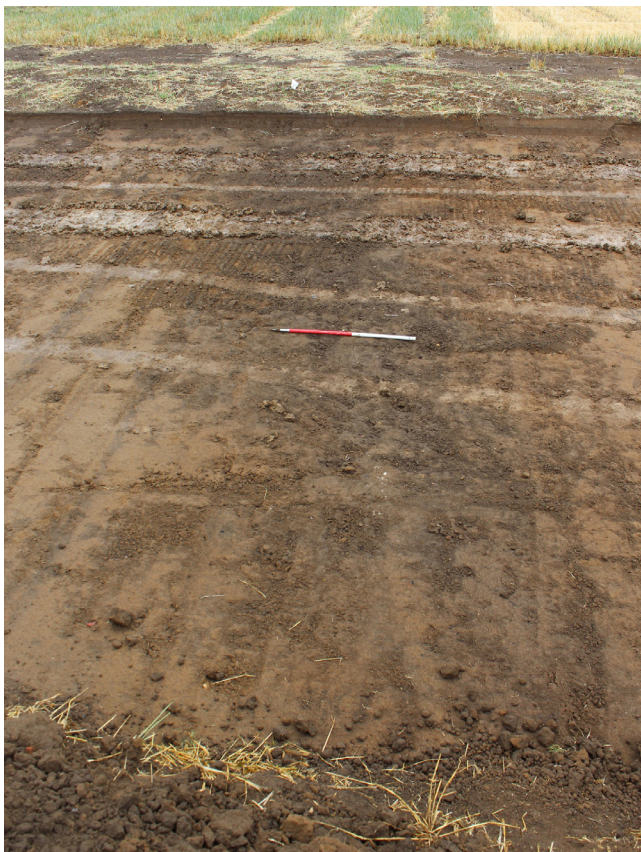
Two further furrows [1004] (Illus 13) and [1006] were also recorded in Field 1 following topsoil stripping. White glazed ceramic sherds, coal and ceramic building material fragments were observed within the fills of the furrows (not retained) and suggested a post-medieval date for the field system.

**ILLUS 13** Probable furrow [1004], Field 1, looking south
