LAND ON THE GREEN, STRATFORD ROAD, SOLIHULL

ARCHAEOLOGICAL EVALUATION

PLANNING REF. PL/2018/02731/MAJFOT

May 2019

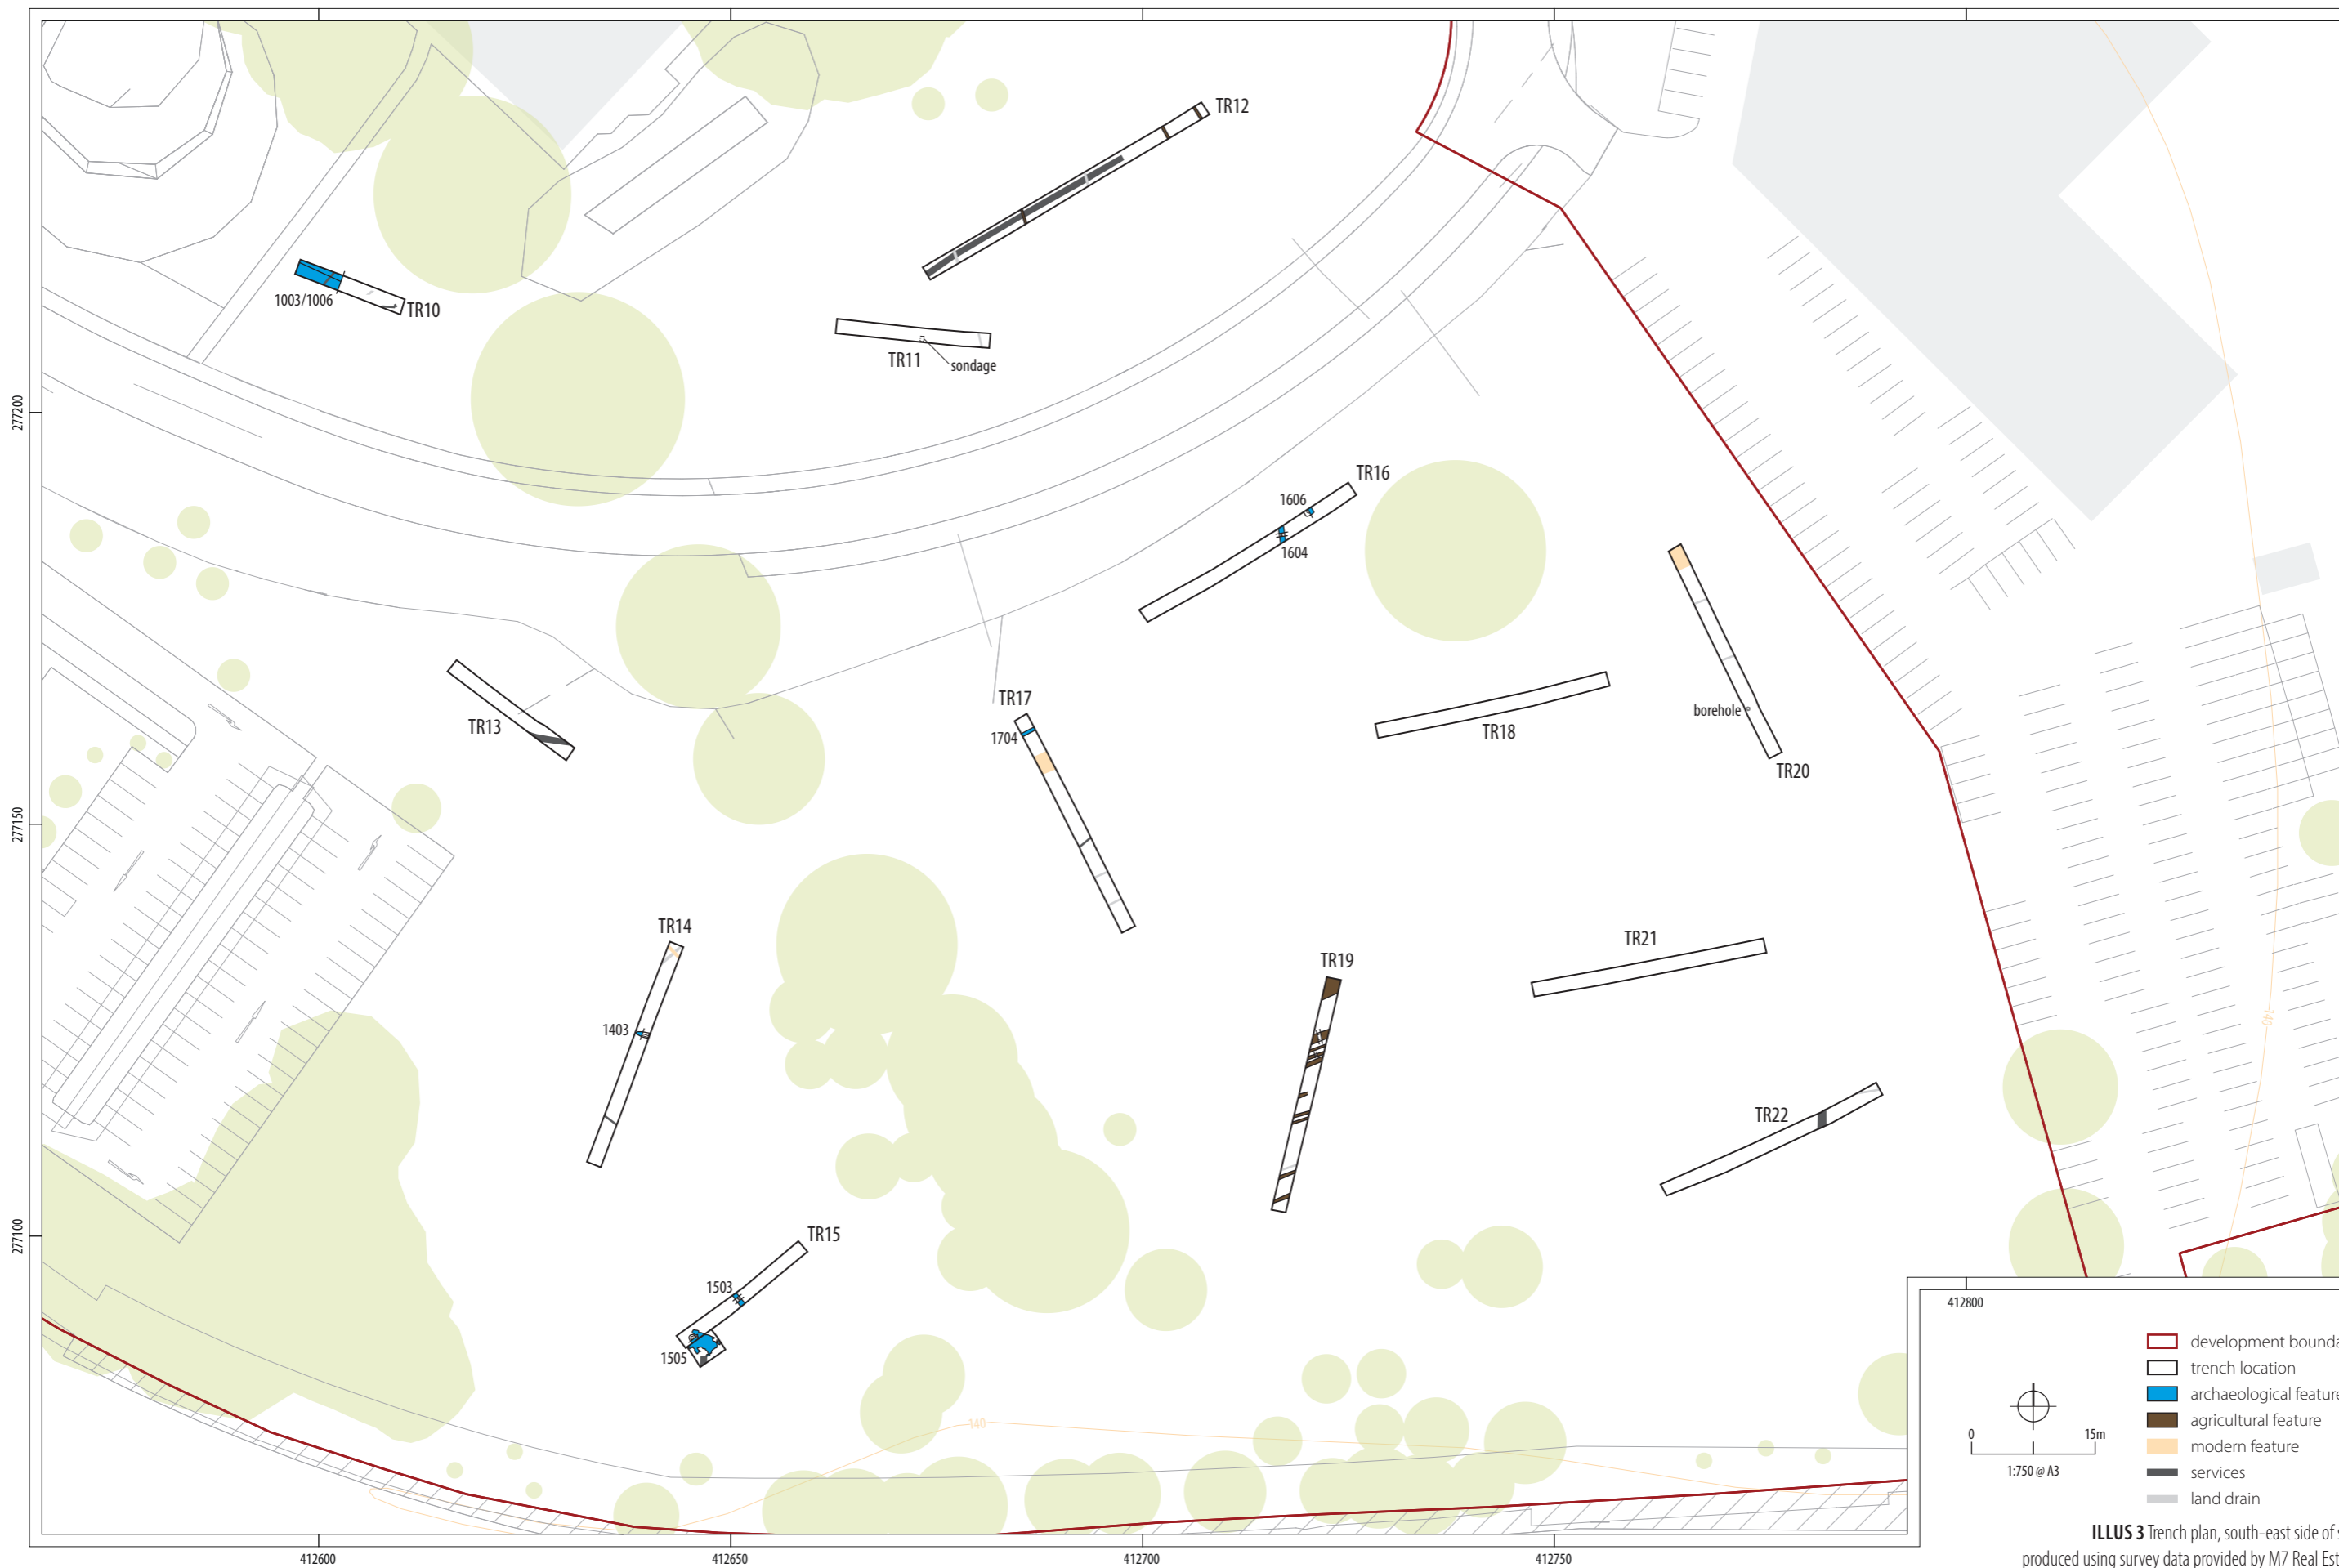
ILLUS 3 Trench plan, south-east side of site
 produced using survey data provided by M7 Real Estate

Trench 10 contained two partially exposed, linear features that run in a broadly WNW-ESE alignment along the trench (Illus 3 & 5). A relationship between the features could not be established. The southernmost linear feature [1003] was visible in the base and north facing section of the trench. It was filled with two deposits (1004); a primary fill consisting a series of lenses deposited by water run off interspersed with sand eroded from the cut and contained no finds. The upper fill (1005), rose to topsoil level and was a deliberately backfilled mix of dark organic rich soil along with elements of redeposited parent geological material. It contained small fragments of ceramic building material (CBM), and two sherds of fine white glazed pottery. The northernmost feature [1006], was visible in the south facing section of the trench and its base. It too contained two deposits, (1007), primary and (1008), upper, from which a sherd of probable 17th to 19th pottery was recovered. Both deposits were very similar in nature to those in [1003]. As the alignment of the trench and the broad alignments of the ditches were near parallel, it was not possible to ascertain whether the features were crossing one another, or if one had cut the other. The position of the features does not correlate with field boundaries shown on maps from 1886 onwards but based on the evidence discussed above are most likely to be later post-medieval or Victorian in date.

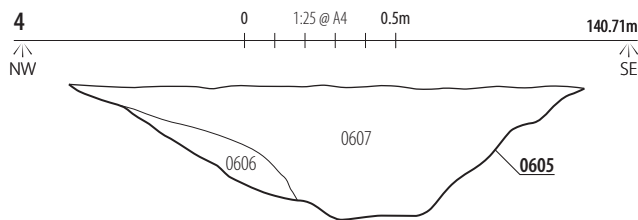
In Trench 06 a north-east to south-west aligned ditch [0605], measuring 1.53m wide and 0.40m deep was recorded (Illus 2 & 4). It contained two deposits, the primary fill indicating initial erosion on the west side of the cut, followed by a period of infill due to low energy water action – water run off causing it to silt up. The upper deposit especially appeared gleyed as a result of fluctuating water levels over a prolonged period. The feature was sealed by

(1602), modern made ground, suggesting the feature had been truncated. No cultural material was recovered during excavation. An environmental sample [ES001] was taken from the primary deposit (0606), and another [ES002] was taken from the upper deposit (0607). The samples contained no evidence that could date or imply the function of the feature. The ditch was interpreted as a boundary ditch, potentially associated with medieval strip fields, due to its similar orientation, the fossilisation of which can still be seen in the local area.

ILLUS 4 Trench 6, south-west facing section through ditch [0605] **ILLUS 5** Trench 10, looking west at partially exposed ditches [1003] and [1006]

A boundary ditch in Trench 6 does not conform to features identified on historic maps and may be associated with an earlier, possible strip field system though may equally be of post-medieval date. No finds were recovered and an environmental sample recovered from the feature offered no information on the nature or further function of the ditch. The lack of cultural material does not suggest any immediate proximity to settlement activity, with its fills indicating gradual sedimentation and gleying and that the ditch is likely to represent a former field boundary.

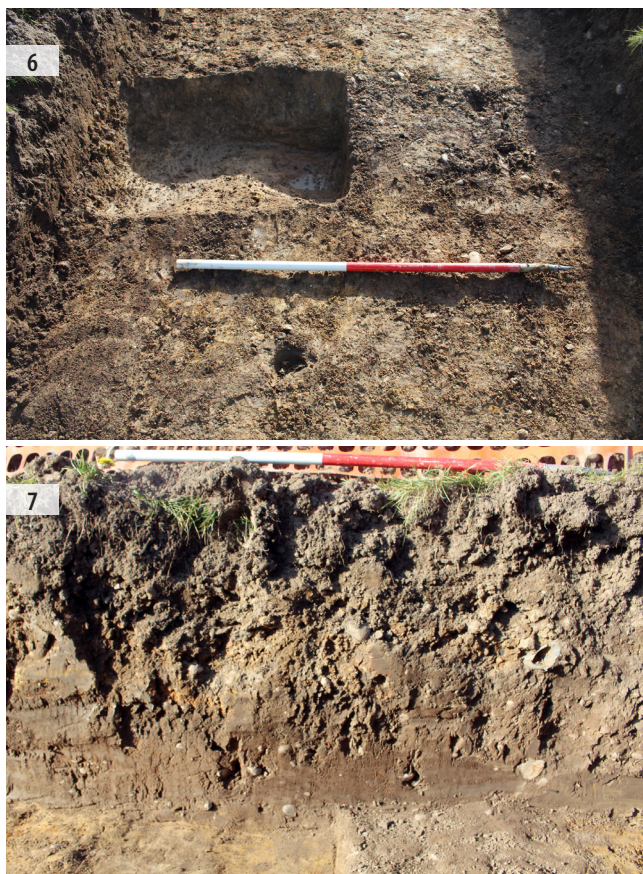
A partially exposed feature [1403], was recorded in Trench 14, which was most likely linear, aligned east to west and with a terminus to the west end (Illus 6). The exposed length was 0.90m and it continued to the east, the width was 0.67m. It contained a single heterogenous deposit, which was the result of deliberate backfill. No cultural material was recovered during excavation. The feature was sealed by modern deposit (1402) and may have been truncated by machine excavation prior to this. The lack of a primary deposit suggests that whatever its purpose, it was rapidly backfilled.

ILLUS 6 Trench 14, looking south at ditch [1403], with terminus to west (right) made ground present across the majority of the south-east side of site
