# BEWDLEY BANK RESERVOIR, BURGHILL, HEREFORDSHIRE

## ARCHAEOLOGICAL WATCHING BRIEF

PLANNING REF. 184286  
EHE NO. EHE80401

July 2019

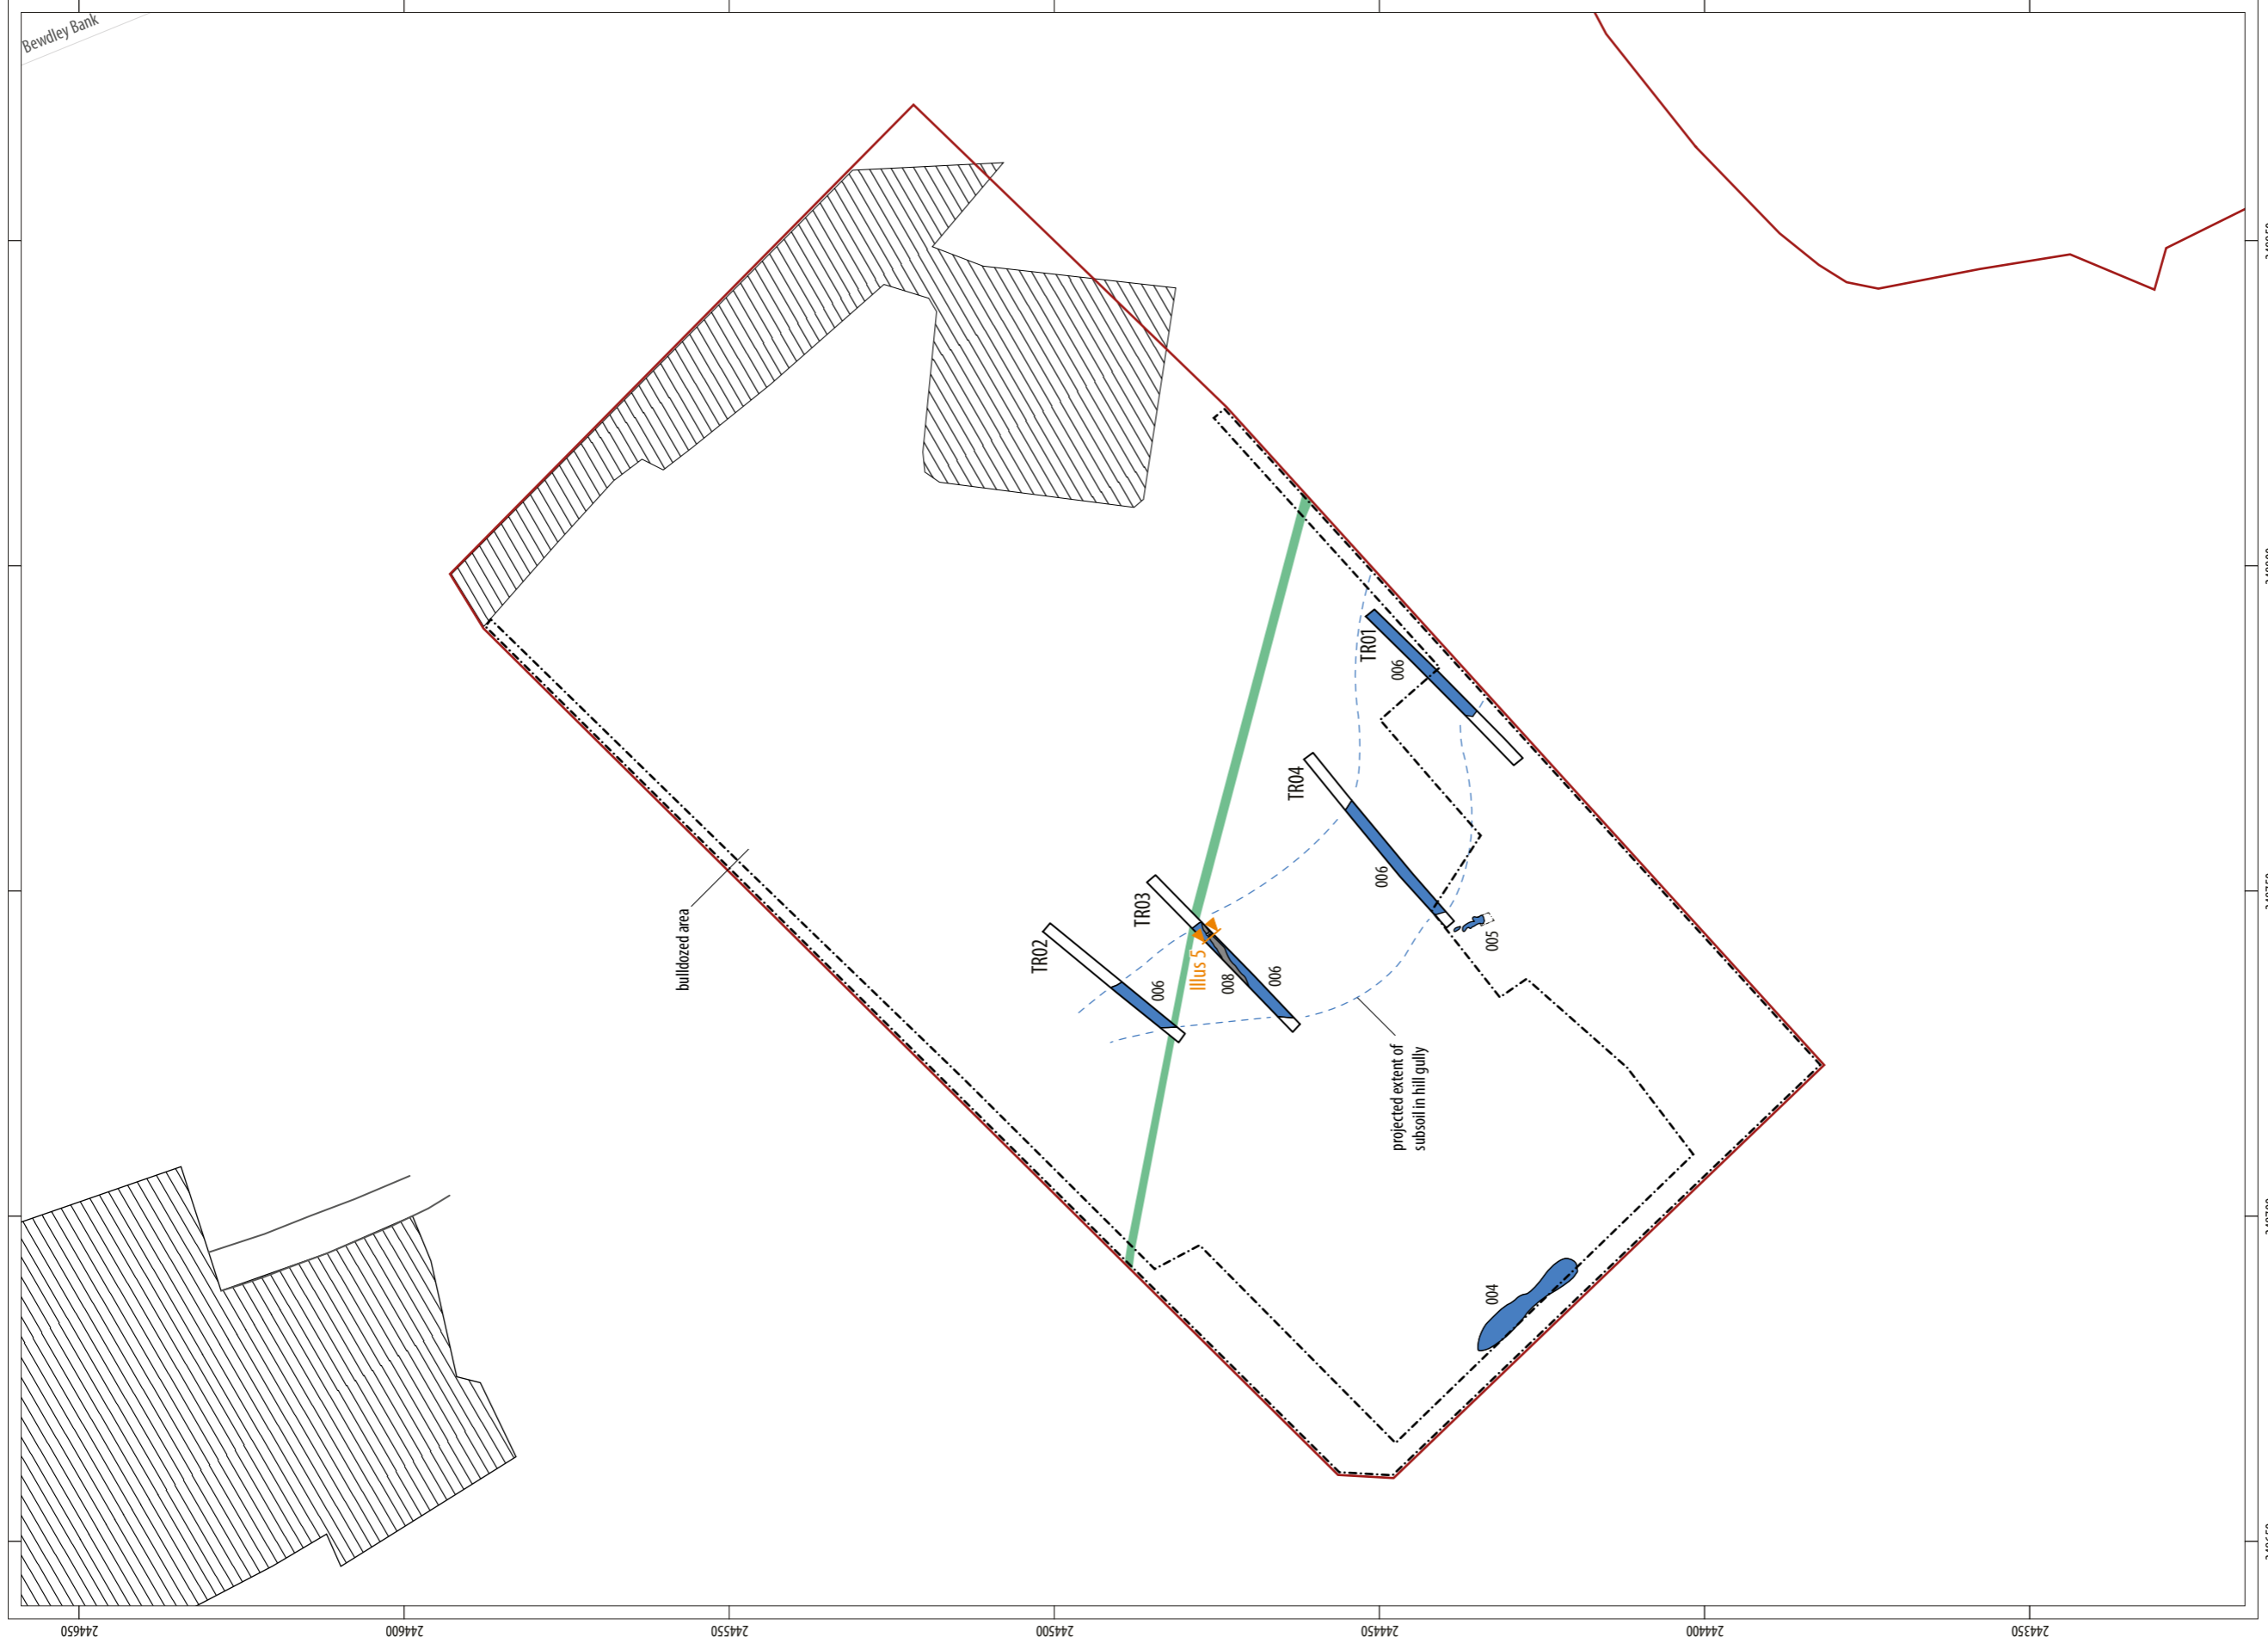
- monitored area
- trench location
- colluvial subsoil
- previously excavated area
- area stripped by mechanical excavator
- hedge
- sondage

Located towards the centre of the reservoir footprint, an approximately 25 to 30m wide band of light pinkish brown slightly sandy, silty clay (006) (Illus 2) was identified which was located in a natural topographic depression in the hill, dropping away to both the north and south of the hill-top. The deposit was at least 0.30m thick and identified as deriving from colluviation and general hill-wash. Four, approximately 30m long, 1.80m wide trenches were excavated across the deposit and feature to fully determine its nature (Illus 4). A few fragments of ceramic building material (CBM) were observed within a generally sterile deposit containing little in the way of inclusions.

Recorded broadly centrally to the reservoir footprint within Trench 03 of four excavated, a linear feature [008] was identified within colluvial subsoil deposits (006). The feature was oriented broadly northeast-southwest, slightly meandering, and measured 0.62m wide by a maximum of 0.12m deep and was interpreted as the remnants of a former hedge-line (Illus 5). It continued beyond the limits of the trenched area but was not visible in other stripped areas, suggesting a high degree of truncation and denudation of the soils. The feature had irregular sides and an uneven base and contained a single, sterile fill (007). No dateable material was recovered.

A Written Scheme of Investigation was prepared by Mott MacDonald (Ricchi 2019) and approved by the Archaeological Advisor. An archaeological method statement (Thomson 2019) was subsequently produced in line with the requirements of the WSI. The WSI identified a monitoring requirement for the reservoir and ancillary areas identified as a valve house; sodium hypochlorite dosing kiosk; sustainable drainage including attenuation basin; access road and any intrusive, associated soft landscaping. The ancillary areas formed part of the overall strip footprint (Illus 2).

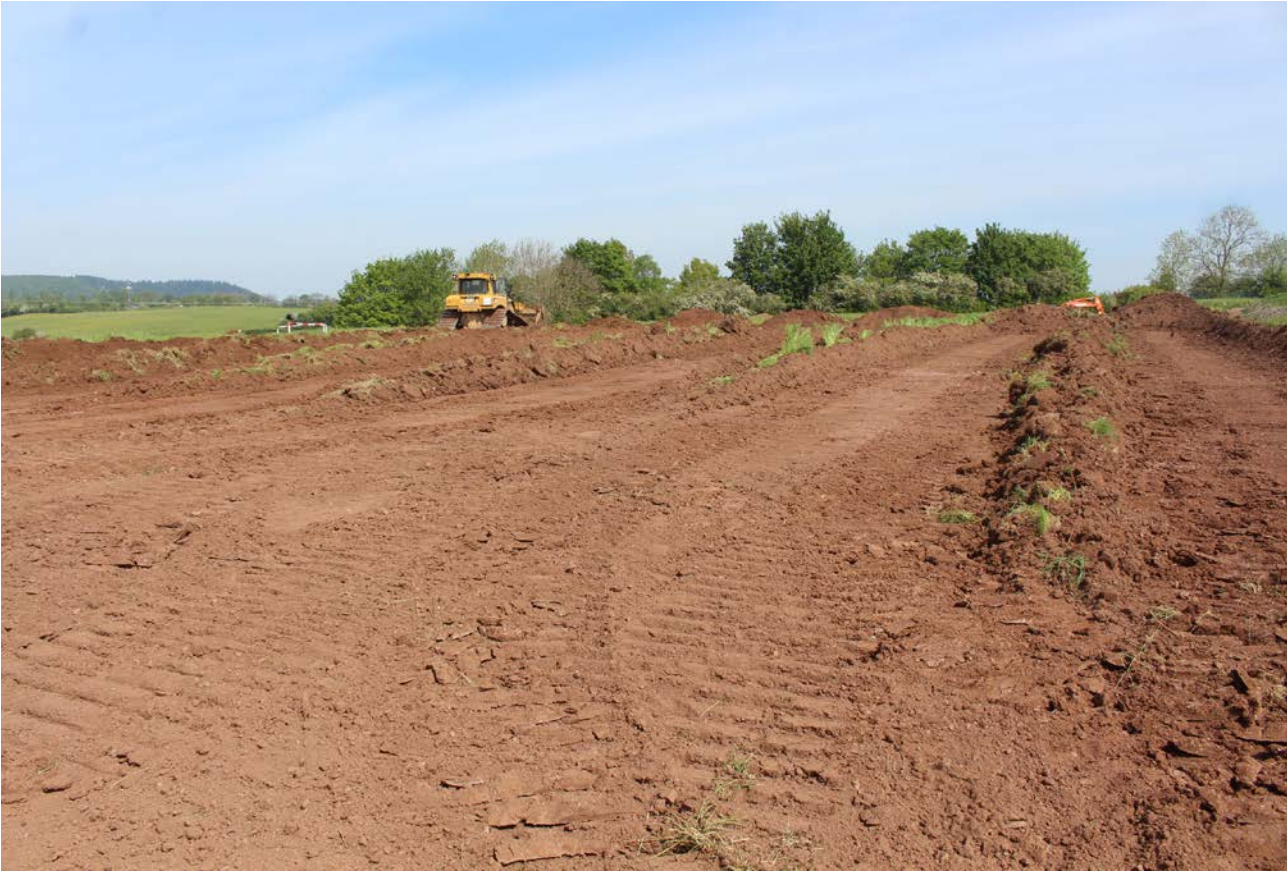
**ILLUS 3** General view of bulldozer stripping reservoir area, looking north-east

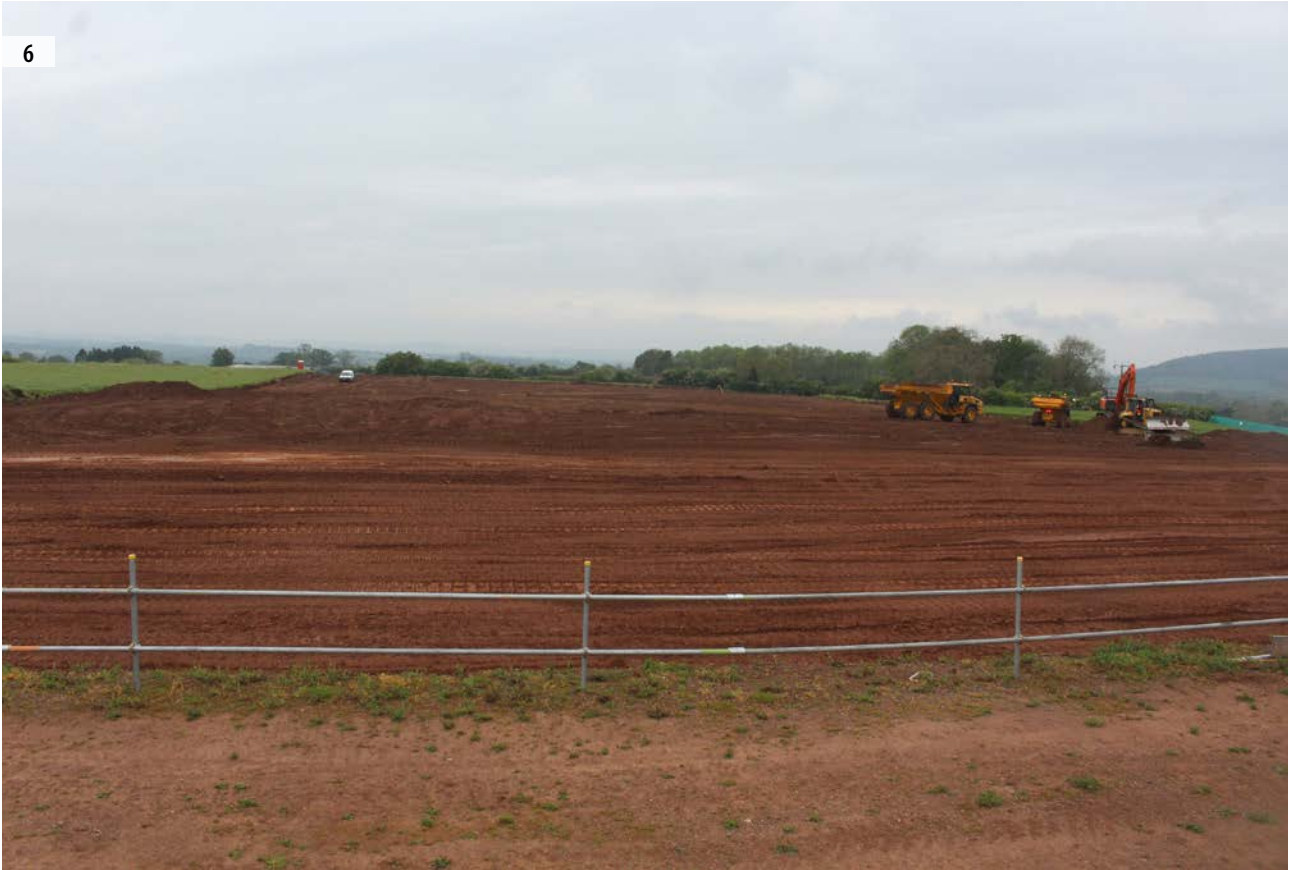
The topography of the site may also have had an effect on the soil profiles and levels of artefactual material observed, with colluviation likely to have occurred to the north, south and west of the site, within an undulating hill-scape (Illus 6). The denudation of soils was apparent from the evidence of a former hedge line identified within a hill gully, which did not continue outside of the confines of the topographic feature where glacio-fluvial gravels were identified. A shallow soil profile was also noted during stripping of the haul road, with patchy subsoil survival and geological gravel deposits variably visible (Illus 7).

**ILLUS 6** General view of stripped reservoir area, looking west **ILLUS 7** View of haul/access road stripping, looking south
