THE OLD GRAMMAR SCHOOL, CHURCH STREET, BROMYARD

HISTORIC BUILDING RECORDING REPORT

PLANNING REF. 16240
EHE NO. 80413

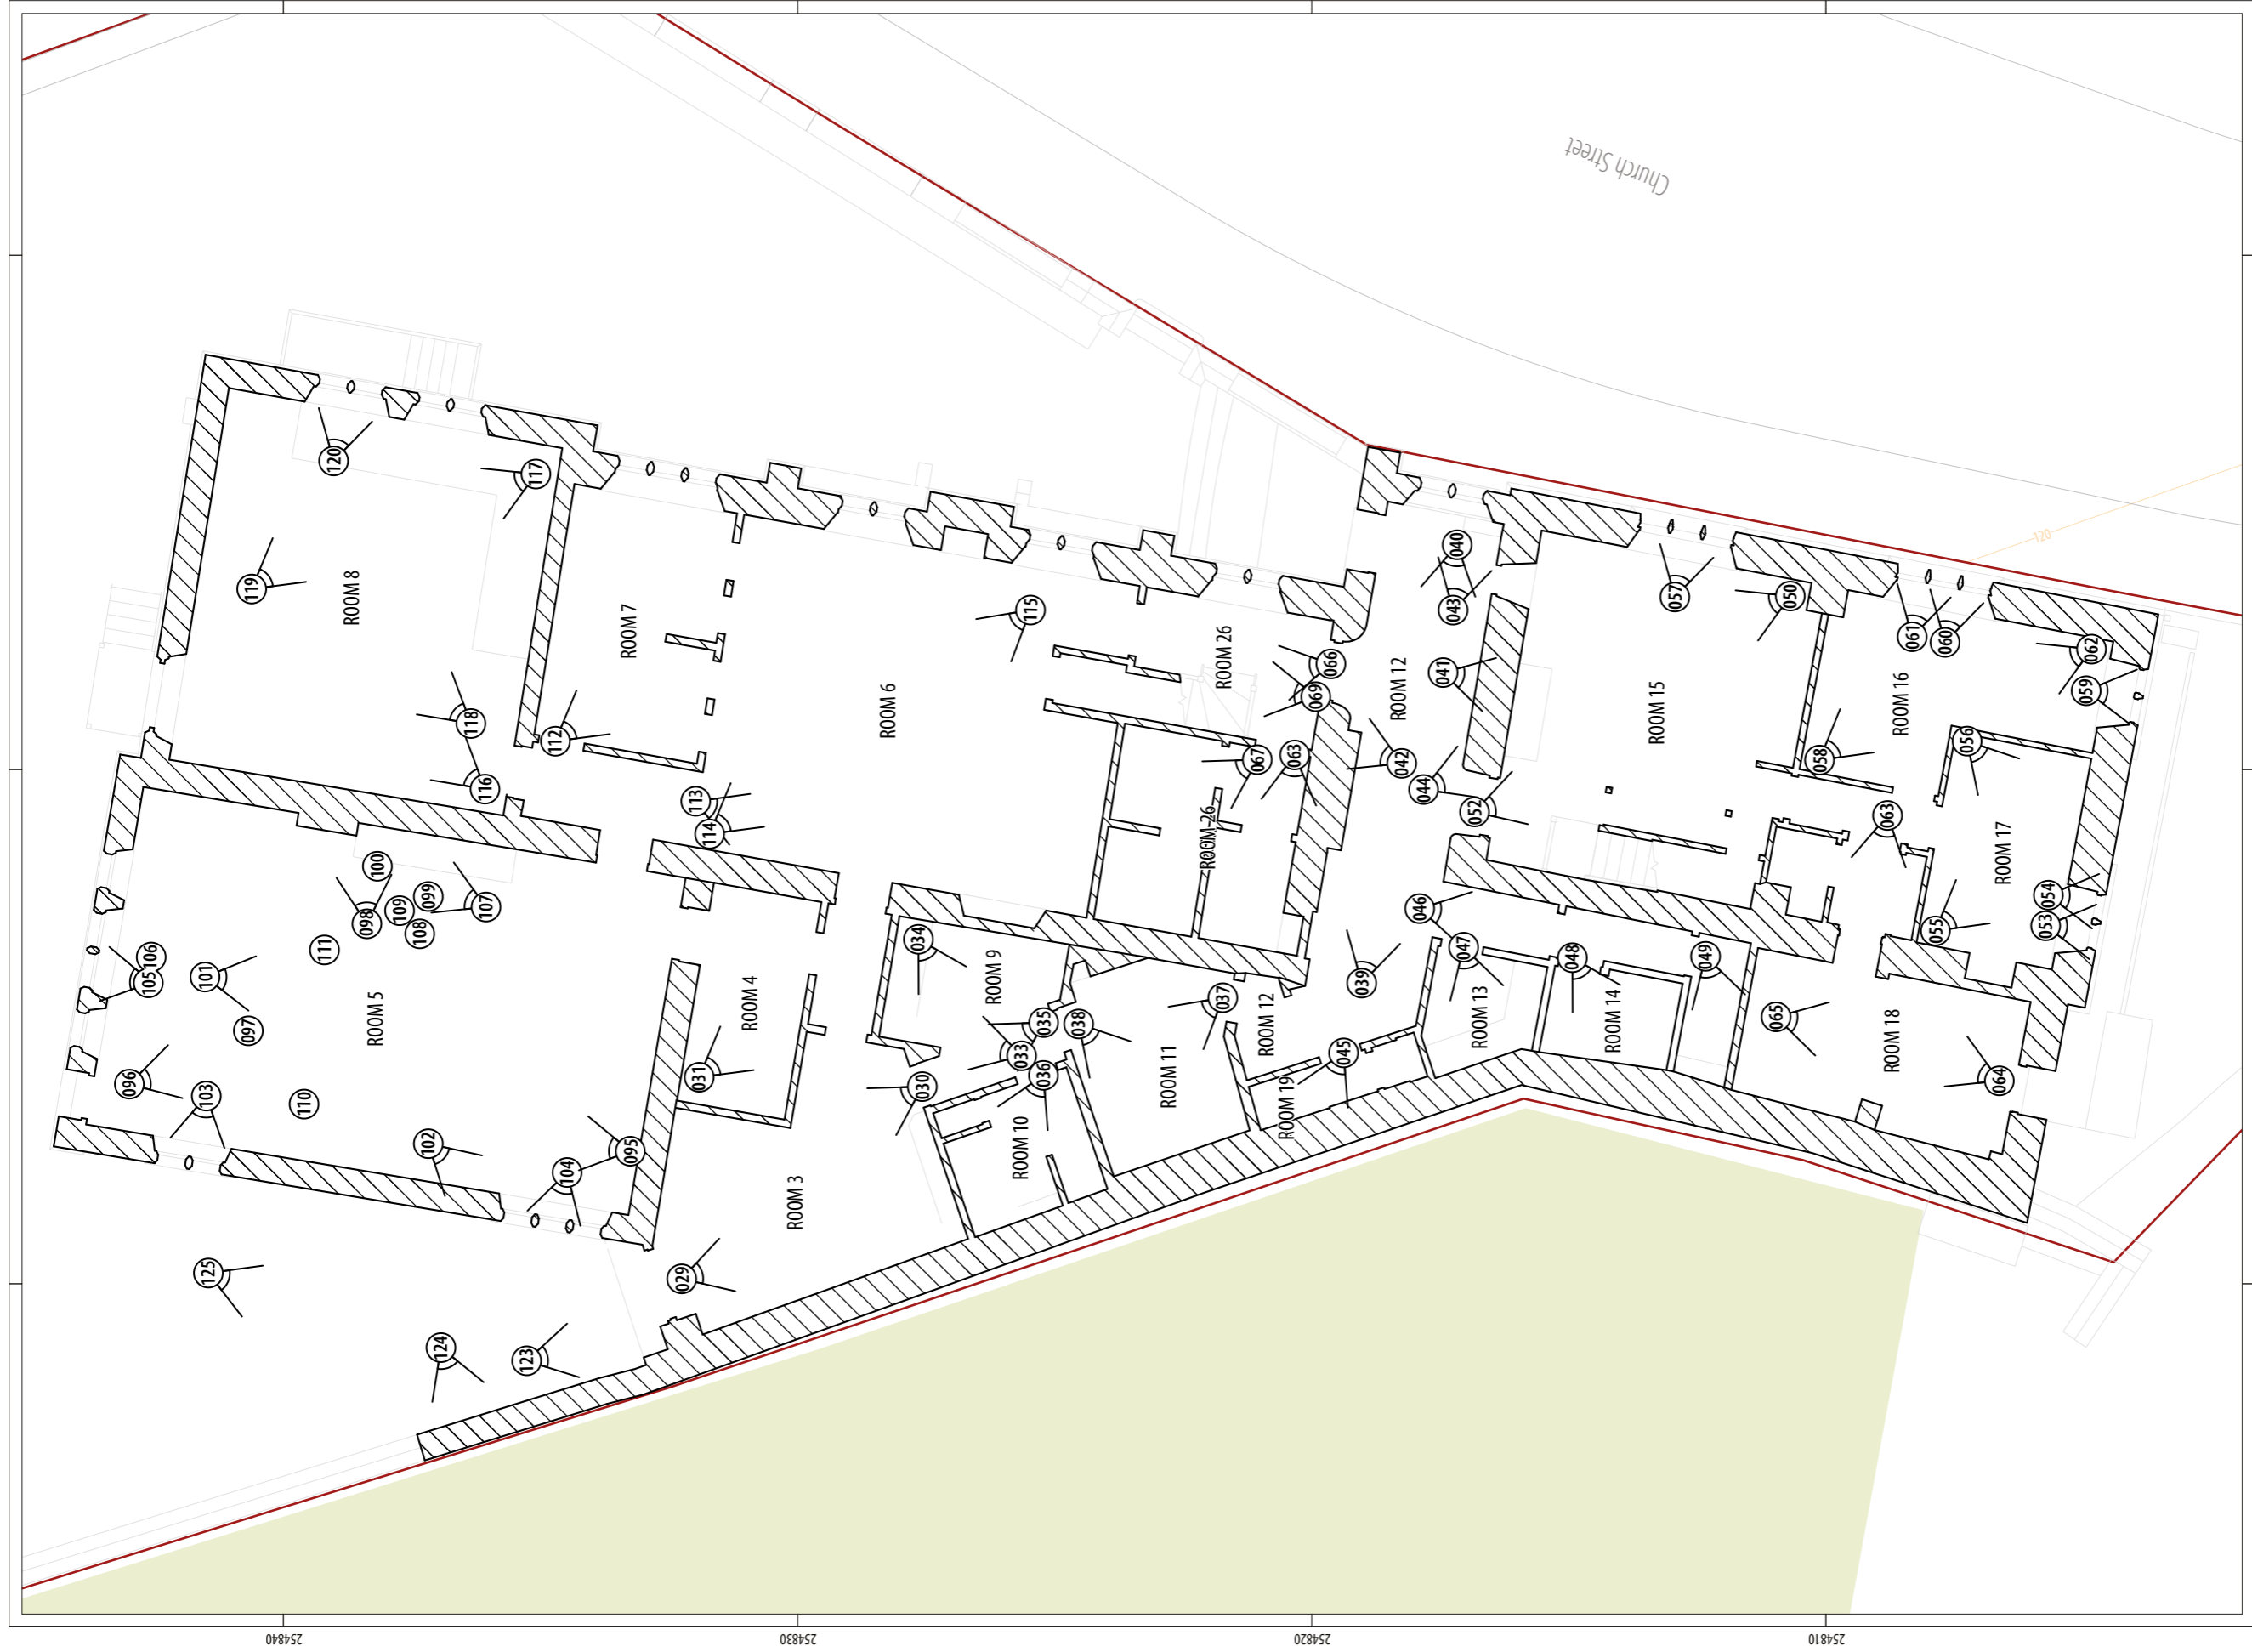
ILLUS 5 Ground floor photographic location plan

photo location

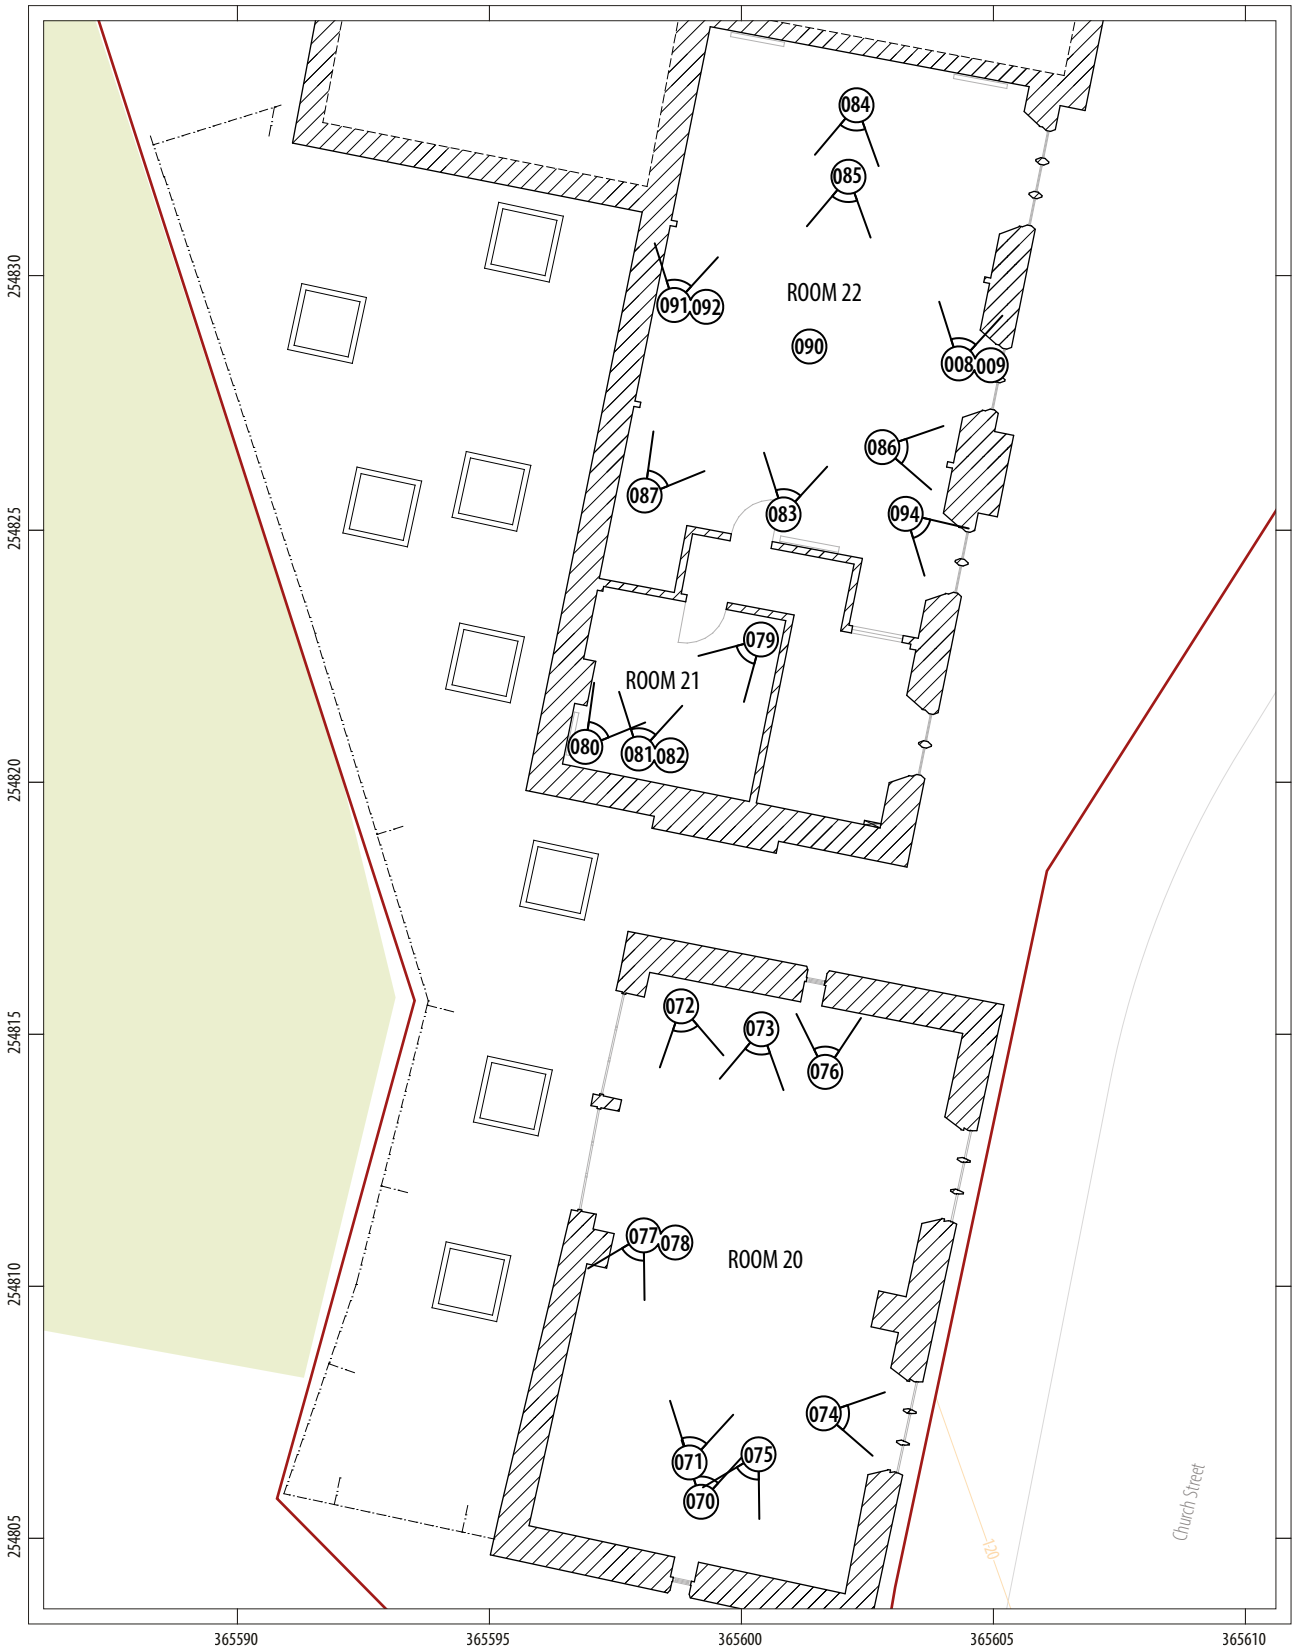
ILLUS 6 Mezzanine floor photographic location plan

photo location

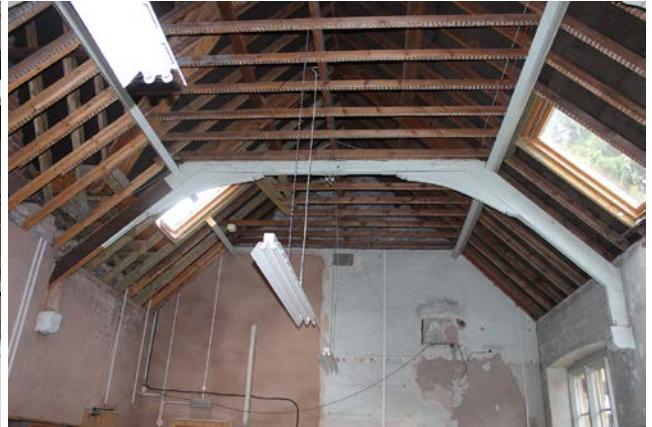
GSBH19-HBR-101.JPG

At the north end of the structure, Room 5 was accessed internally from Room 6 and externally from the north-west corner of the building. The room was a large open rectangular area with plastered and partially painted walls (Photo 101) and a cement floor, with a faded yellow linoleum type covering. No skirtings or other decorative features were present. A small area of exposed brickwork was observed around a doorway in the northern wall, possibly suggesting an inner skin of brick construction. Two stone framed multi-light windows were located on the west wall. With a mix of fixed lights and casement openings. On the north wall a large tripartite, stone framed Palladian or Venetian style window consisted of a combination of fixed lights, casement and hopper openings, with decorative casement catches.
