INSTALLATION AND CONNECTION OF SERVICES AT EAST STREET, HEREFORD

ARCHAEOLOGICAL WATCHING BRIEF

EHE NO. 80414

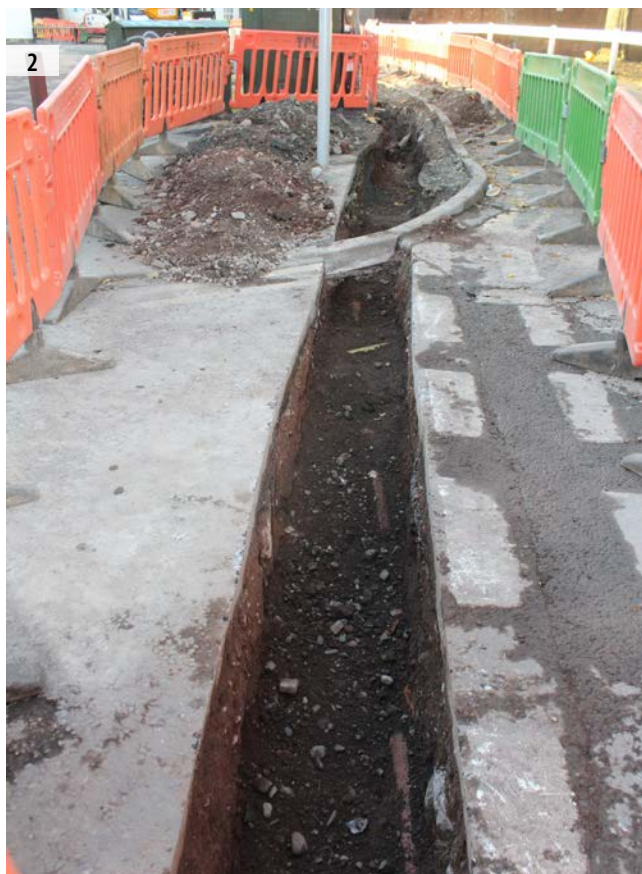
ILLUS 2 Trench 1, looking north-west

Trench 1 was primarily located along the southern edge of East Street within the pavement area, only crossing to the north beyond its junction with Offa Street. It measured 40m long and 0.60m wide and was excavated to a maximum depth of 0.60m (BGL).

The only potential archaeological features identified within the trench consisted of the heavily truncated remains of a possible stone wall (0103) along the front of the adjacent carpark plot. This consisted of irregular sized sandstone with a maximum block size of 0.30m x 0.20m. This appeared to in a roughly linear arrangement with up to two potential courses visible in patches. The entire feature only survived for a length of 2m and was only present in the north facing section of the trench. It was truncated by concrete post settings for the modern car park barrier. Just to the east of this feature were the remains of a brick walls (0102) which also followed the contour of the modern carpark plot adjacent to the pavement. The remainder of the trench was infilled with modern made ground (0101) which predominantly represented the mixed backfill of existing service trenches. The tarmac pavement and road surface (0100) formed the latest deposit in the sequence.

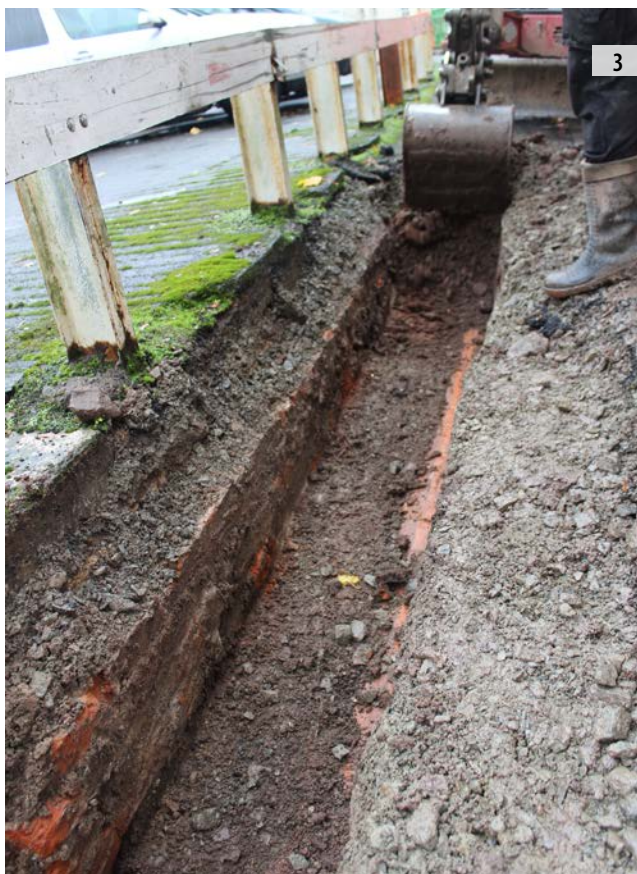
ILLUS 3 Trench 1, looking north-west showing brick walls (0102)

The majority of the groundworks were restricted to the connection of new utilities into existing services. However, brick walls and a possible stone wall surviving in the section of Trench 1 appeared to represent the remains of property frontages which formerly occupied the modern carpark plot just the south of the trench. The deep deposit of mixed silty gravels, encountered in Trench 3 potentially represented redeposited natural associated with the former location of the Saxon rampart; however, due to the limited nature of the excavations, it was not possible to investigate this in any further detail. No artefacts were recovered.

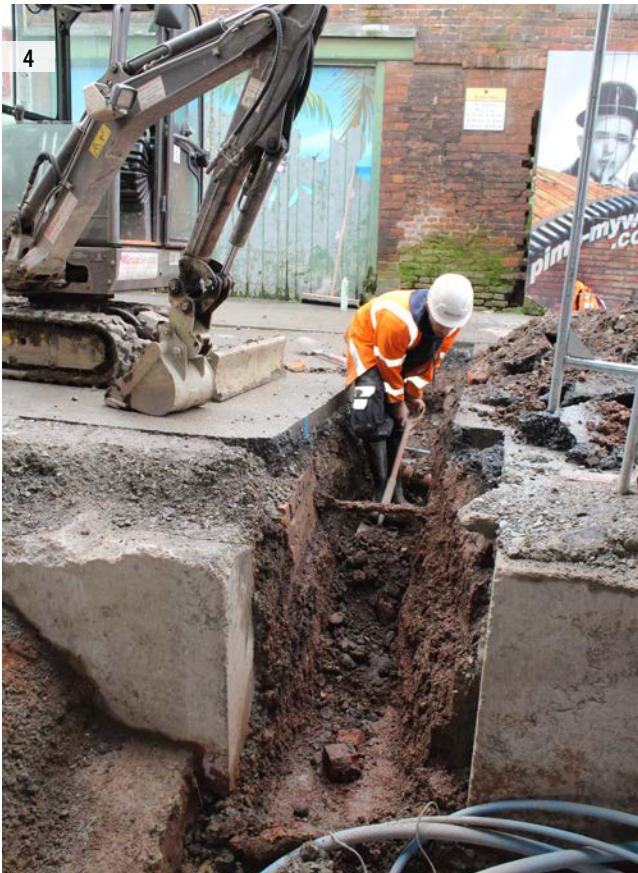
Trench 2 was adjacent to 12 East Street and was orientated north-south across the road; it measured 3.0m long and 0.60m wide. The northern end of the trench was excavated to a depth of 1.2m BGL, shallowing toward the south. The earliest deposit encountered was of mid-brown silty sand and gravel (0202), limited to the northern end of the trench, sealed beneath 0.55m of made ground (0201) which increased in depth to the north. This deposit was repeatedly truncated by modern services and was sealed by the tarmac road surface.

ILLUS 4 Trench 2, looking south ILLUS 5 Trench 3, looking east

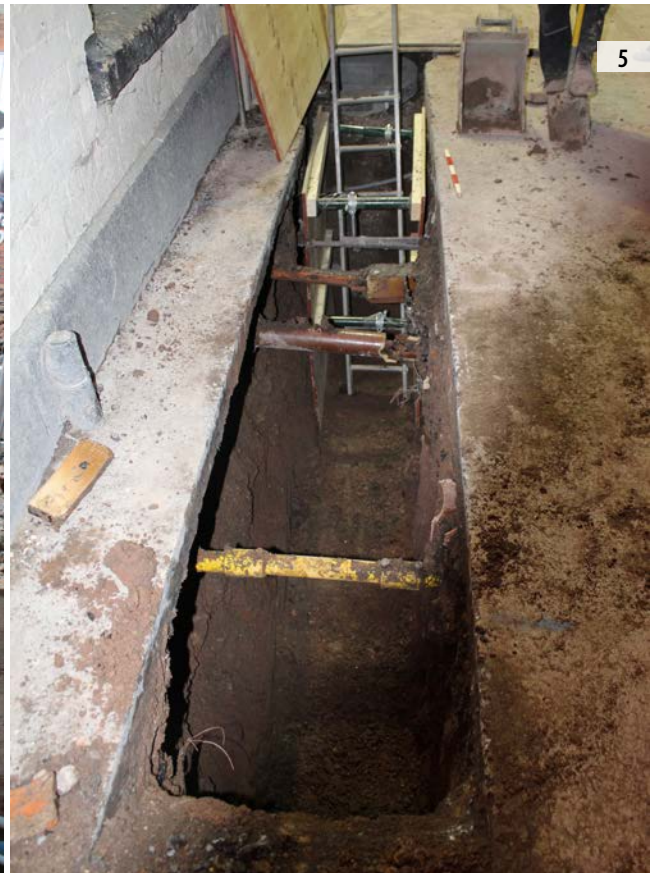
Trench 3 was located on the northern side of East Street, immediately adjacent to the Booth Hall. The trench measured c 12.0m long and 0.60m wide and was excavated to a maximum depth of 1.8m BGL at its eastern end, shallowing to 1.2m BGL to the west. The trench contained four distinct deposits. The earliest layer encountered was revealed at a depth of approximately 1.8m BGL and was represented by a mid-brown silty deposit (0303), sealed by a 0.40m thick layer of clean, pinkish coarse sand and gravel (0302). This, in turn was sealed by a 1.4 m deep thick deposit of mid-brown silty sand and gravel, the upper surface of which were repeatedly truncated by modern existing service trenches and deposits associated with the construction of the cellar for the Booth Hall; the exterior wall of which was partially exposed by the excavations. The modern ground surface comprised the tarmac road surface of East Street.
