GAMMONS FARM CLOSE, WATFORD

Archaeological Evaluation

for Affinity Sutton

11/00272/FULM

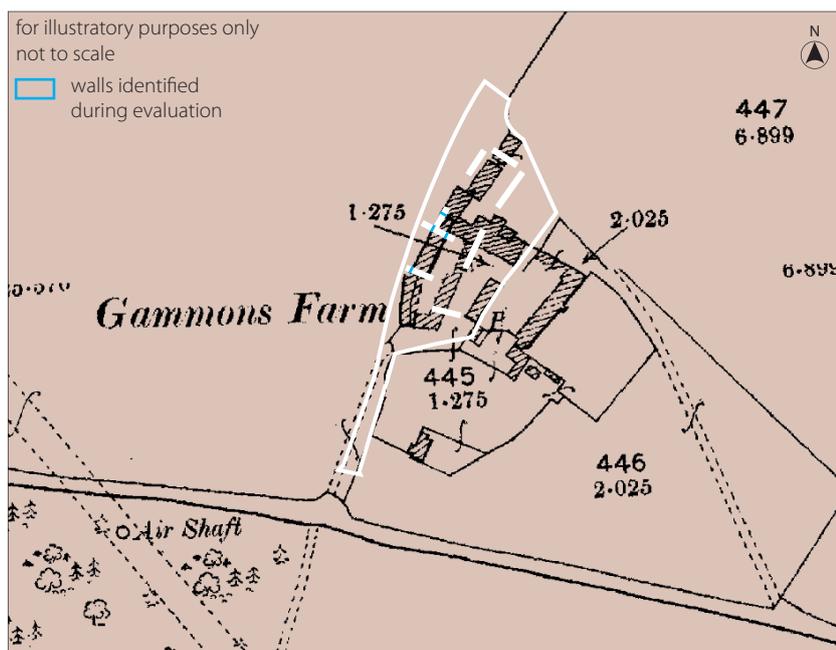
Illus 2

Trenches overlain onto 1898 OS map
© Crown copyright and database rights Ordnance Survey 2012 all rights reserved.

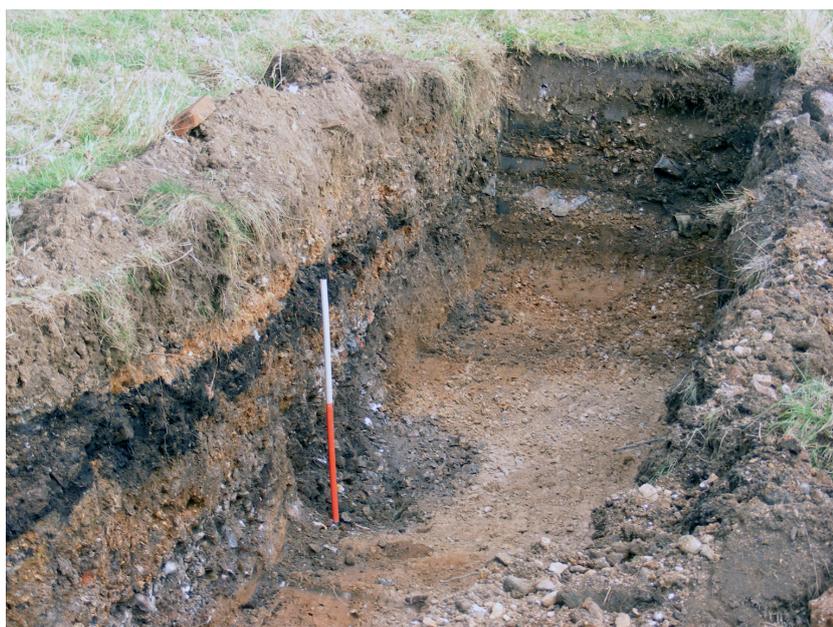
Illus 3

Trench 4 – South-east facing section. Pit [406]

Natural gravels were present at a depth of 1.26m below ground level (BGL). Overlying the natural was a dark grey stoney clay (407) which was in turn cut by a pit approximately 1.10m in diameter. The pit [406] contained domestic refuse including broken glass, transfer printed pottery and a stoneware jar marked 'J.S. Sainsbury, Bloater Paste'. The pit was sealed by a deposit of orange gravel followed by a black clinker deposit (402) and a further layer of orange gravel (401).

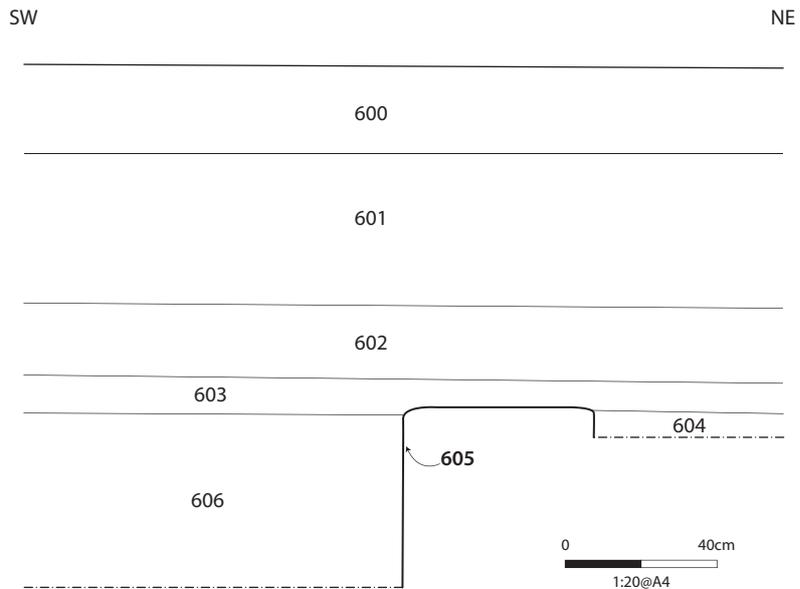
Natural deposits were present at a depth of 0.92m BGL. Cut into the natural on a north-west / south-east alignment was a red brick wall [605]. The wall amounted to 5 courses of hand made red brick laid in an alternating header and stretcher pattern (English bond) with a lime based mortar. A further course of brick at the base of the wall projected beyond the face of the overlying courses and appears to be the lower foundation course. The top of the brick wall was identified at 0.9m BGL. A black tar-like layer (605) sealed the wall and this was subsequently overlain by a layer of orange gravel (602).

Illus 4
Trench 6 – South-east facing section

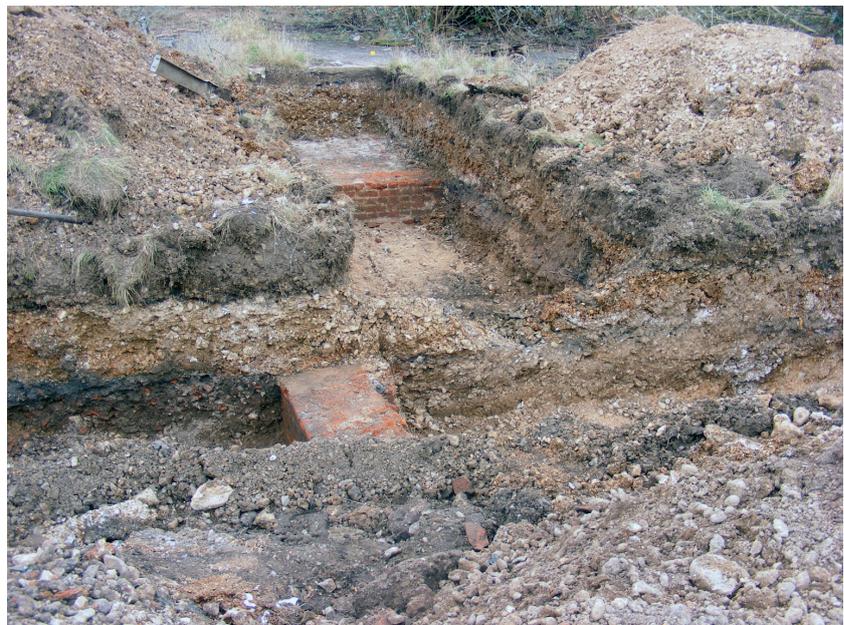
Trench 7 was orientated at 90° to the southern end of Trench 6. Natural deposits were present at 0.8m BGL. Two brick walls, [704] and [707], were revealed on a north-east / south-west alignment. The top of wall [704] was revealed at a depth of 0.8m BGL and the wall survived to a depth of five courses. Natural deposits (706) were present to the east of the wall, whilst to the west, a mid brown silty clay (705)

deposit was present. Overlying these deposits and the top of the wall was a black tar-like deposit (703).

Wall [707] was located 4.6m to the east of wall [704]. The wall was on the same alignment but in a poorer state of preservation than wall [704] with only one clearly defined course surviving at 0.8m BGL. This wall was also sealed by deposit (703) which was overlain by orange gravel aggregate (702). This deposit was subsequently overlain by a degraded black tarmac surface (701).

Illus 5
Walls [704] (foreground) and [605]

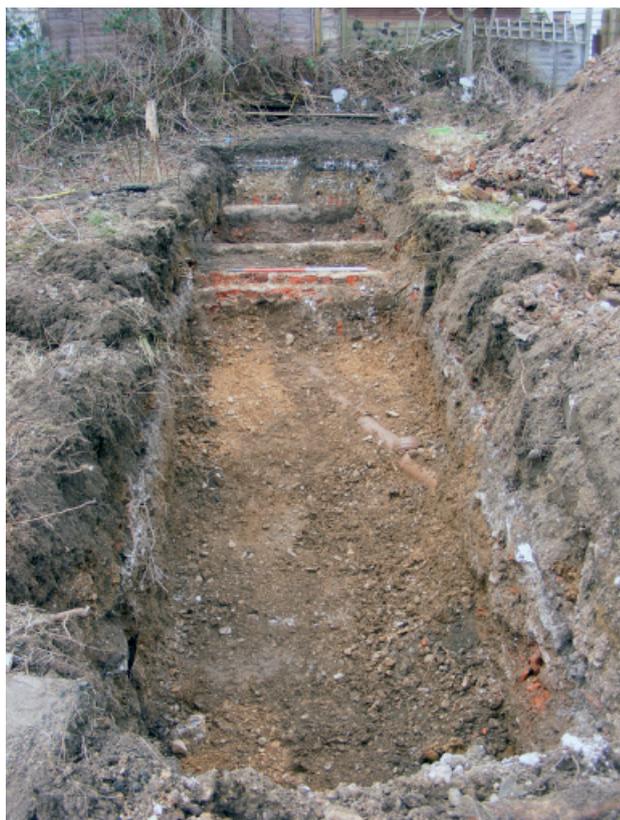
Illus 6

Trench 8 – Pit [805] in foreground

Natural deposits were present at a depth of 1.08m BGL. A red brick wall [806] of similar form to those identified in Trenches 6 and 7 was identified at a depth of 0.67m BGL and crossed the trench on a north-east / south-west alignment. Immediately to the west of the wall was a concrete footing or concrete lined tank [807].

To the east of wall [806] was a large pit [805], over 2m in diameter, containing redeposited topsoil and a large quantity of red clay roof tiles. The pit was cut from a level of 0.88m BGL and was overlain by a deposit of chalk or lime (803), further broken roof tiles (802) and a mixed deposit of topsoil, brick and modern rubbish (801).

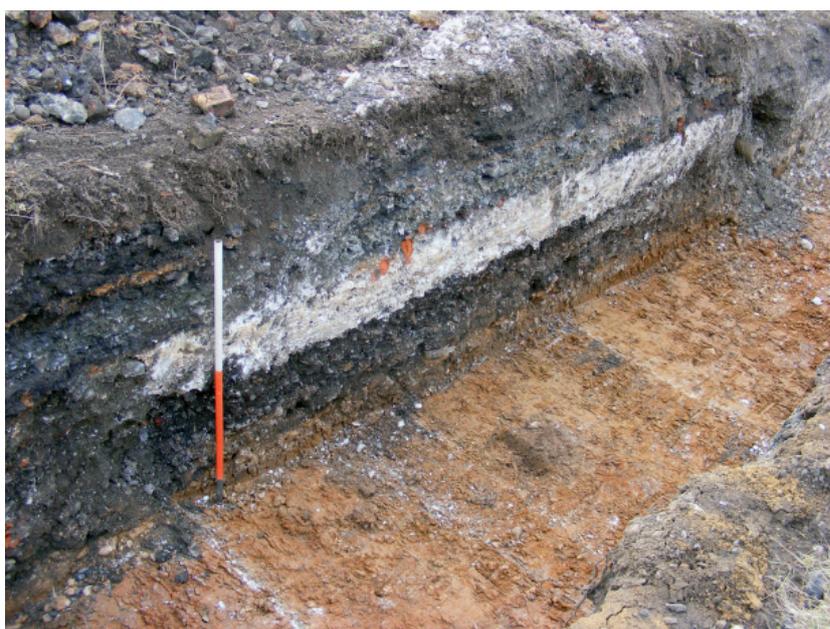
Illus 7

Natural deposits on the eastern side of the site were present at a depth of between 1.22m and 1.64m BGL. A succession of deposits appear to have been laid over the natural to raise the

level of the site. Material included red brick, stone rubble, chalk and layers of redeposited natural gravel.

Trench 1 – North facing section. Made ground over natural deposits
