JESSAMINE COTTAGE, ST MICHAELS, ST ALBANS, HERTFORDSHIRE

Results of an Archaeological Watching Brief

commissioned by Frost Conservatories

April 2012

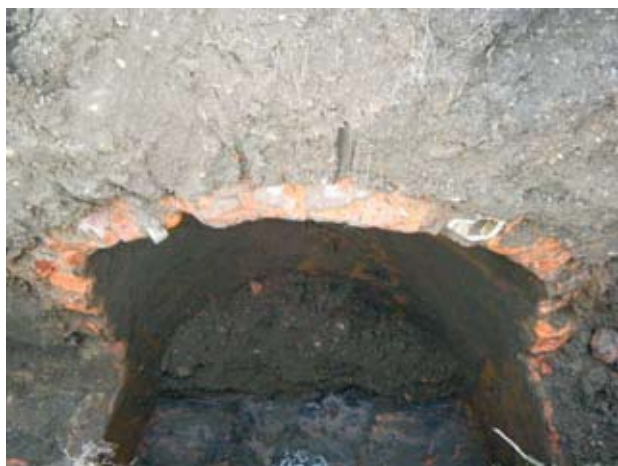
Illus 5

In the northern most footing trench, a modern water storage unit was uncovered (006) which measured 1.6m in diameter and had a depth of 2.2m from its top to base (Illus 5). The structure was made from red frogged bricks measuring 230x110x70mm with a lime mortar bonding agent and was filled with a mix of dark grey silty and sandy clay and gravels with brick inclusions. It contained several sherds of modern blue and white china, glass bottles, a bell and clay pipe fragments. Adjacent to this is a modern manhole measuring 1.1m by 1.1m was also revealed during later ground reduction. The presence of these more recent truncations suggests that this area of the DA has been extensively truncated, most likely during the construction of Jessamine Cottage, explaining the lack Roman of finds in comparison to those within the southern footing.

Modern water storage unit (006) facing north in northern footing

related structures like the water storage unit (006) and man hole. The construction of these would have had an impact on any archaeological remains within their footprints, indeed the base of (006) extended well beyond the lowest Roman deposit revealed. The construction of St Michaels church to the south could also have an indirect effect on the DA with disturbed soils from the construction being deposited within the DA.

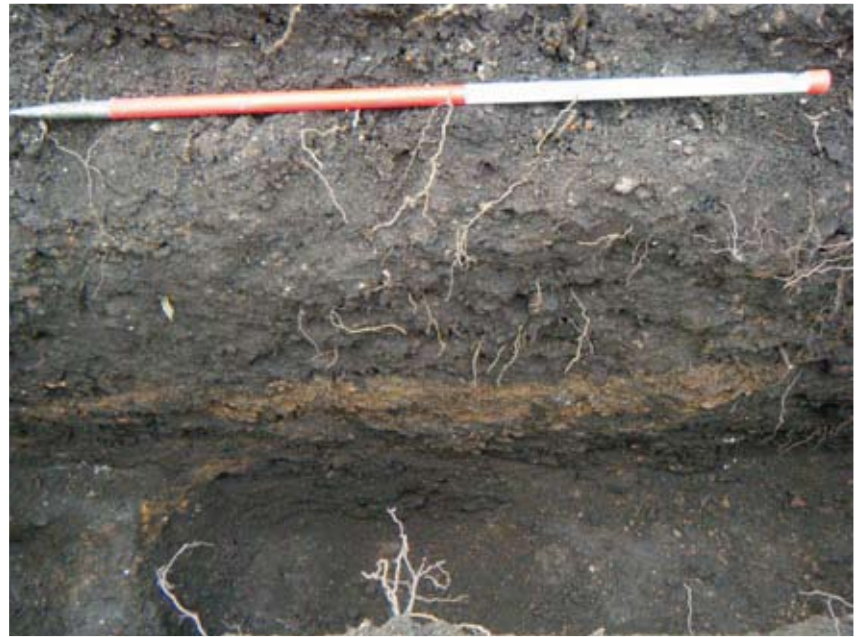
and 004) and orange brown gravels (003 and 005) (Illus 3 and 6). They lay at a 40° gradient, broadly consistent with the natural slope of the garden. Roman pottery was recovered from the dark grey band (004). A sondage dug at the base of the southern footing trench revealed further sherds of Roman pottery and a coin within deposit (004). These deposits might be the result either of natural movement of material downslope. However, the presence of Roman artefacts within them indicates they may be the result of human disturbance of land upslope of the site in the Roman/post-Roman era.

Illus 6 ▶
North facing section of footing

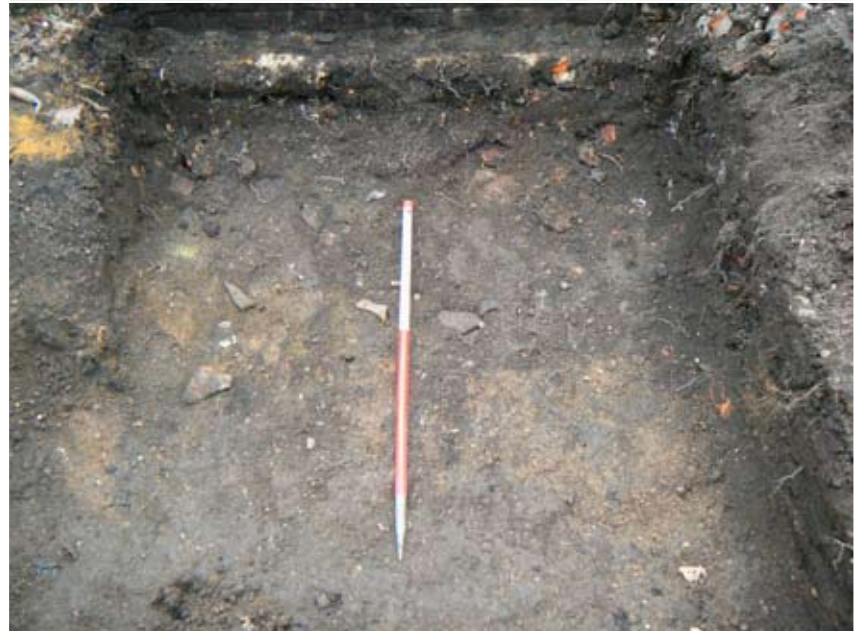
Ground was reduced by 0.3m to the east and west of the footings and within the footprint of the proposed building revealing deposits of grey silt (002 and 007). These contained Roman pottery and tile and lenses of orange brown gravel (008), (Illus 7). These deposits are thought to represent possible silt washed down a slope, possibly from the known Roman road to the south. As ground reduction was not threatening these deposits no further investigation was undertaken.

Illus 7 ▶
South facing section of ground reduction showing different deposits
