## DUFFIELD MILL, DUFFIELD, DERBYSHIRE

*Archaeological Evaluation*

*for Environment Agency*

*September 2012*

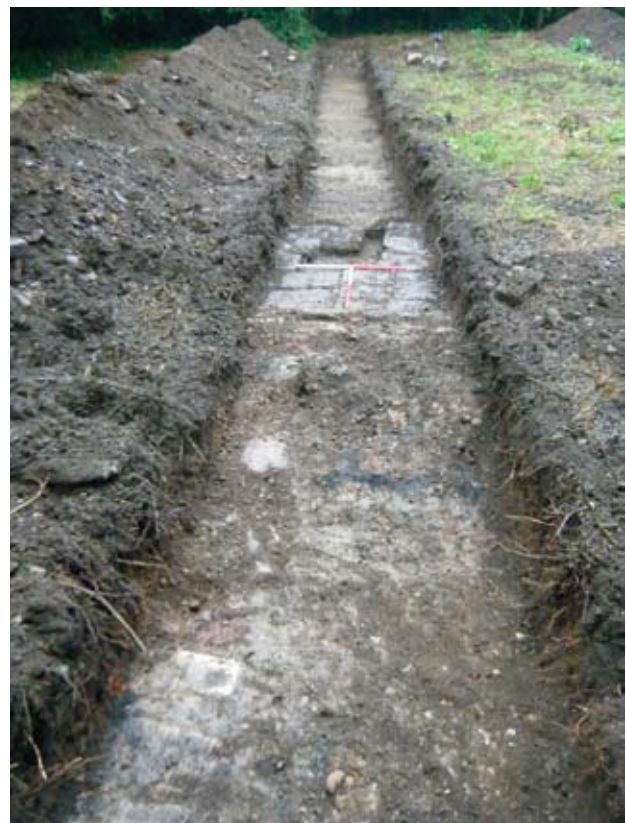
**Illus 5**  
South east facing view of Trench 1

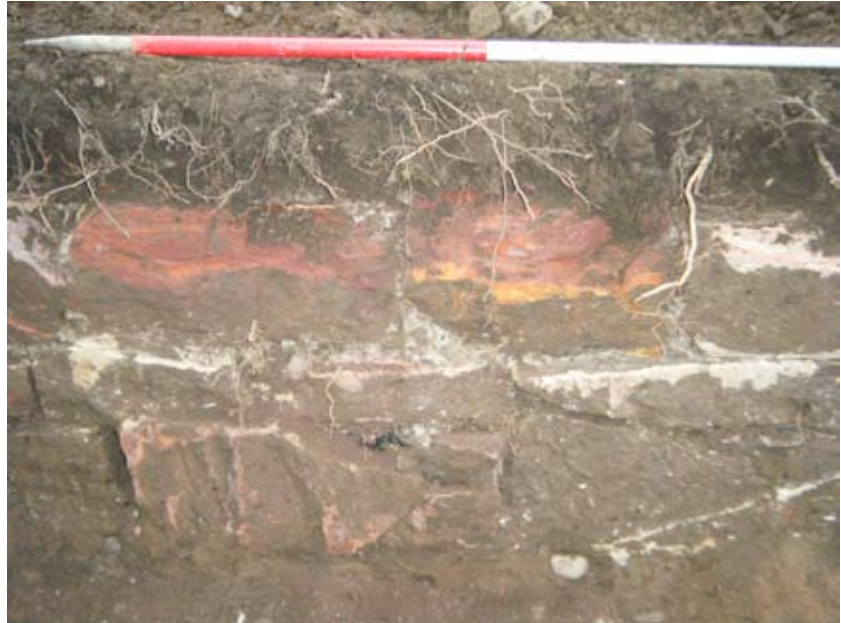
**Illus 6**

North face of wall [107]

A sandstone floor (110) was recorded adjacent to walls (108) and (109) (*Illus 6*). It was laid directly onto the subsoil (103), was 0.15m thick and composed of small to large rectangular blocks up to 1.0x1.0m in size. The floor also contained five unfrosted red bricks measuring 230x100x70mm. A break in wall (109) is considered to represent a doorway within the mill.

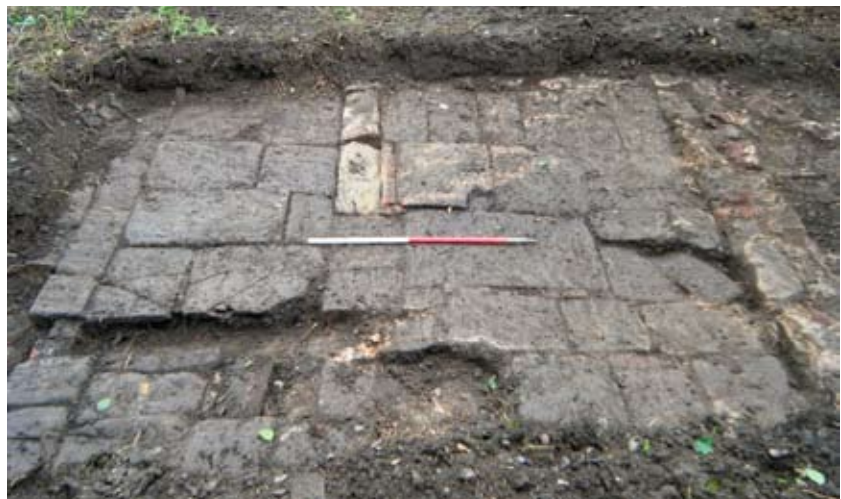
**Illus 7**

Floor [110] and walls [108] and [109] facing south

At the NW end of Trench 1, wall footings and floor surfaces associated with the corn mill (111) (*Illus 7*) were uncovered covering an area 10.0m x 3.0m (*Illus 2*). Four wall footings (106), (107), (108) and (109) were uncovered as was a stone floor surface (110) representing a single phase of construction based on the evidence to hand. The footings were up to three courses high, built onto the subsoil and were constructed from variously sized rectangular sandstone blocks with dimensions between 400-1000mm (L) x 200-300mm (W) x 230-260mm (D). A mortar bonding was present in the majority of the walls, within which nails were found. Large amounts of tile were also observed within the topsoil overlaying the building.

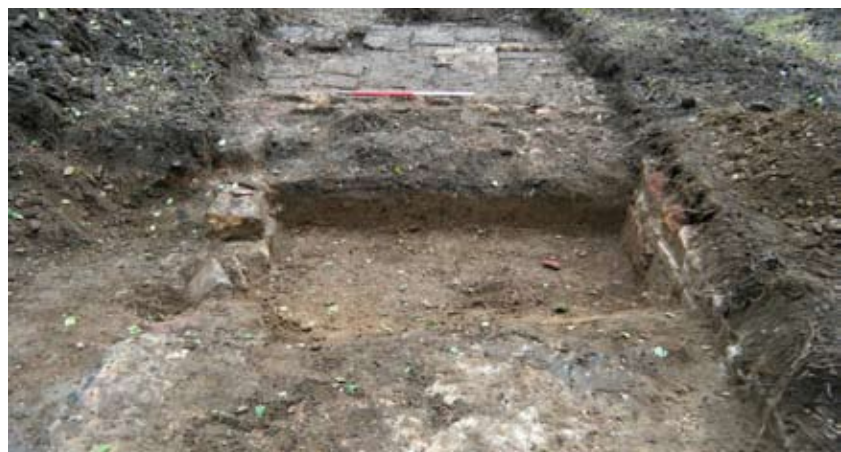
**Illus 8**

Corn Mill [111]

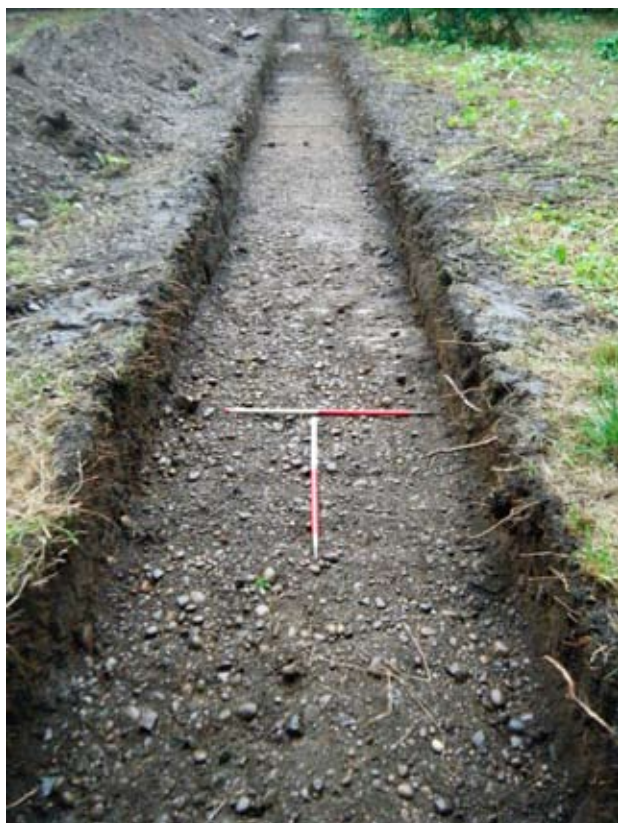
**Illus 9**

South east facing view of Trench 2
