TRING MEMORIAL GARDENS, TRING, HERTFORDSHIRE

Archaeological Monitoring

*commissioned by John Henry Group Ltd
on behalf of Virgin Media*

September 2013

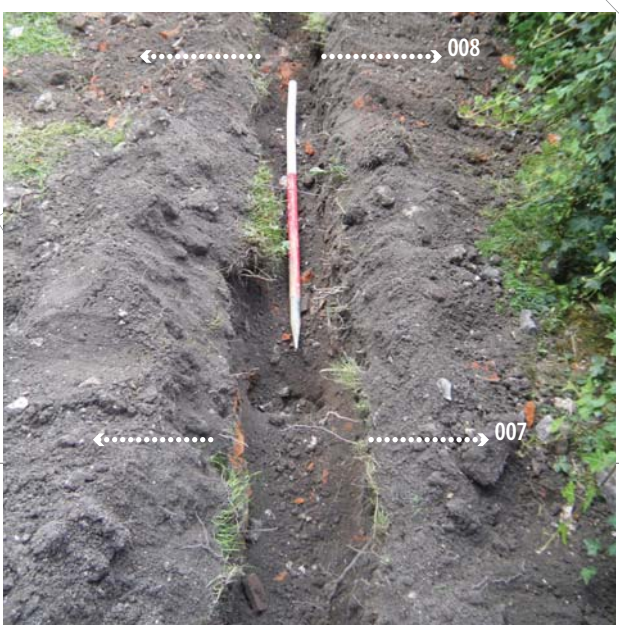
Illus 1a
Brick structures [007] & [008]

Two brick walls (007) and (008) of post-medieval date were revealed in plan in Trench 1 (Illus 1a, 1b and 1c). Excavation ceased at the level of the walls which lay between 0.25m and 0.30m below ground level. Wall (007) was approximately 0.46m wide whilst structure (008) was approximately 0.40m wide. They were positioned 1.30m apart aligned north-south.

Two brick samples taken from wall (007) indicate a date range from the 18th-20th centuries. Indeed, (007) and (008) correspond with two buildings shown on the 1877 to 1879 Town Plan as fronting the High Street (Illus 2). These buildings were demolished prior to the construction of the memorial garden.
