# BUNKERS FARM, BUNKERS LANE, HERTFORDSHIRE

ARCHAEOLOGICAL EVALUATION, HISTORIC BUILDING RECORDING,  
STRIP, MAP AND SAMPLE, AND WATCHING BRIEF

commissioned by Darren Andrews Homes Ltd.  
July 2017

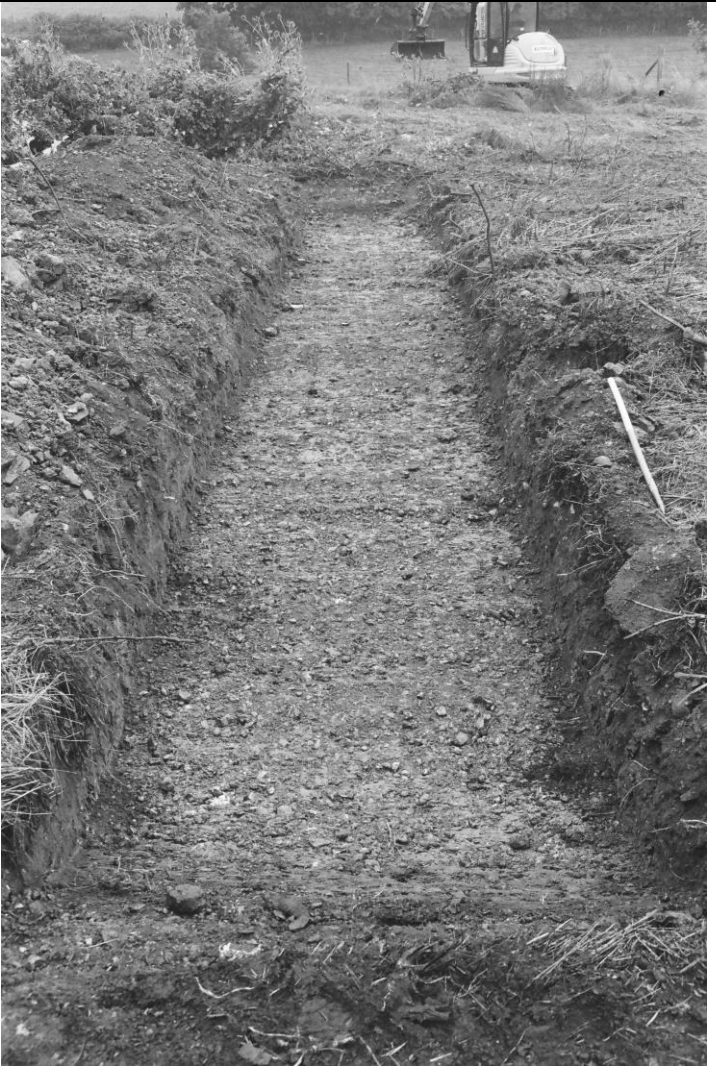
<b>Trench Number</b>	01

<b>Length</b>	12m	<b>Width</b>	1.6m		
<b>Minimum Depth to Geological Deposit/level of archaeological significance</b>	N/A	<b>Maximum Depth to Geological Deposit/level of archaeological significance</b>	0.45m BGL		
<b>Context No</b>	<b>Description (Layer, Cut, Fill)</b>	<b>Dimensions (as appropriate)</b>			
		<b>Diameter</b>	<b>Length</b>	<b>Width</b>	<b>Depth</b>
(101)	Spread of yellow rubble and general building debris. Levelling dump	-	-	-	0-0.15m
(102)	Deposit of mixed soils, dark brown and rubble inclusions, Levelling dump	-	-	-	0.15-0.30m
(103)	Dark brown black , clay soil with infrequent red brick inclusion, (pervious topsoil horizon)	-	-	-	0.30-0.45m+
(104)	Yellow clay with naturally occurring flint nodules	-	-	-	0.45m+

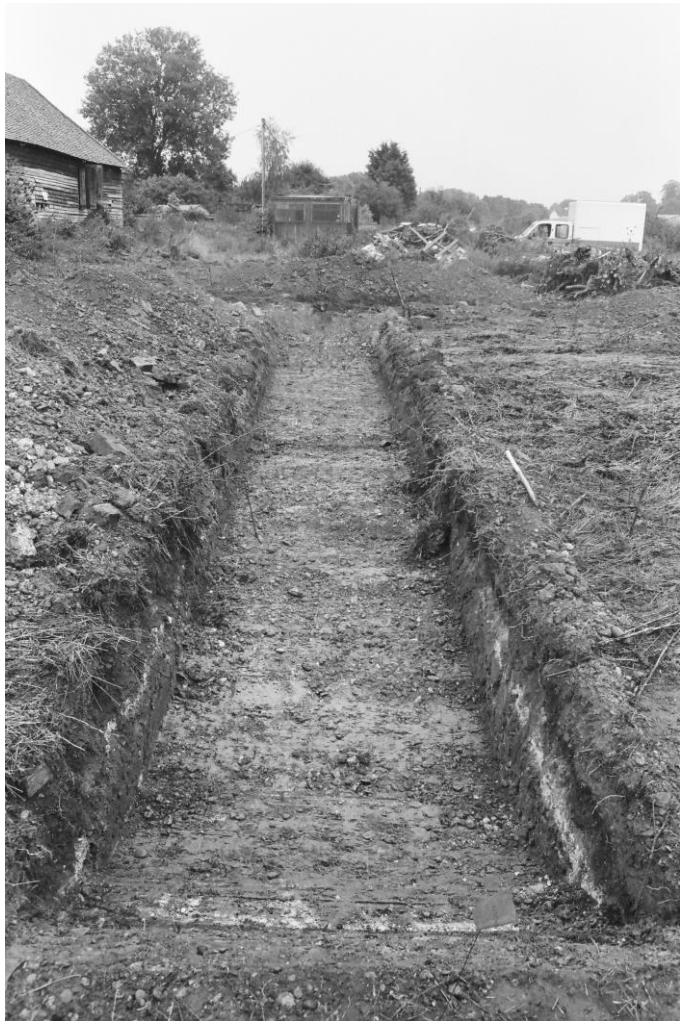
<b>Trench Number</b>		02

<b>Length</b>		12m					
<b>Minimum Depth to Geological Deposit/level of archaeological significance</b>		0.5m BGL		<b>Maximum Depth to Geological Deposit/level of archaeological significance</b>		0.65m BGL	
<b>Context No</b>	<b>Description (Layer, Cut, Fill)</b>	<b>Dimensions (as appropriate)</b>					
		<b>Diameter</b>	<b>Length</b>	<b>Width</b>	<b>Depth</b>		
(201)	Topsoil-Mid black brown loam. Slightly stony with sub-rounded medium sized stones.	-	-	-	0-0.15m		
(202)	Black cinder type deposits , dump (made up ground)	-	-	-	0.15-0.25m		
(203)	Mixture of white mortar and demolition waste, dump (made up ground)	-	-	-	0.25-0.40m		
(204)	Dark brown black , clay soil with abraded red brick inclusion, (pervious topsoil horizon)	-	-	-	0.40-0.65m		
(205)	Yellow clay with naturally occurring flint nodules	-	-	-	0.65m+

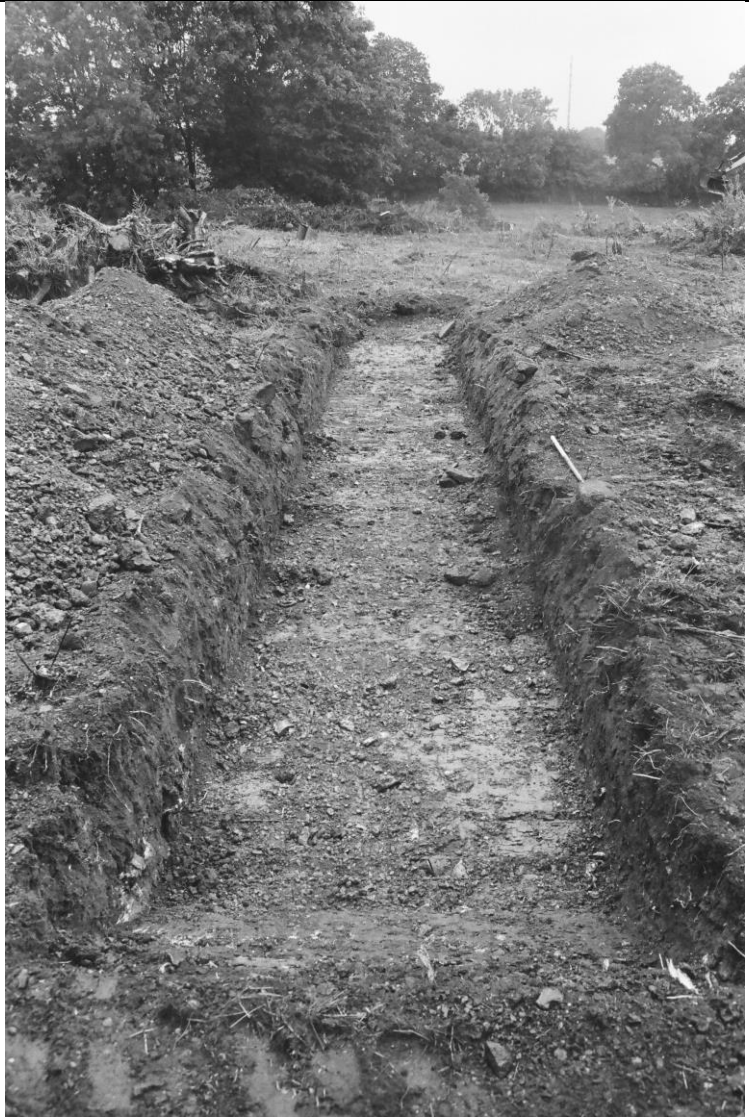
<b>Trench Number</b>	03

<b>Length</b>	12m	<b>Width</b>	1.6m		
<b>Minimum Depth to Geological Deposit/level of archaeological significance</b>	0.5m BGL	<b>Maximum Depth to Geological Deposit/level of archaeological significance</b>	0.55m BGL		
<b>Context No</b>	<b>Description (Layer, Cut, Fill)</b>	<b>Dimensions (as appropriate)</b>			
		<b>Diameter</b>	<b>Length</b>	<b>Width</b>	<b>Depth</b>
(301)	Topsoil-Mid black brown loam. Slightly stony with sub-rounded medium sized stones.	-	-	-	0-0.15m
(302)	Black cinder type deposits , levelling dump (made up ground)	-	-	-	0.15-0.25m
(303)	Mixture of white mortar and demolition waste, levelling dump (made up ground)	-	-	-	0.25-0.30m
(304)	Dark brown black , clay soil with occasional abraded red brick inclusion, (pervious topsoil horizon)	-	-	-	0.30-0.55m
(305)	Yellow clay with naturally occurring flint nodules	-	-	-	0.55m+

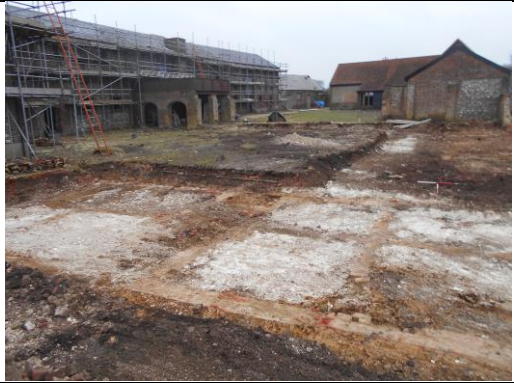
<b>Area Number</b>	01, 02, 03

<b>Total Area</b>	4000m <sup>2</sup>					
<b>Minimum Depth to Geological Deposit/level of archaeological significance</b>	0.53M BGL		<b>Maximum Depth to Geological Deposit/level of archaeological significance</b>	0.55m BGL		
<b>Context No</b>	<b>Description (Layer, Cut, Fill)</b>	<b>Dimensions (as appropriate)</b>				
		<b>Diameter</b>	<b>Length</b>	<b>Width</b>	<b>Depth</b>	
1001	Topsoil	-	-	-	0-0.06m	
1002	Subsoil	-	-	-	0.06-0.31m	
1003	Natural geology	-	-	-	0.31-0.53m	
1004	20th century concrete footpath (Area 1, Phase C)	-	10.1m	1m	0.1m	
1005	19th century brick foundations (Area 1, Phase A)	-	10.5m	0.7-4.7m	0.5m	
1006	20th century concrete footpath (Area 2)	-	11m	0.9m	0.25-0.9m	
1007	19th century brick foundations (Area 2)	-	0.7m	3.15m	0.1m	
1008	20th century concrete slabs (Area 2)	-	-	-	-	
1009	19th century brick foundations (Area 3)	-	3m	2.6m	0.07m	
1010	19th century brick floor (Area 2)	-	2.4m	2.4m	0.1m

1011	19th century brick foundations (Area 1, Phase B)	-	7.7m	2.4m	-	
1012	19th century made-ground, compact chalk	-	17.9 (vis)	6.7m (vis)	0.1-0.6m	
1013	19th century brick foundations (Area 1, Phase B)	-	3.88m	0.36m	0.07m	
1014	19th century brick foundations (Area 2)	-	2m	0.2-0.98m	0.07m	
1015	Buried soil horizon - former topsoil (Area 1)	-	-	-	0.15-0.25m	
1016	20th century concrete footpath (Area 3)	-	6.8m	0.72m	0.12m	
1017	Demolition rubble (Area 3)	-	-	-	-	
1018	Re-deposited chalk (Area 3)	-	1.15m	-	0.05-0.1m

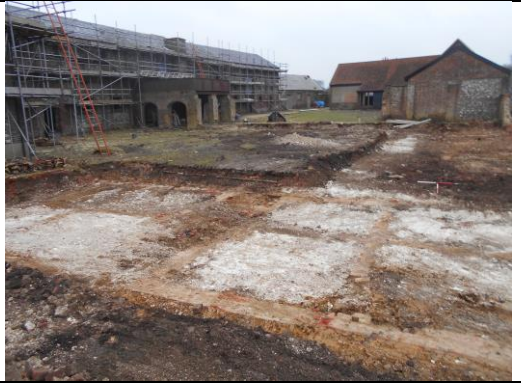
<b>Area Number</b>	01, 02, 03

<b>Total Area</b>	4000m <sup>2</sup>					
<b>Minimum Depth to Geological Deposit/level of archaeological significance</b>	0.53M BGL		<b>Maximum Depth to Geological Deposit/level of archaeological significance</b>	0.55m BGL		
<b>Context No</b>	<b>Description (Layer, Cut, Fill)</b>	<b>Dimensions (as appropriate)</b>				
		<b>Diameter</b>	<b>Length</b>	<b>Width</b>	<b>Depth</b>	
1019	Re-deposited clay (Area 3)	-	1.15m (vis)	-	0.06-0.13m	
1020	Layer of charcoal / burnt material (Area 3)	-	2.3m	-	0.01m	
1021	Layer of chalk (Area 3)	-	1.05m	-	0.03m	
1022	Fill of [1023] - not excavated due to presence of asbestos	-	10.2m	3m	-	
1023	Linear feature (Area 2)	-	10.2m	3m	-

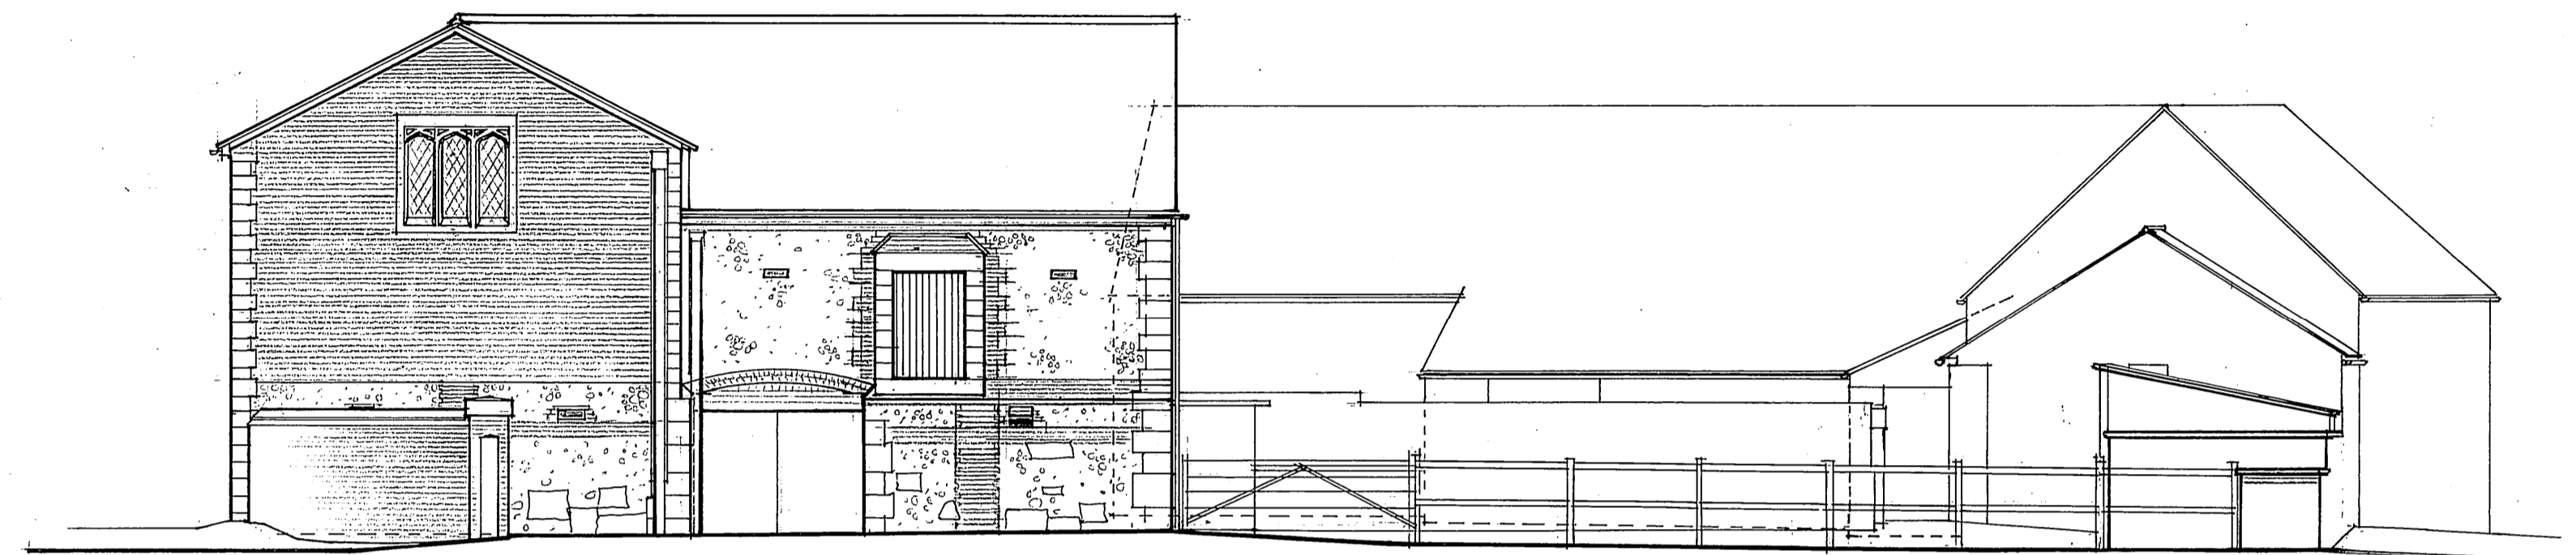
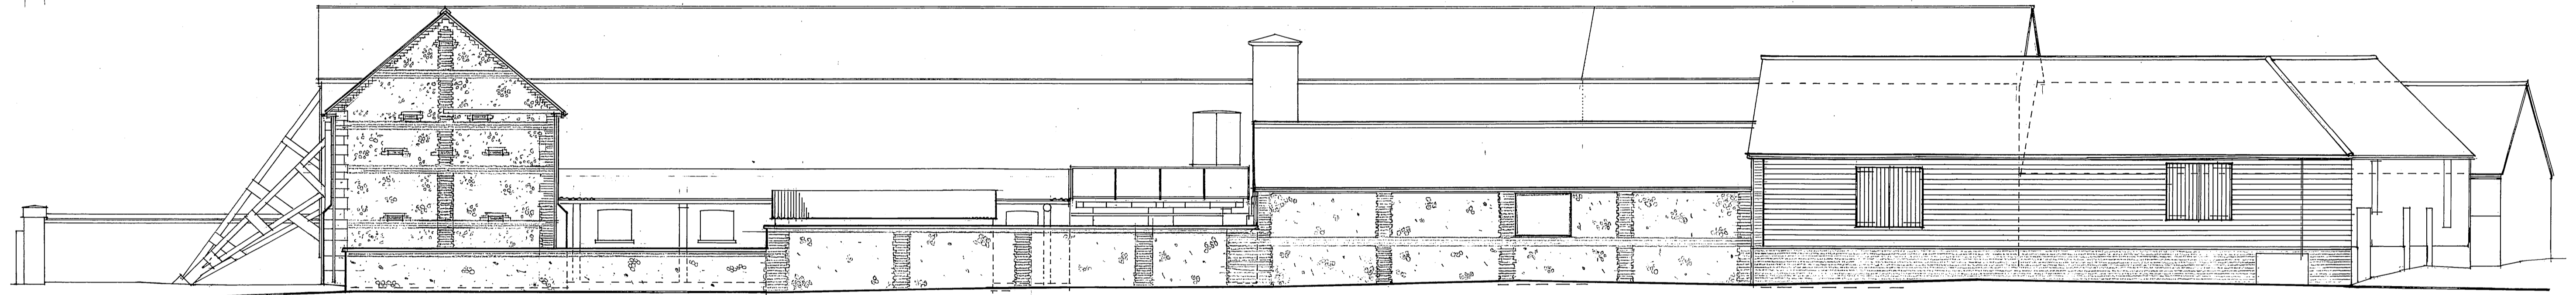
NORTH ELEVATION

WEST ELEVATION

SOUTH ELEVATION

EAST ELEVATION

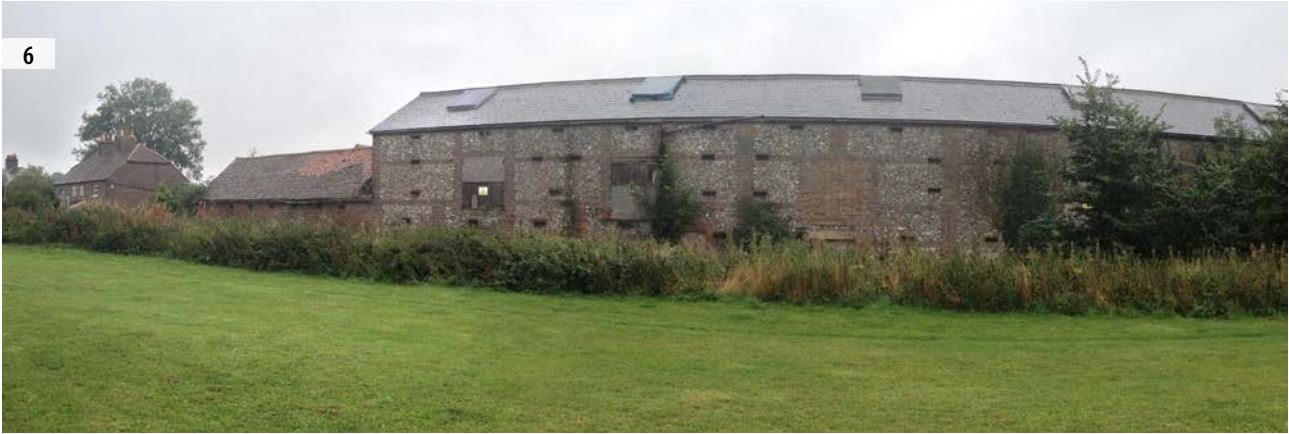
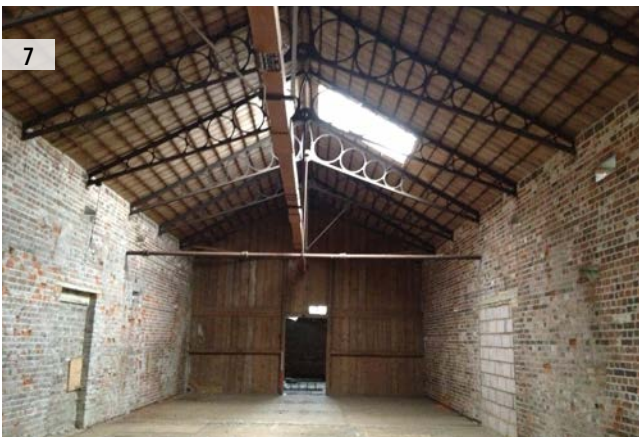
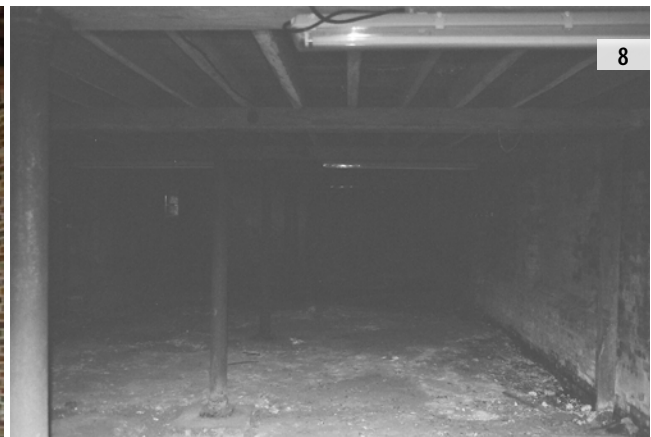
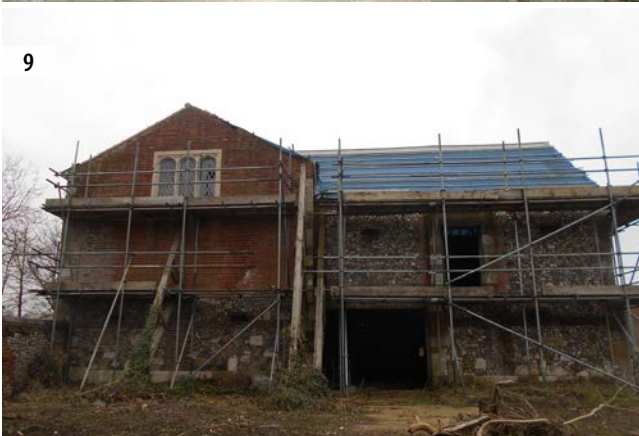
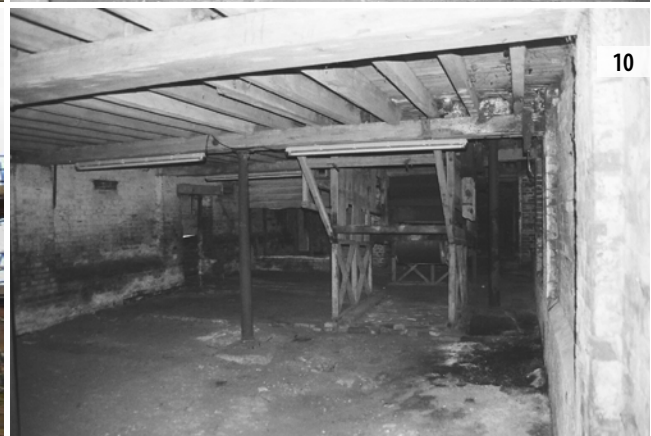
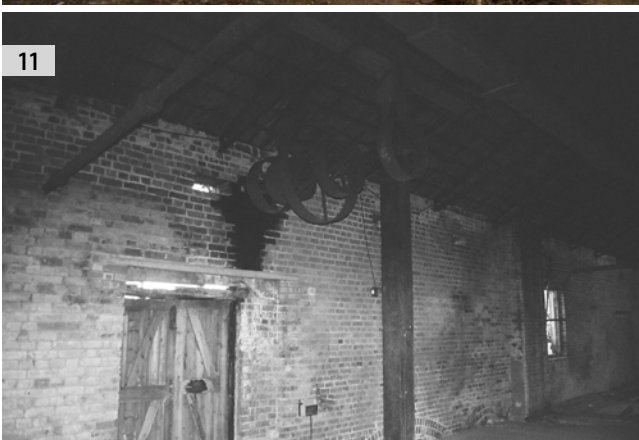
**ILLUS 6** Building A exterior, northern elevation, facing south    **ILLUS 7** Building A interior, east-west wing, facing E    **ILLUS 8** Building A interior, east-west wing, lower floor    **ILLUS 9** Building A exterior detail – west gable, mullioned tudor window, return north-south wing visible to the right of image    **ILLUS 10** Building A interior detail – east-west wing lower floor, winnowing machine    **ILLUS 11** Building A interior detail – east-west wing, upper floor, belt-wheels

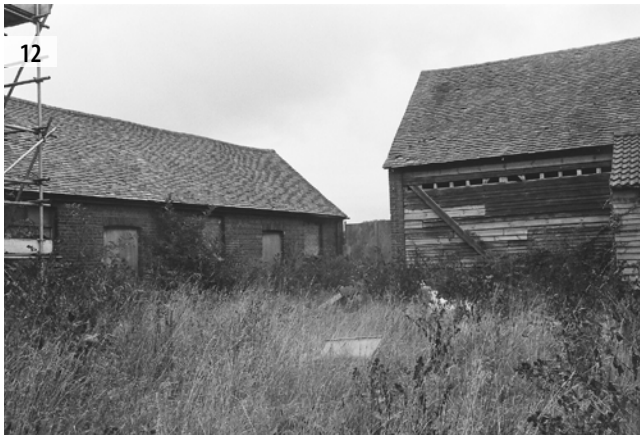
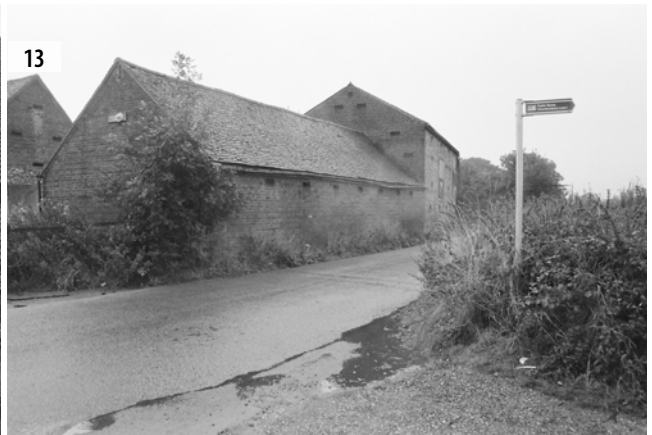
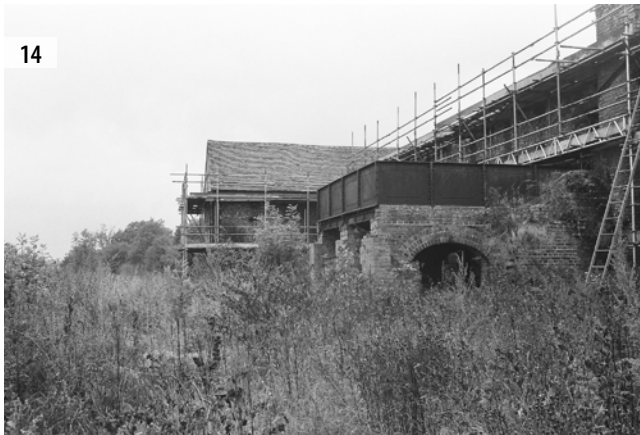
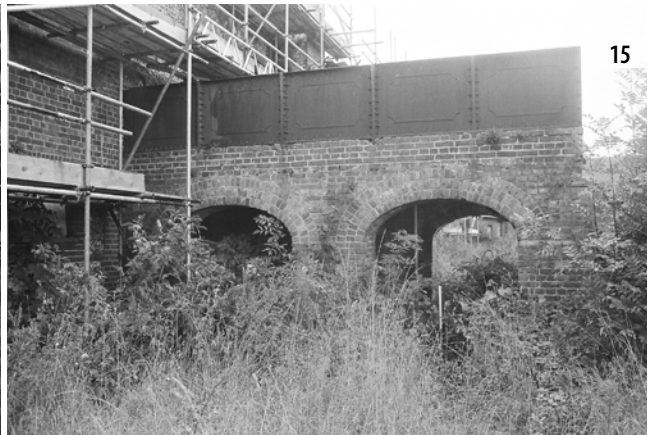
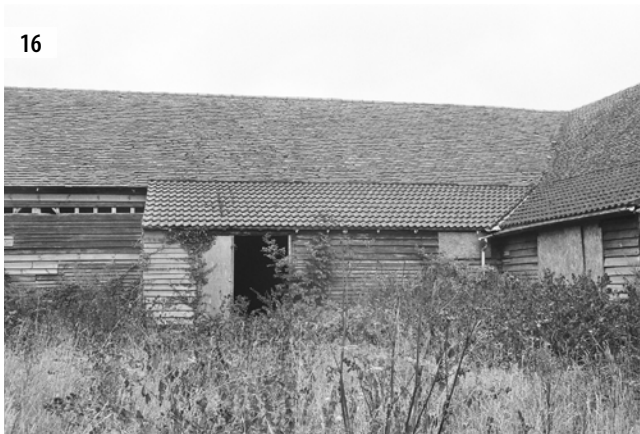
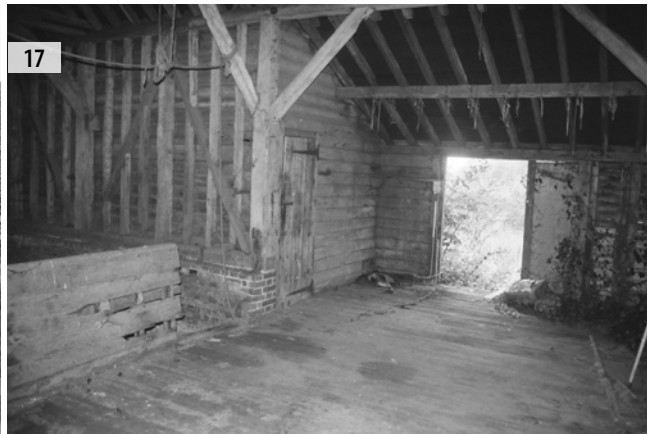
**ILLUS 12** Building B exterior, southern elevation, facing north-east    **ILLUS 13** Building B exterior, northern elevation and eastern gable, facing south-west    **ILLUS 14** Building C exterior (foreground), eastern and southern elevations, Building A north-south return wing in background, facing north-west    **ILLUS 15** Building C exterior, western elevation, facing east    **ILLUS 16** Building D exterior (foreground), western and northern elevations, Building E in background, facing east    **ILLUS 17** Building D interior, facing west taken from inside Building E, central threshing floor of building E can be seen in foreground with an example of the surviving mowstead visible to the left of the image

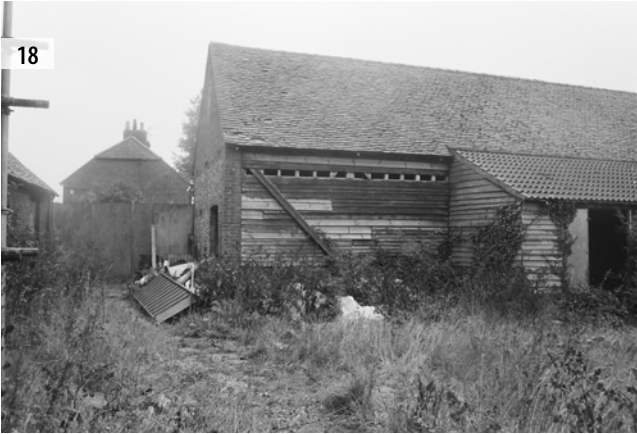
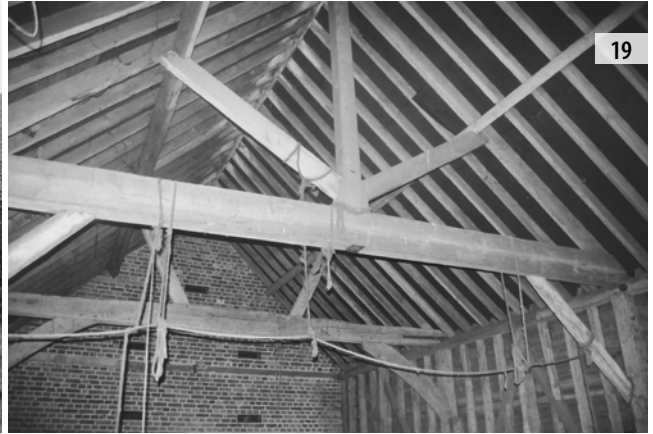
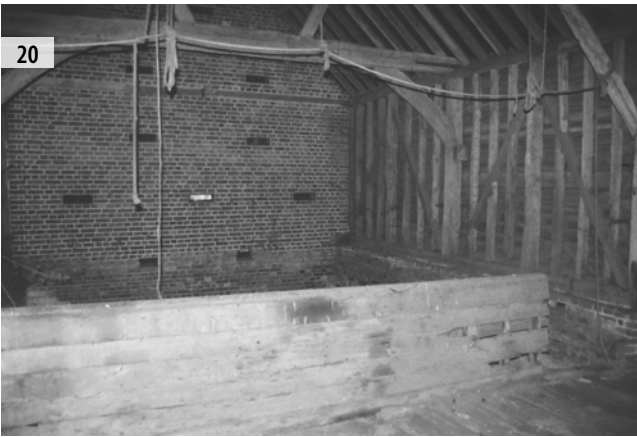
**ILLUS 18** Building E exterior, western and northern elevations, facing west, Building D in foreground **ILLUS 19** Building E interior detail – Roof trusses **ILLUS 20** Building E interior detail – Mowstead, northern gable visible in background

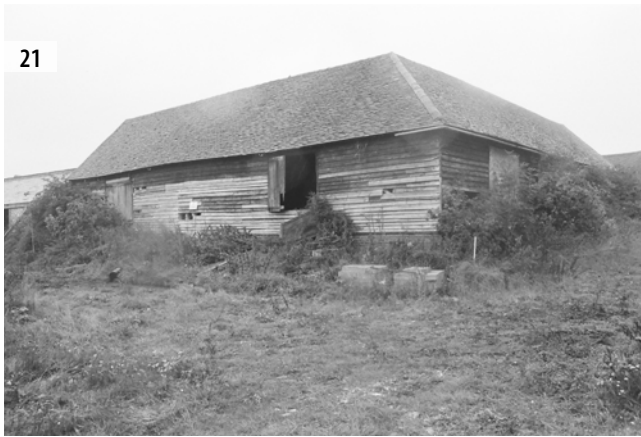
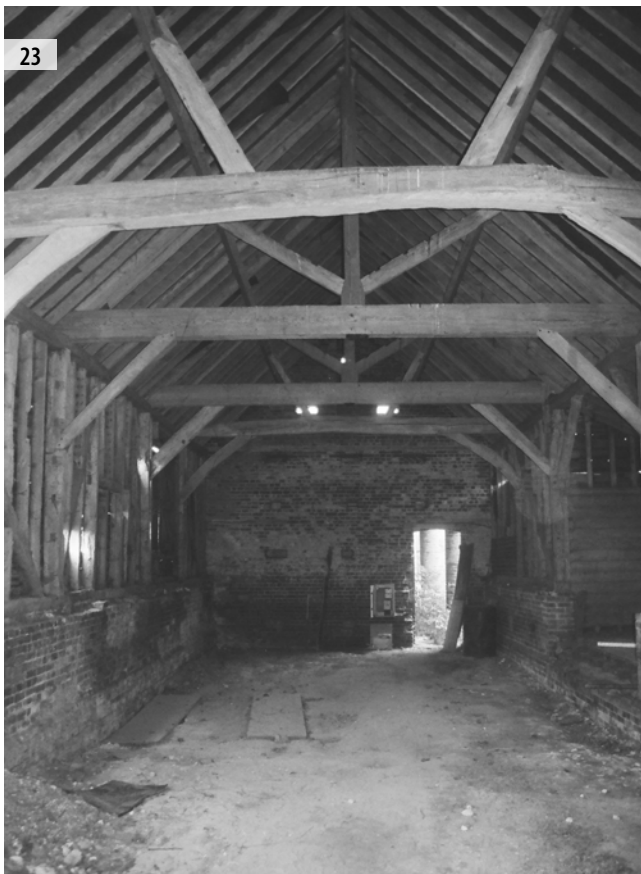
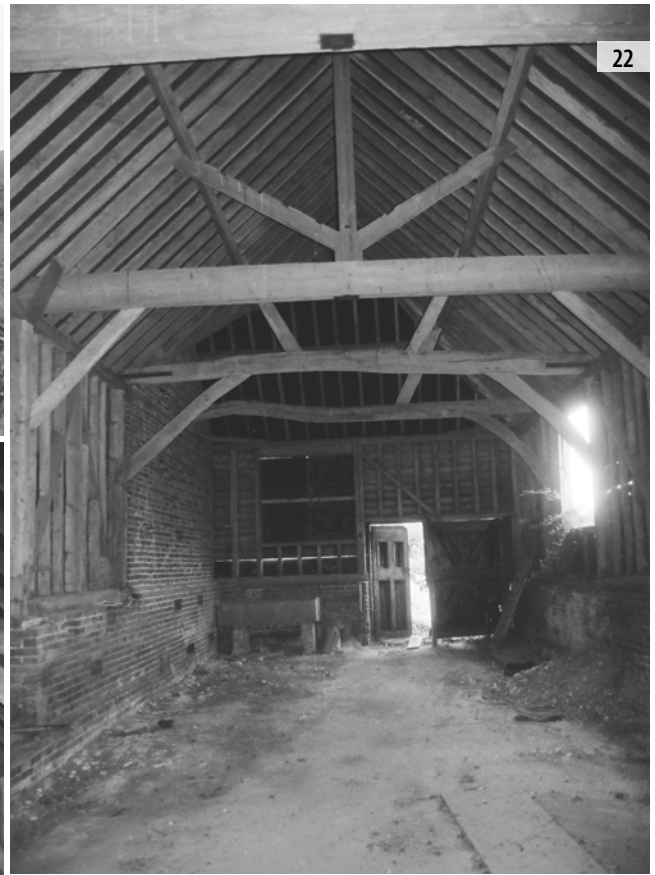
**ILLUS 21** Building F exterior, southern elevation, facing north-west, eastern elevation of Building E to the right of image **ILLUS 22** Building F interior, detail of roof trusses, east gable in background, facing east **ILLUS 23** Building F interior, west gable in background, facing west, entrance to Building D to the right of image

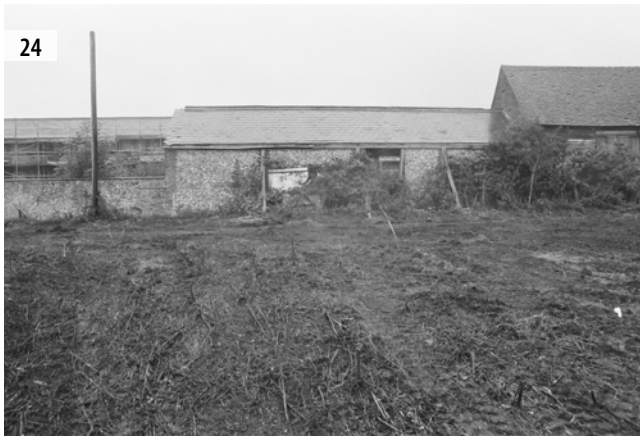
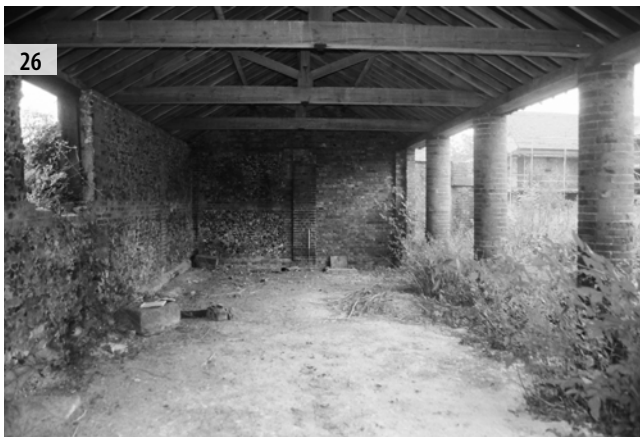
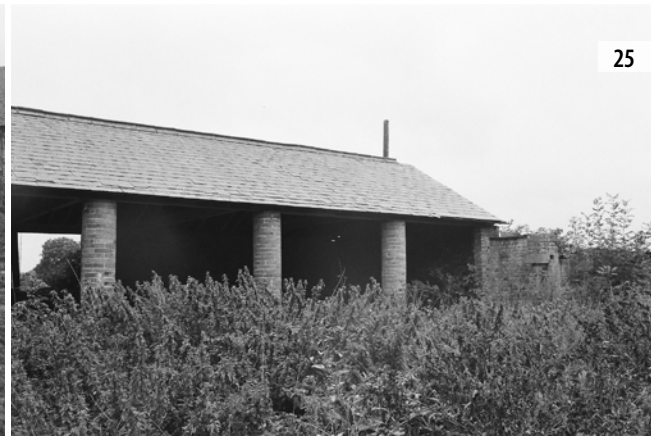
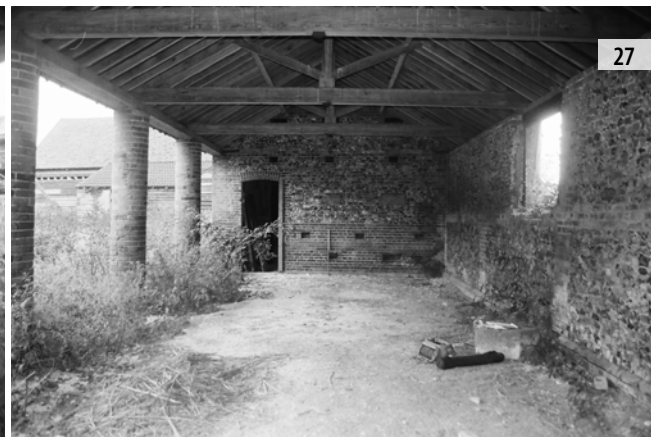
**ILLUS 24** Building G exterior, southern elevation, facing north, building F to right of image and original enclosure wall to the left    **ILLUS 25** Building G exterior, northern elevation and brick columns, facing south-west, note short extent of original courtyard wall extending northwards from west gable of Building G    **ILLUS 26** Building G interior, west gable in background, facing west    **ILLUS 27** Building G interior, eastern elevation (west gable of Building F), facing east

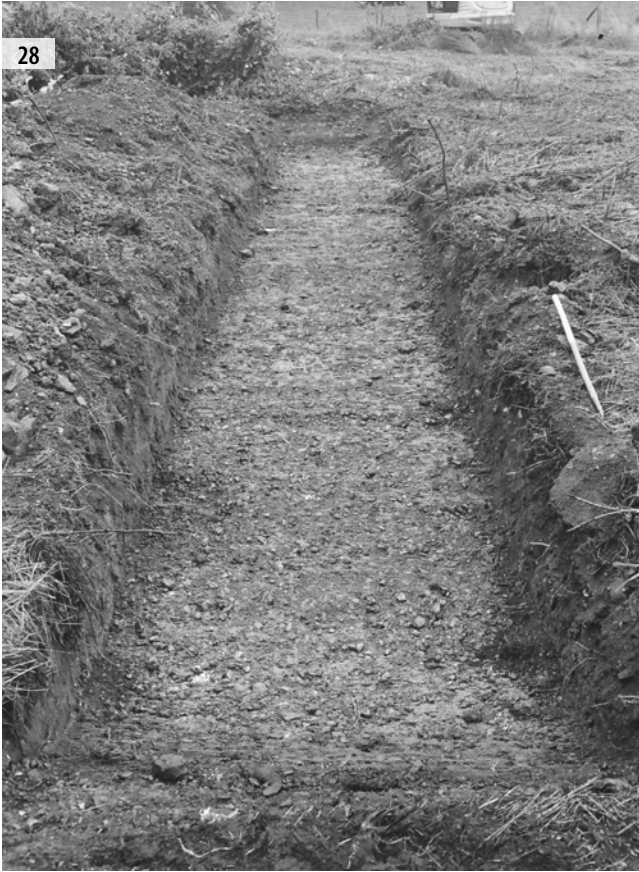
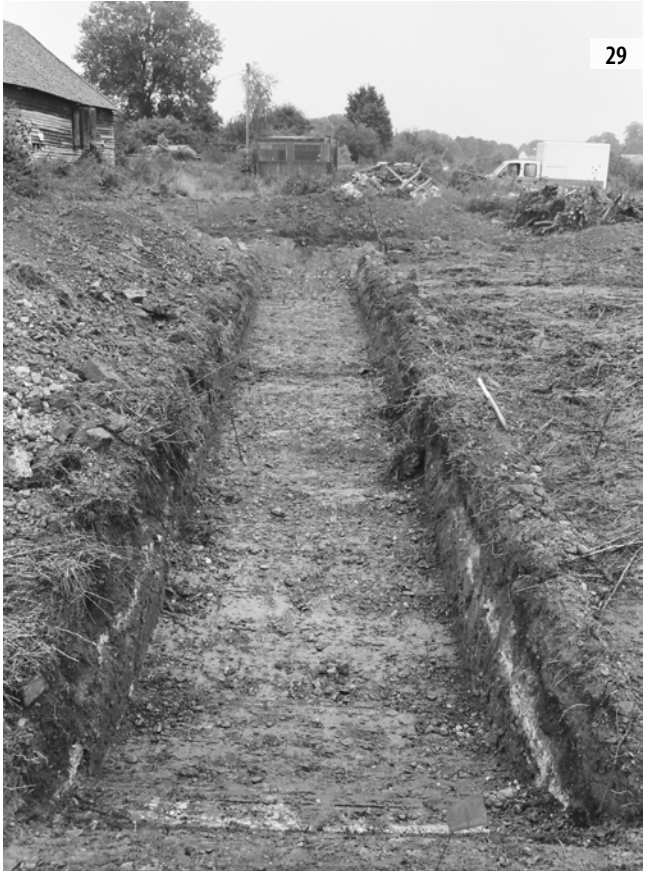
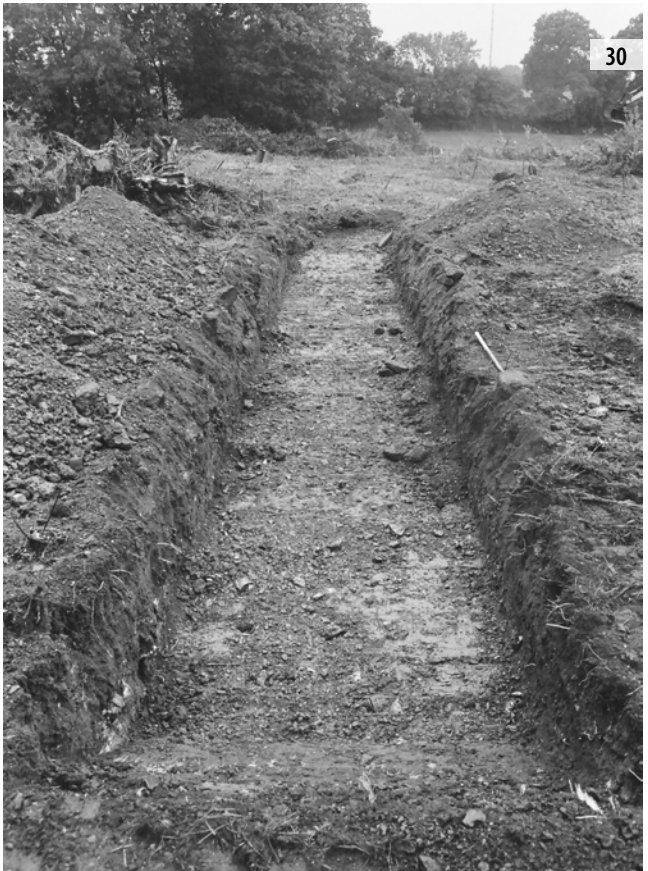
**ILLUS 28** Trench 1, facing south    **ILLUS 29** Trench 2, facing east    **ILLUS 30** Trench 3, facing south

The general stratigraphic make up the of the site consisted of the present day turf line, overlaying a mixture of levelling deposits and dumps of demolition material, that subsequently overlay a previous soil horizon overlaying natural flint and clay deposits. Within the excavated trenches a slight variation to this sequence was noted, particularly within trench 1, where a large dump of modern material was noted.

No archaeological features were found in any of the trenches, however 104, 204, and 304 possibly represent an intact soil horizon dating to the construction of the 19<sup>th</sup> century farmstead, if so the brick material identified within this may relate to the original demolition of the earlier farm buildings which stood here. Alternatively this material may relate to the demolition of buildings H, I, and J during the late 20<sup>th</sup> century.

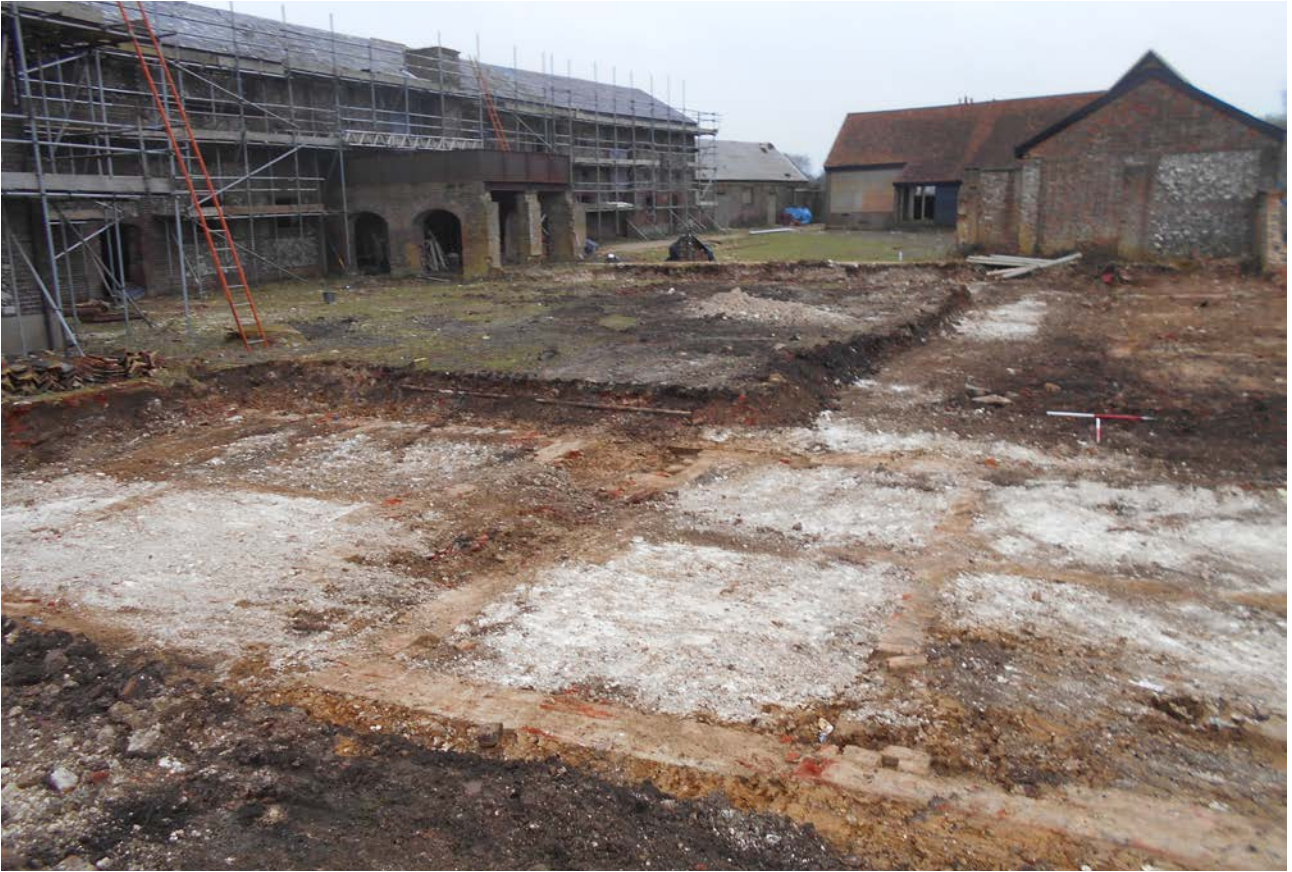
**ILLUS 31** Excavation areas (SMS), facing north-east

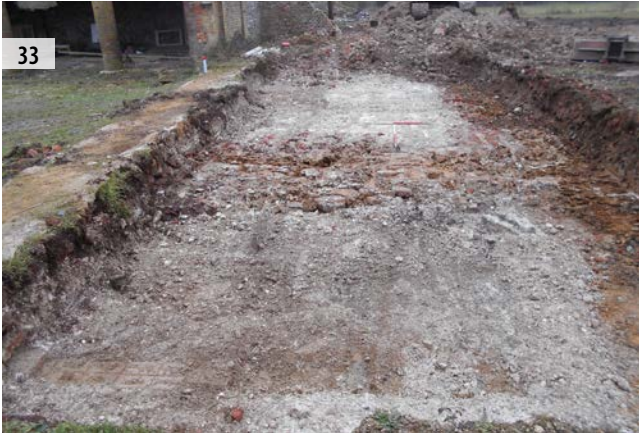
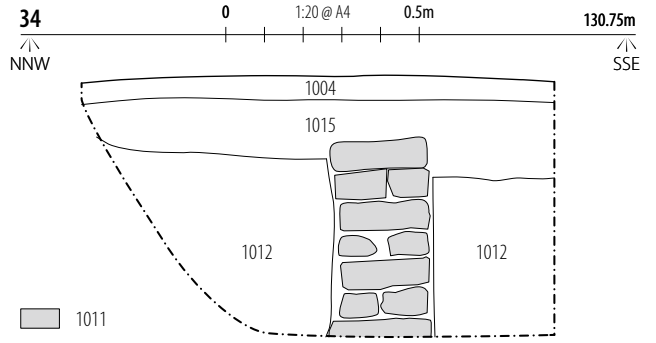
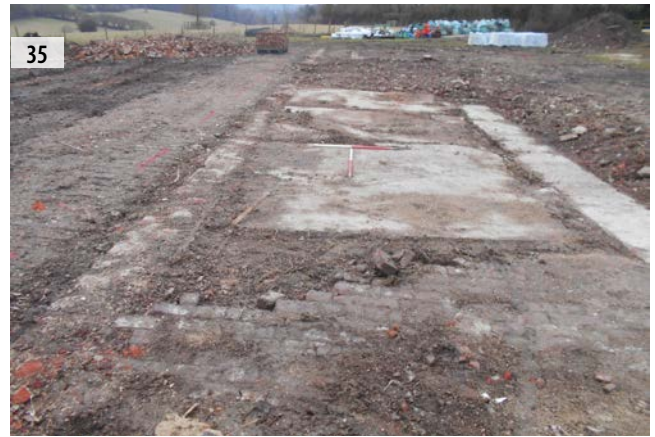
**ILLUS 33** SMS Area 1, facing south    **ILLUS 34** Sample section Area 1, west facing section    **ILLUS 35** SMS Area 2, facing west, in situ 19th century floor in foreground of image

Structurally only the upper foundations of the buildings remained with the exception of Building I (Area 2) which partially retained the original 19<sup>th</sup> century brick-built floor surface. Evidence of made ground in the form of (1012), a layer of compacted chalk visible in areas 1, 2, and 3 is indicative of a phase of levelling having taken place prior to the construction of the 19<sup>th</sup> century buildings.

The foundations of Building I (Area 2) are indicative of a series of sequential small square spaces, with the westernmost three measuring approximately 8m<sup>2</sup> (possibly covered pens or stalls for livestock) and the eastern most (brick floor intact) measuring 10m<sup>2</sup> (possibly for the storage of machinery and / or tools). It is of note that OS mapping indicates a sub-circular enclosure extending northwards from the western gable of Building H measuring approximately 64m<sup>2</sup>, it would seem likely that this was an external animal pen for livestock.

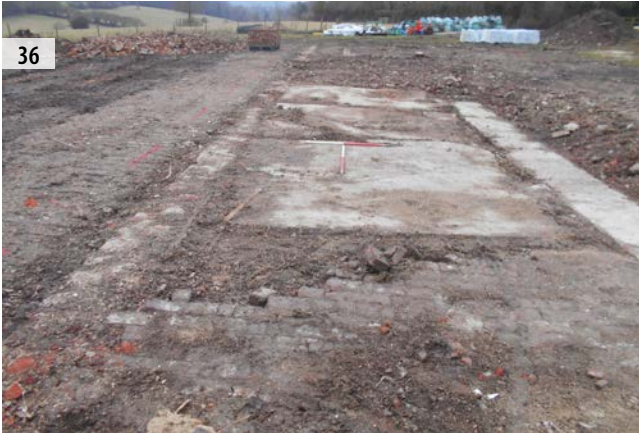
**ILLUS 36** SMS Area 3, facing south

The remains of Building J (Area 3) are also of interest, OS mapping indicates a single contiguous structure, however the internal layout of the foundations are indicative of two substantial square spaces (32m<sup>2</sup>) divided by a short corridor. It is possible that this corridor denotes an entrance way with doors existing both within the western and eastern facades, facilitating entrance to and from the western courtyard for livestock and vehicles.

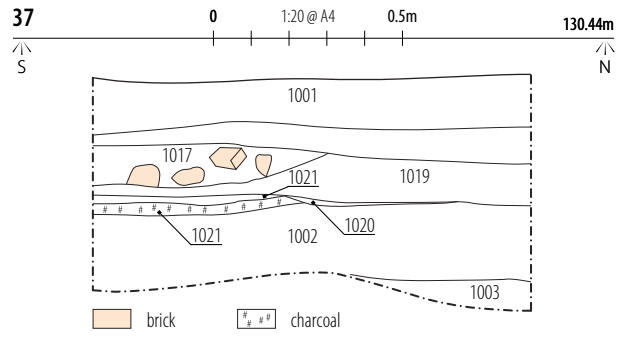
**ILLUS 37** Sample section Area 3, east facing section
