RADAR SURVEY OF CAR PARKS AT BISHOPS ROAD, PETERBOROUGH

Radar Survey of car parks

for ECUS Ltd

March 2011

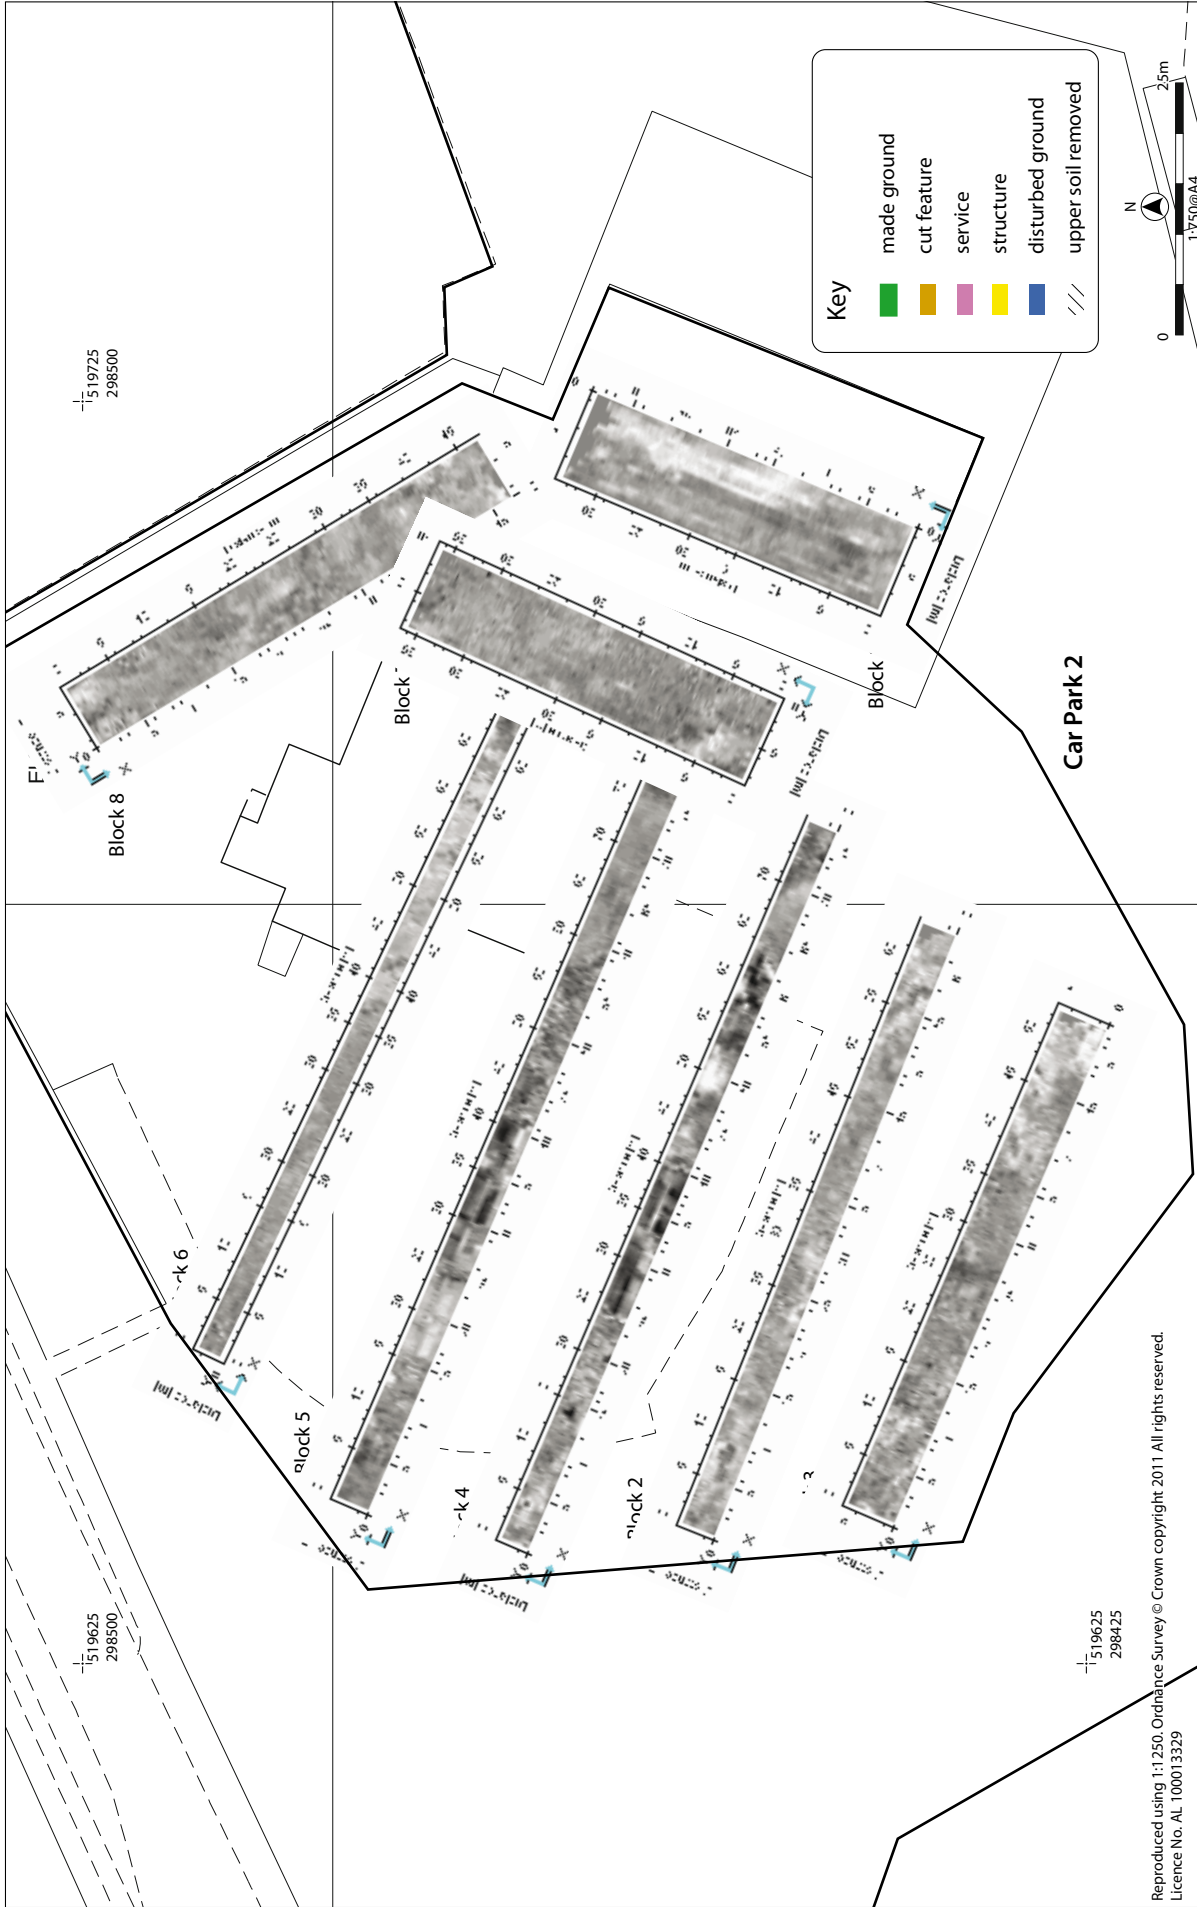
Illus 6
Car park 2, with interpretive shading

The data from the eight blocks surveyed in this area contrasts with that from Car Park 1 in that it appears to contain areas of disturbance and also areas where the upper soil surface may have been stripped off (perhaps in an attempt to level the site). In Block 6 there appears to be the remains of a floor (perhaps concrete) of a building that once stood on that part of the site (Illus A1.12 and A1.13). To the east of this an area of disturbance probably relates to the demolition and grubbing up of remains of this building. In the adjacent Block 1 (Illus A1.7) the distinction between what may be a concrete floor of another building (not shown on maps or air photos) is clearly visible and shown on Illus 6 between 40–62 m along the block.

In a similar fashion to Car Park 1 there are indications of cut features in this part of the site too, such as Block 2 (Illus A1.8), Block 4 (Illus A1.10) and Block 7 (Illus A1.14). In Block 3 most of the earlier ground surface appears to have been stripped (Illus A1.9 – the arrow shows the buried ground surface and where it stops).

At the north side of this car park, in Block 8, there is an indication that the ground surface has been made up, perhaps within a hollow in this part of the site (Illus A1.15).

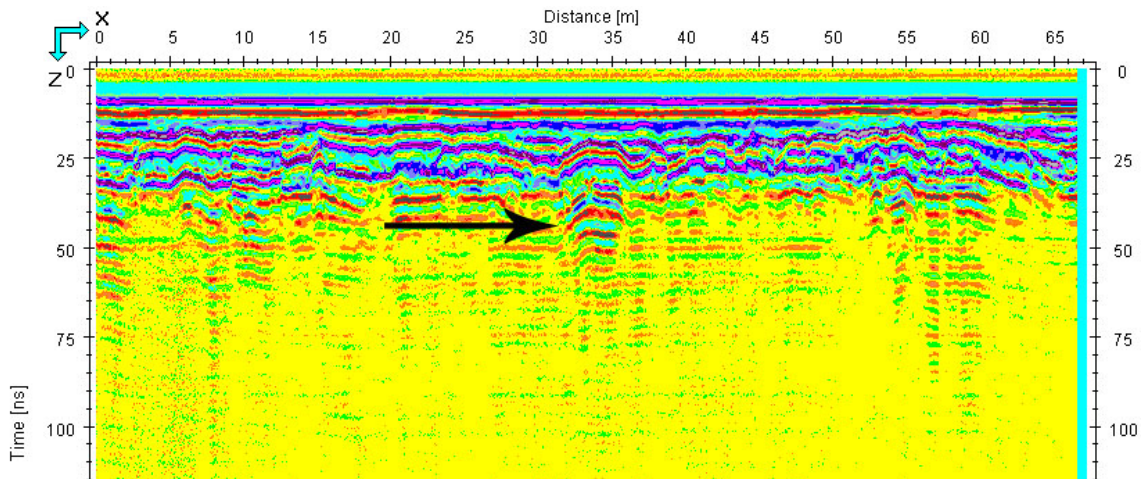
Section 3

The most interesting feature visible within the data lies within Block 2. This data appears to contain a relatively large and deep hollow (Illus A1.4) adjacent to what may be a small structural feature (Illus A1.3) visible in plan from 30–45m along this block (Illus 5). The cut feature appears at face value to be relatively deep – although it is not clear whether the equipment is seeing the base of the feature or simply its fills. The structural feature stands out in contrast to this, where the bands of responses curve upwards. It is quite broad in form and possibly relates to masonry or concrete. The juxtaposition of the two features is interesting and could result from a tip of rubble in one quarter of a large pit or a large concrete base cast in a bigger feature. Given how high up the profile the feature appears it is likely to be relatively recent in date.

The natural geology is evident in all the sections produced in Appendix 1 where the blue data suddenly gives way to yellow. It is at this point that alluvial deposits may occur and the moister, clayey nature of these deposits tends to absorb almost all reflections of the radar signal so that all that is left are echoes of features or deposits at a higher level in the profile. It is clear that features have on occasion been cut through this horizon, the most noticeable being visible in Illus A1.3.
