Newnham Grounds, King's Newnham, Warwickshire

Archaeological Observation, Investigation and Recording

Archaeological Monitoring

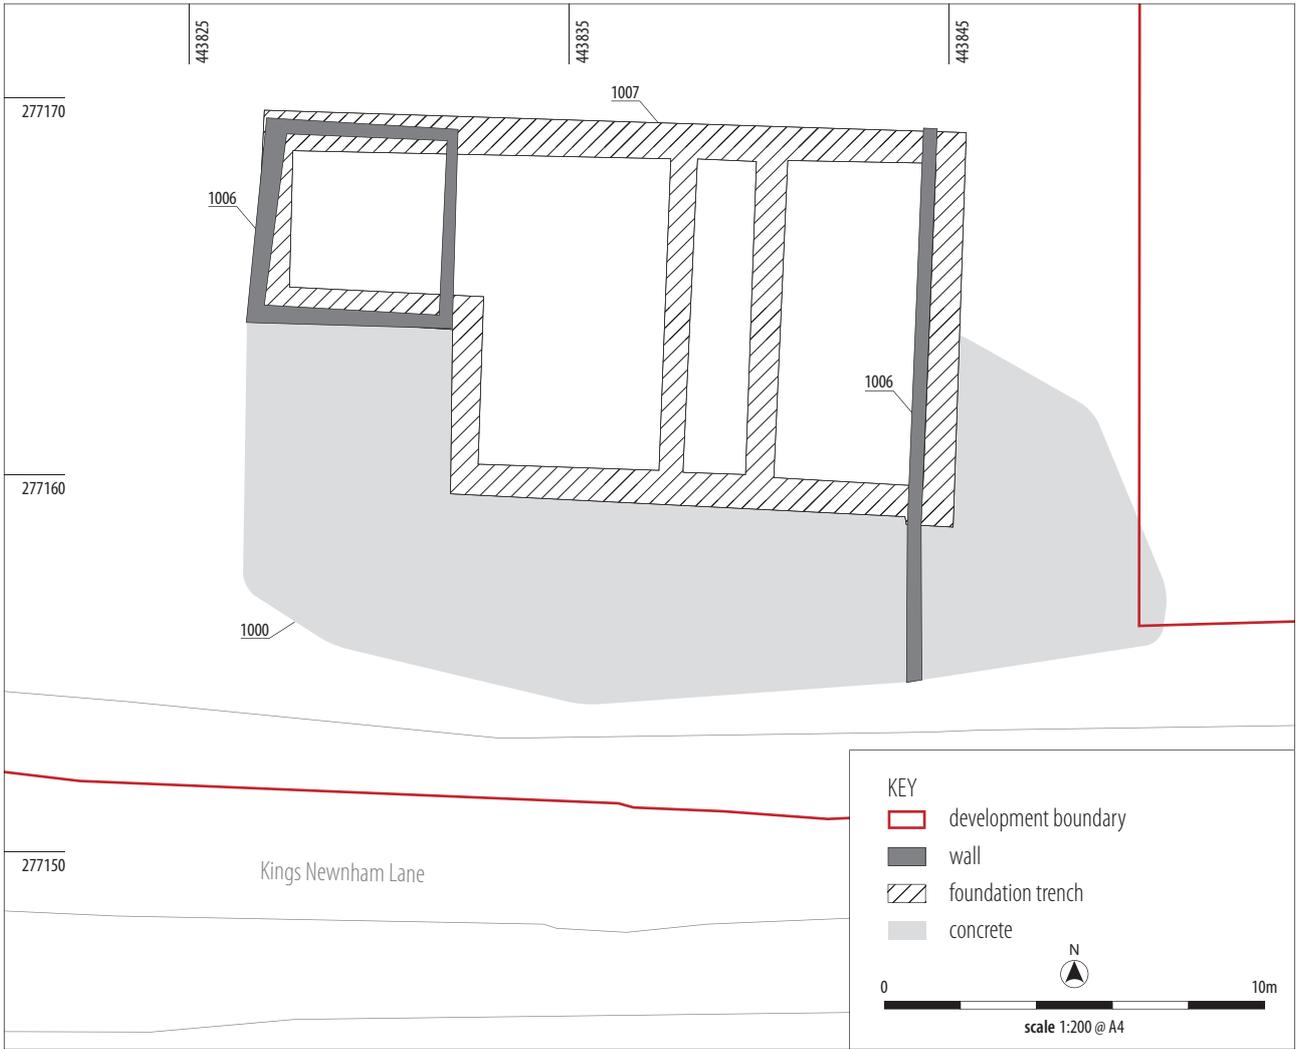
ILLUS 2
Plan of foundation trenches monitored

Archaeological monitoring was undertaken on the 13th and 14th April 2015. This included the observation of the excavation of foundation trenches for the new building (Illus 2). This covered a total length of 76m, by between 0.45m and 0.8m in width, by 1m in depth (Illus. 2).

The foundation trench consisted of a 0.8m cut along the outside of the new building's footprint, which largely coincided with that of the demolished structure, and two cross trenches, 0.45m wide, at approximately the centre of the new building (Illus. 2).

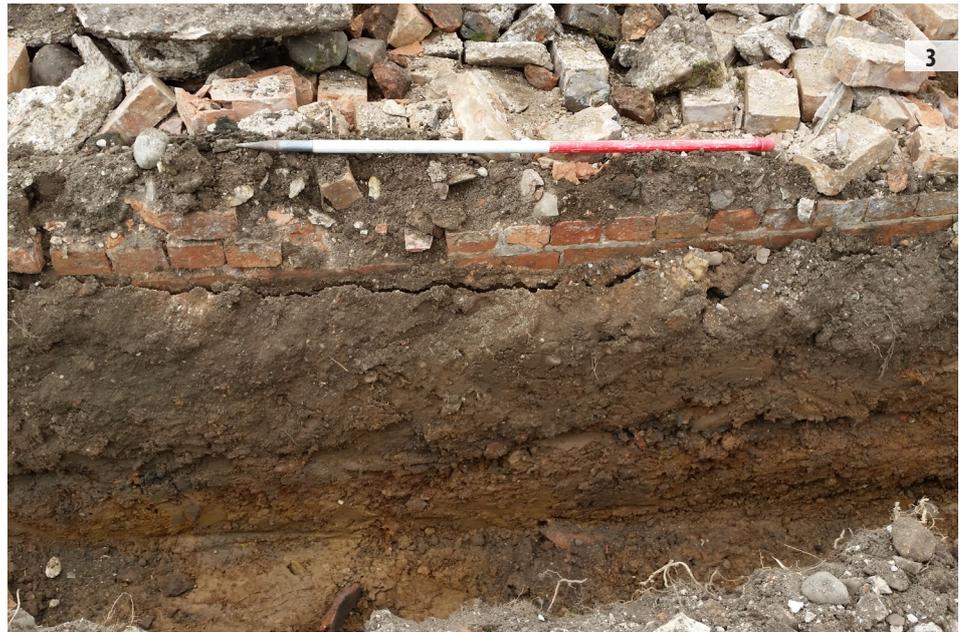
ILLUS 3

E facing section of foundation trench, showing wall [1006]

The remains of the foundations of the 19th-20th century barn were mostly removed during the excavation of the new foundations. The only elements which survived this were the length of the east side of the demolished barn and the eastern wall of the smaller structure, where the new foundations were cut outside the structural remains (see Illus. 5).

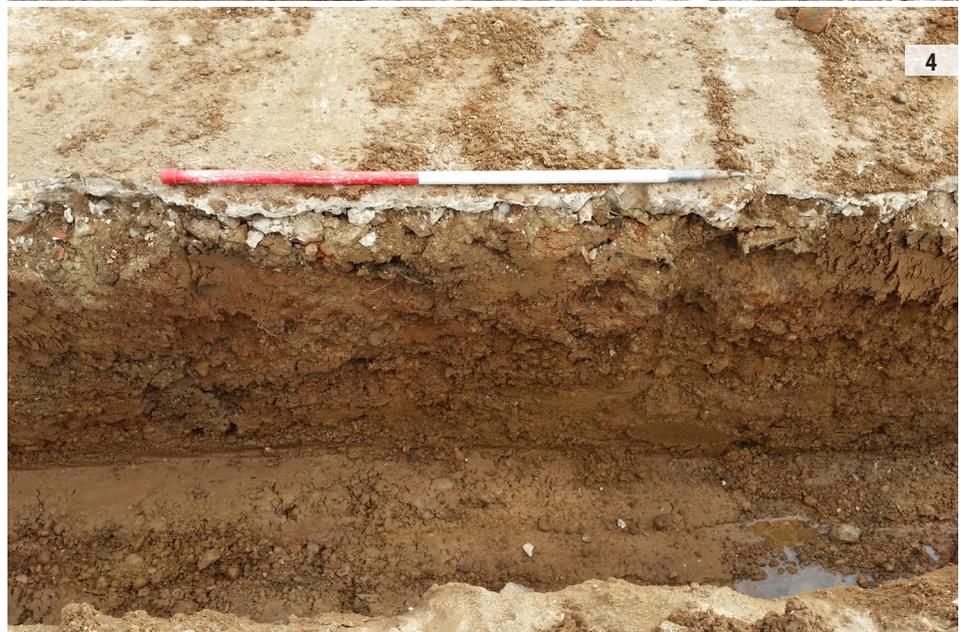
ILLUS 4

N facing section of foundation trench, showing concrete (1000) over make-up deposit (1001) over subsoil (1003) over natural (1004)

To the north of the site, grey brown sandy silt topsoil (1005), 0.2m in thickness, overlay a red brown silty sand subsoil (1003) (Illus. 3). Beneath the concrete yard and within the footprint of the building, foundation layers, (1001), a dark grey brown sandy silt, and (1002), an orange brown sandy silt, both 0.2m thick, overlay the subsoil. This was finally overlain by the concrete yard surface (1000), 0.1m thick (Illus. 4). Within the building, this concrete layer had been broken up and partially removed prior to the monitoring works but is clearly visible in the photographs from the building survey (ABRS 2013). Across the entire site the subsoil (1003), between 0.1m and 0.2m in thickness, overlay red brown sand natural deposits (1004).

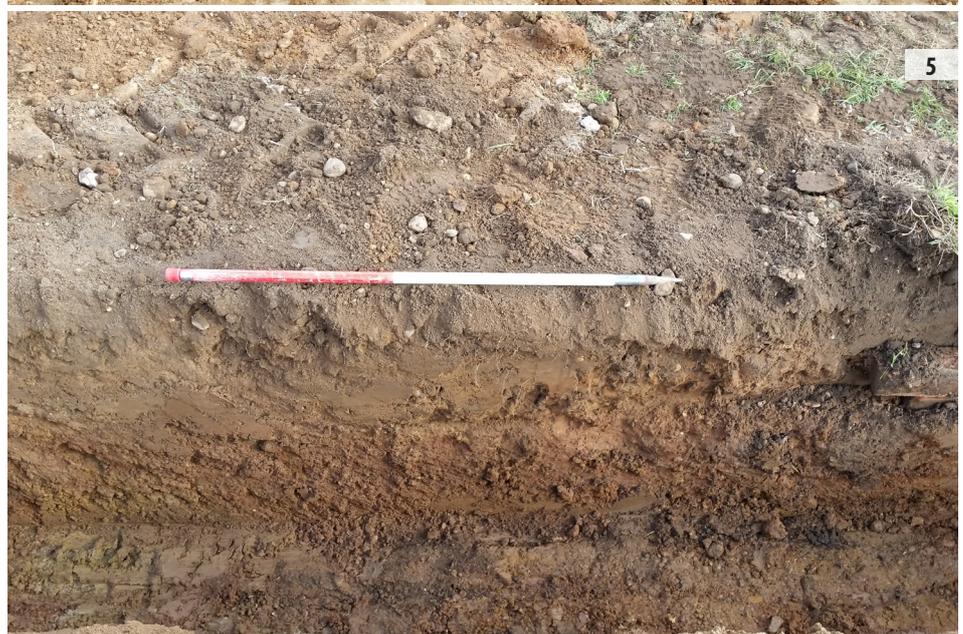
ILLUS 5

S facing section of foundation trench, western part of the site, showing topsoil (1005) over subsoil (1003) over natural (1004)
