## **Rye Hill, Watford Gap: Archaeological Trial Trenching Evaluation**

*Prepared for Fisher German LLP*

HA Job no.: RHWG13-002

## Archaeological Evaluation

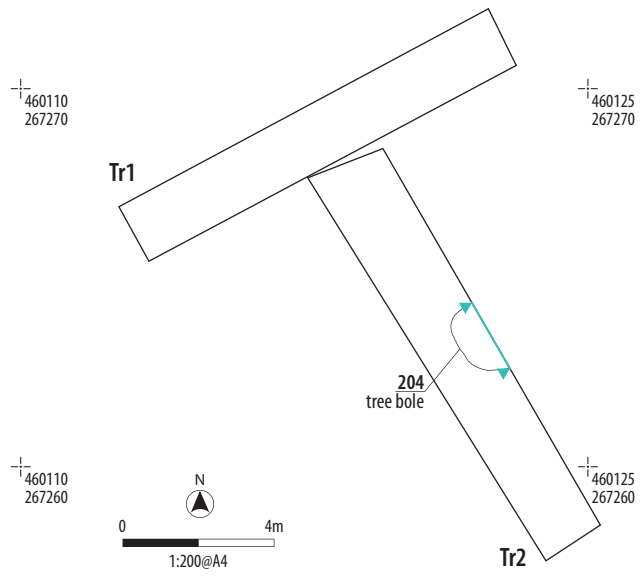
**Illus 2**

*Detail of Trenches 1 and 2 showing excavated feature*

Detailed records of the excavated trenches are available in appendix 1. The locations of trenches are shown in illustrations 1 and 2. The single feature excavated is also

shown in plan on illustration 2, and in section, with appropriate reference to the Ordnance Datum, in illustration 3.

A single negative feature was recorded in the centre of Trench 2. The form and fill of this feature was diffuse; amorphous in plan, it has several offshoots which appeared to be connected to voids in the ground. The base of the feature was also pitted with several voids. When the section was cleaned back, there was an obvious slump in the plough soil over the feature, suggesting that it too had been a void, and had collapsed (Illus 2, 4).

This feature was interpreted as a likely animal burrow, possibly taking advantage of a pre-existing tree-bole. No archaeological material was recovered from the fill, which might provide dating for this feature.

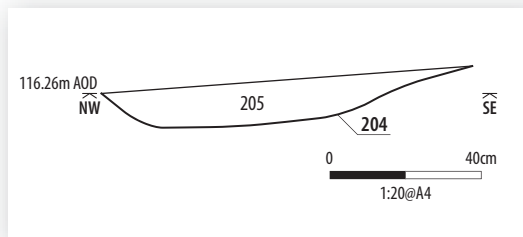
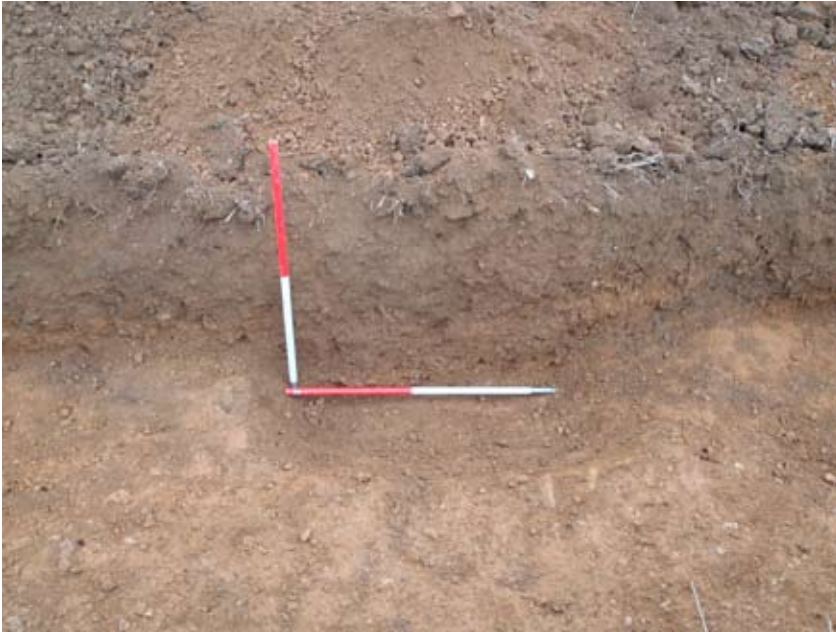
**Illus 3**

*Post-ex – SW facing section through tree bole  
[204]*

[204]	2	Cut of Tree Bole. Shallow sides, concave base, single fill (205) 2.03m long, 0.60m wide. Max Depth = 0.21m	0.21
(205)	2	Fill of tree bole [204], mid red brown sandy silt with occasional gravel fragments. Max depth = 0.21m	0.21
(301)	3	<b>Topsoil</b> Mid red-brown silty sand, friable	0.00 - 0.38
(302)	3	<b>Subsoil</b> Mid Brown Red Clay Silt -friable	0.38 - 0.47
(303)	3	<b>Natural</b> Light Brown Red Clayey Sands and Gravels	0.47 -

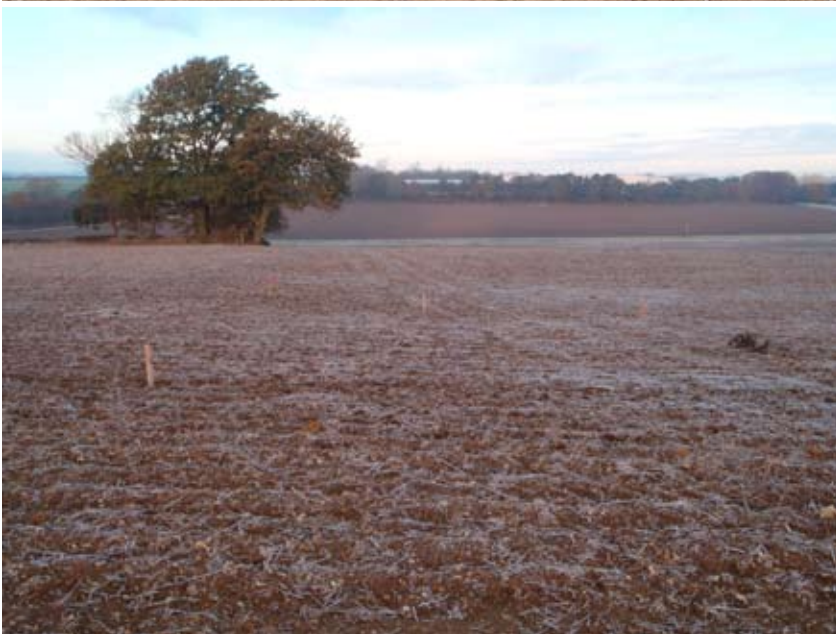
**Illus 4**

*Pre-ex shot of turbine base area*

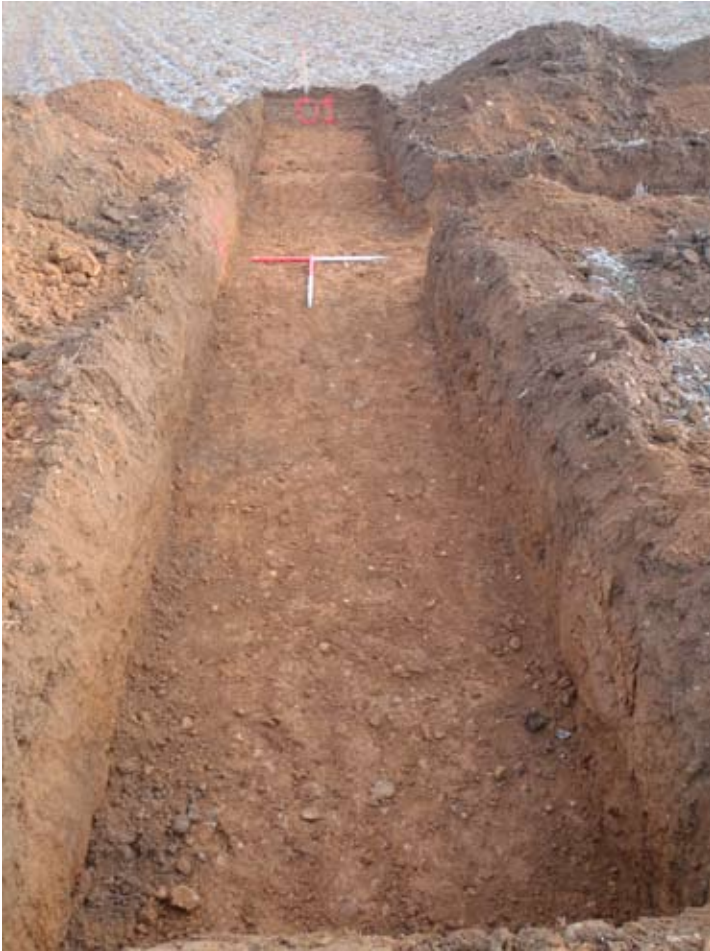
**Illus 5**

*NE facing post-ex shot of Trench 1*

Plough truncation was noted in all of the three trenches, with plough scars across the natural subsoil down to a depth of 0.35- 0.45m.

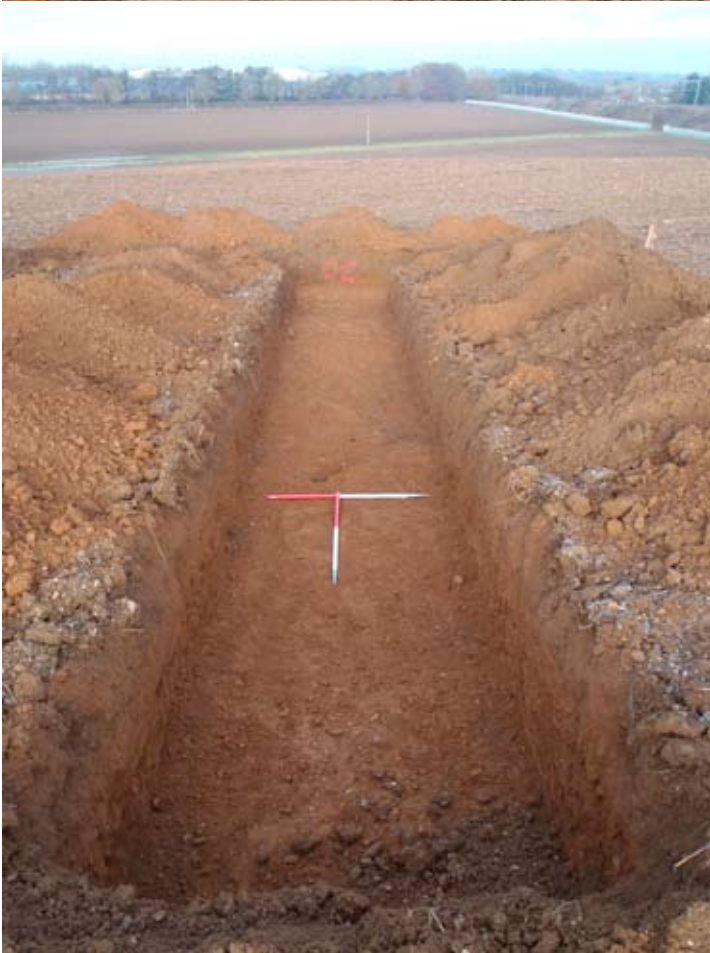
**Illus 6**

*NW facing post-ex shot of Trench 2*

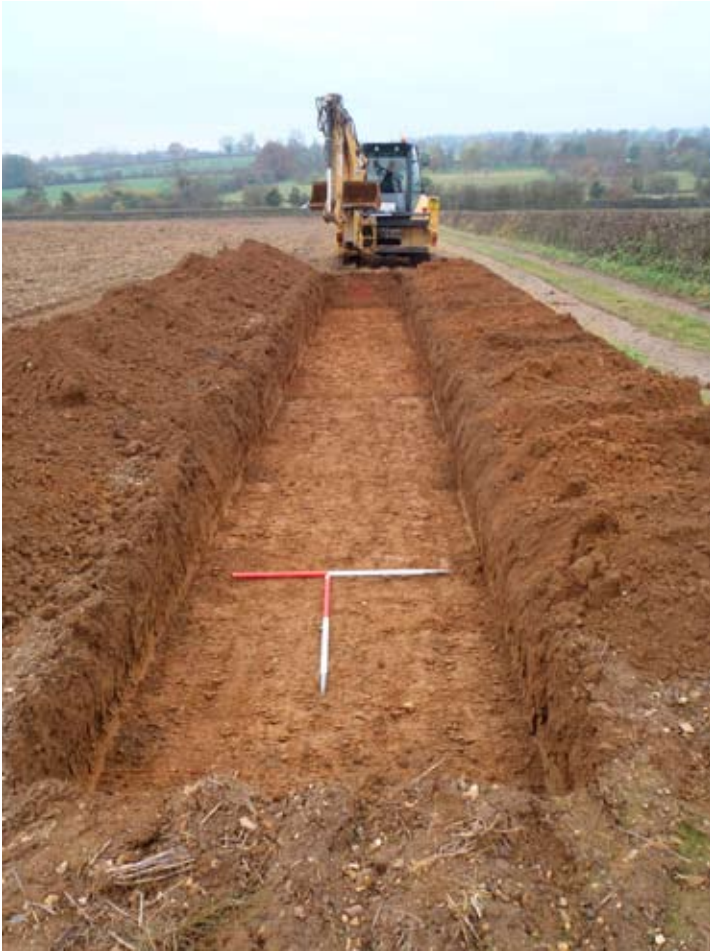
**Illus 7**

*SW facing post-ex shot of Trench 3*

The fieldwork took place on the 26<sup>th</sup> of November 2013. A total of 3 trenches were excavated amounting to 37 linear meters at 1.8m wide. The trenches were laid out in order to cover the extents of the turbine base and the likely route of the haul road. The stakeout of Trench 3

was altered, shifting 5 meters south, in order to preserve a pre-existing access track, while still presenting a representative sample of the ground affected by the improvement of the haul road (Illus 1).
