**Home Farm, Wicken, Northamptonshire:  
Archaeological Watching Brief**

HA Job no.: HOME14-001  
NGR: SP 7426 3925  
Parish: Wicken  
Council: South Northants  
OASIS ref.: headland4-177898

## Archaeological Watching Brief

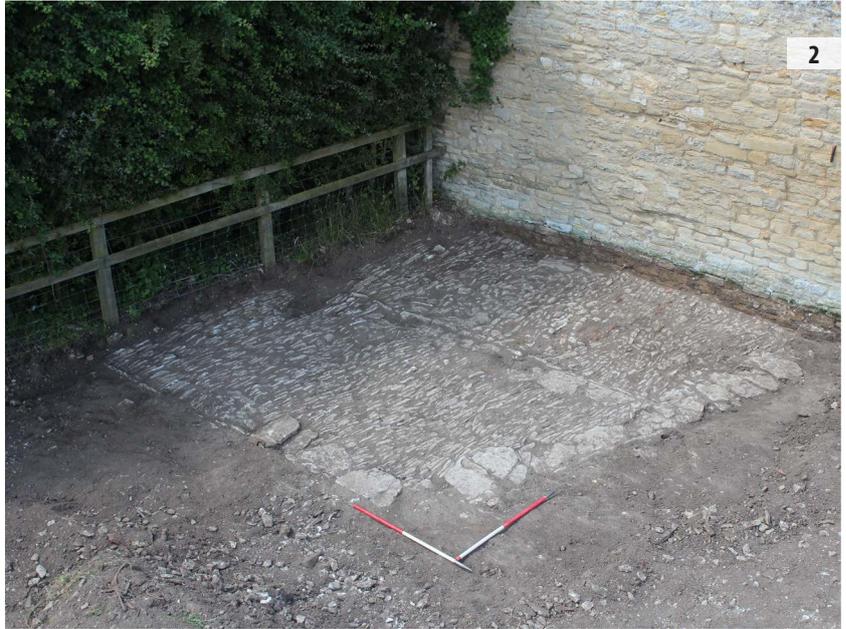
ILLUS 2

Elevated view of surface 004

Removal of topsoil in the area immediately adjacent to the east end of the barn revealed a hard surface, comprised of stone cobbles, surrounded by a kerb of large flat stones, and smaller edge-set stones positioned perpendicular to the cobbles. The cobble surface was observed abutting the wall stones, suggesting that the cobbles post-dated the wall construction. A void at the north eastern corner of the surface suggested the presence of a timber upright, which may have supported a flat or lean-to roof.

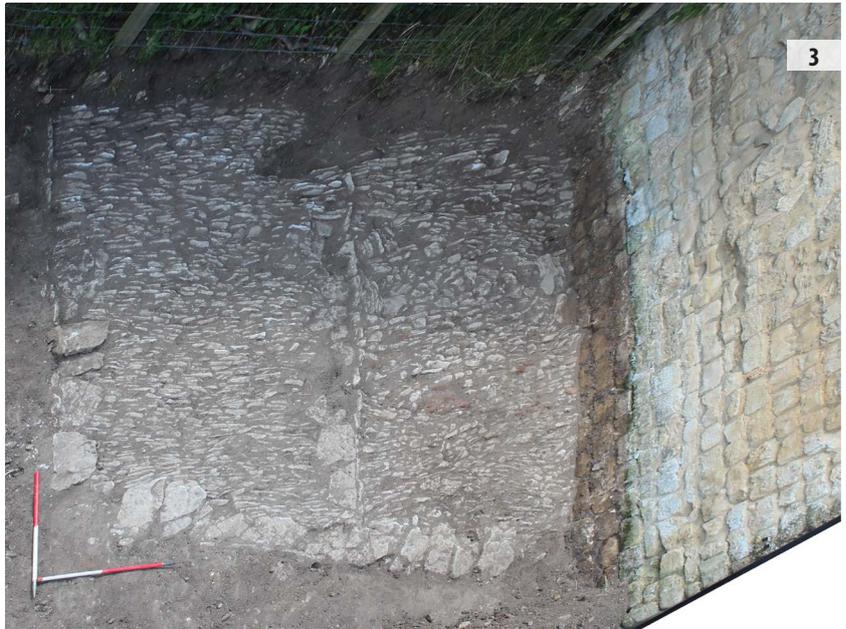
ILLUS 3

Rectified photograph of surface 004

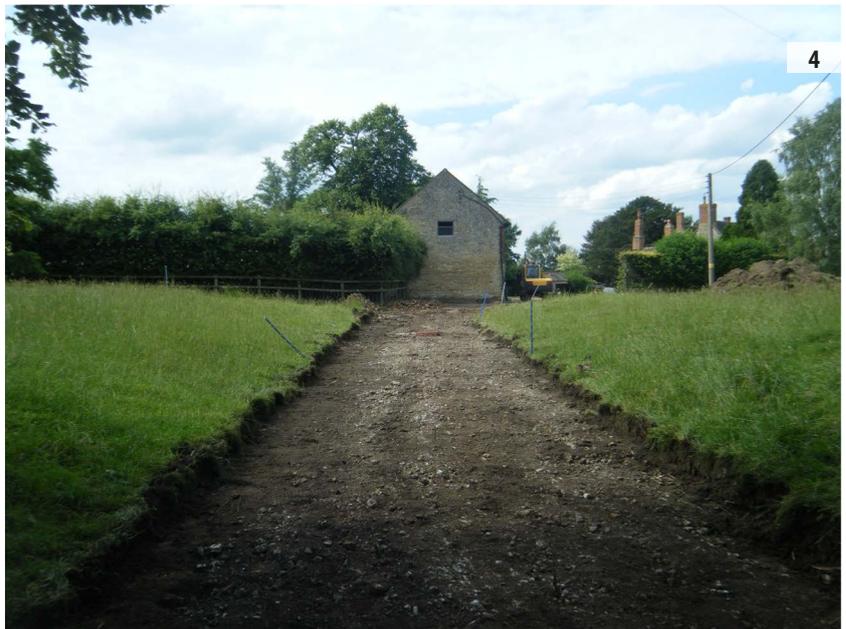
ILLUS 4

West facing view of hollow way

A deposit of demolition material consisting of fragments of limestone, brick other 19<sup>th</sup> century midden waste was observed lining the base of the hollow way. Exploratory excavations through this layer at the eastern end, and adjacent to the barn revealed that the rubble had a uniform depth of around 0.5 meters. Such a thickness of made ground is indicative of a purposeful upgrade, rather than intermittent re-surfacing. No evidence to support the existence of an early medieval hollow way was recovered during monitoring.

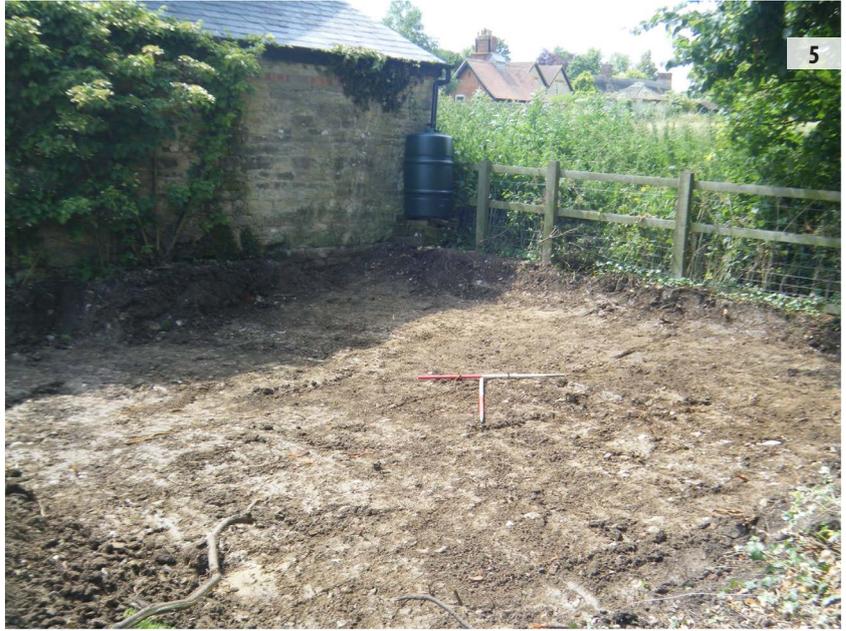
ILLUS 5

Southeast facing view of garage strip

To the west of the barn, the area for the garage was stripped down to clean geological deposits. Stripping removed a well-developed garden soil with a maximum depth of 0.48m. Throughout the garden soil column the watching brief officer continued to observe fragments of 19<sup>th</sup> and 20<sup>th</sup> century ceramics, suggesting that the soil had been actively improved with midden material.
