LGFD13-001

Langford Wind Turbine, Langford, Bedfordshire

Archaeological Monitoring

Prepared for Fisher German on behalf of Nick Parrish

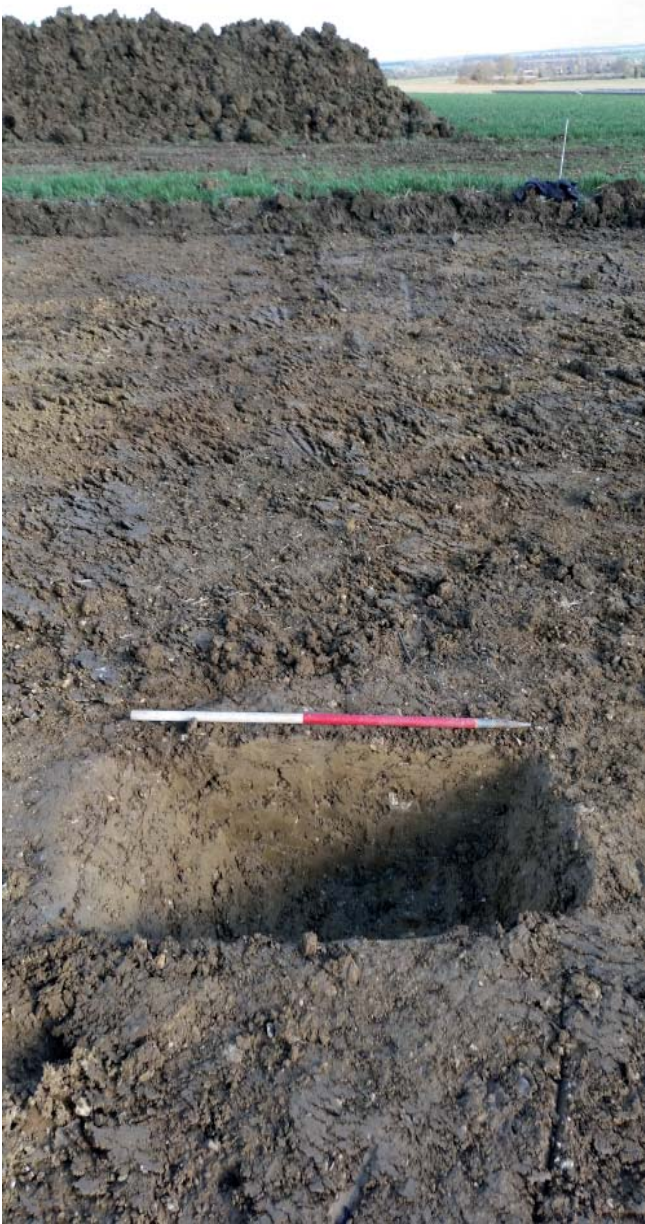
ILLUS 3

W facing section through ditch [106]

One ditch, [106], was observed crossing the compound area on an east-west alignment. It measured at least 30m in length, by 1.2m in width, by 0.48m in depth. It had steep sides and a slightly concave base, and contained a single orange-brown silty-clay fill with occasional small – medium sub-angular stones. Two small fragments of the rim of an earthenware jar, dated to the 18th / 19th century, were recovered from the fill of this ditch, demonstrating that this ditch was backfilled in the post-medieval period. It is most likely that this ditch functioned as a field boundary, although no field boundaries are shown in this position on any of the available historic maps (1807 onwards). This may suggest that this boundary pre-dates the 19th century, as is supported by the dating of the pot in the backfill.

The only archaeological feature recorded during this watching brief was the post-medieval field boundary ditch [106]. This demonstrates that the DA was in use for agriculture during the post-medieval period. This is considered to have low local significance.

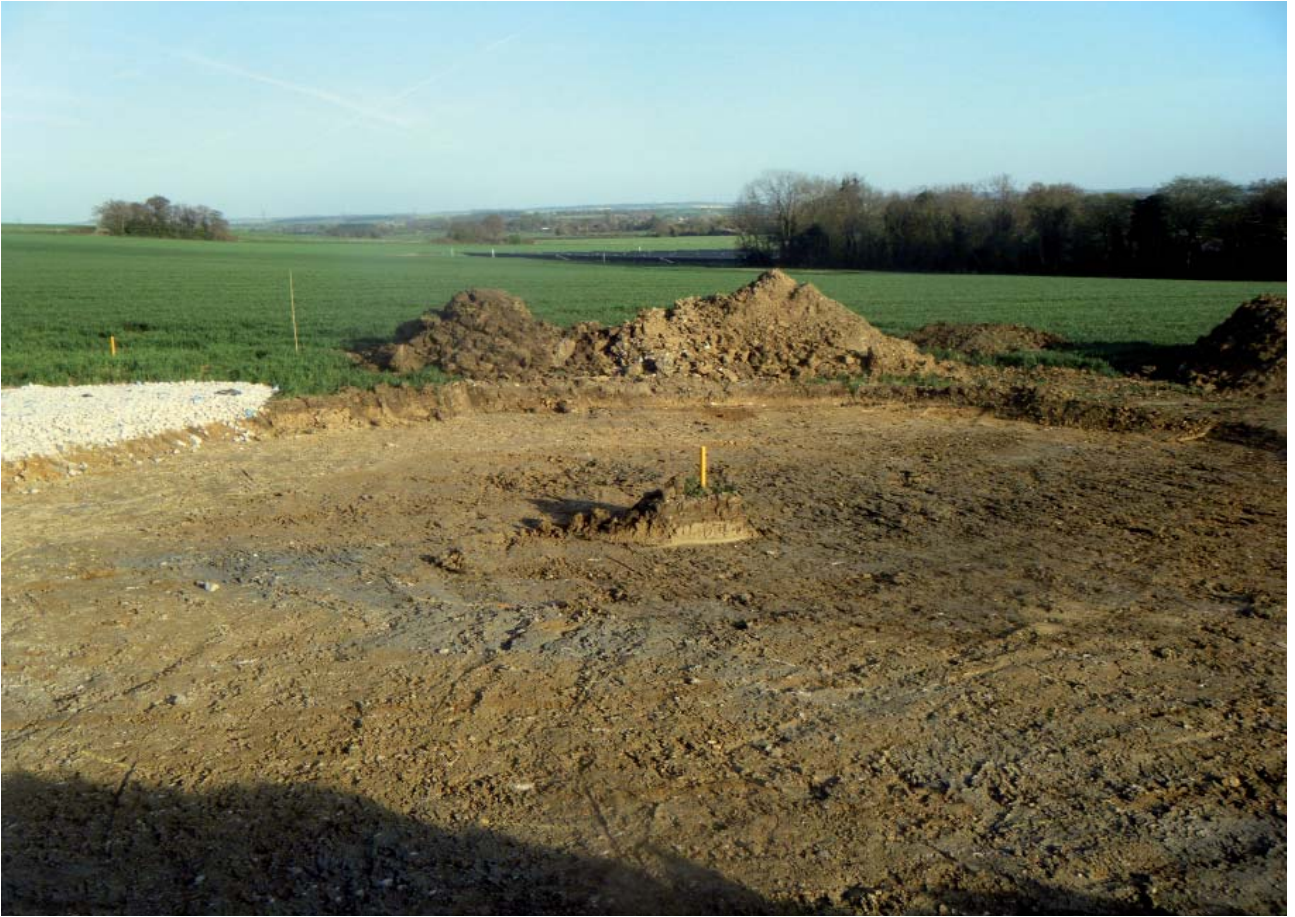
ILLUS 4

Photo showing stripped turbine base

The stratigraphy generally comprised the topsoil (102) / (108) / (110) – a dark grey silty-sandy-clay with gravel, flints, and stones, approximately 0.2-0.4m in thickness. Some finds, including metal and pottery dated to the 19th century onwards, were recovered from the topsoil. This overlay the subsoil (103) / (109) – an orange-brown sandy-clay with frequent flints and gravels and occasional chalk, ironstone, and limestone fragments, between 0.2 and 0.4m in thickness. Two fragments of sheep humerus were recovered from the subsoil. There was also evidence for ploughing within the subsoil. This overlay the natural geological deposit (104) / (107) – a grey-brown clay, observed at around 0.5m beneath the present ground-surface. Variations in the natural geological deposit were observed, with (111), exposed at the southern and eastern edges of the turbine base, a compact light red-brown sandy-clay, thought to be an outcropping of the bedrock.

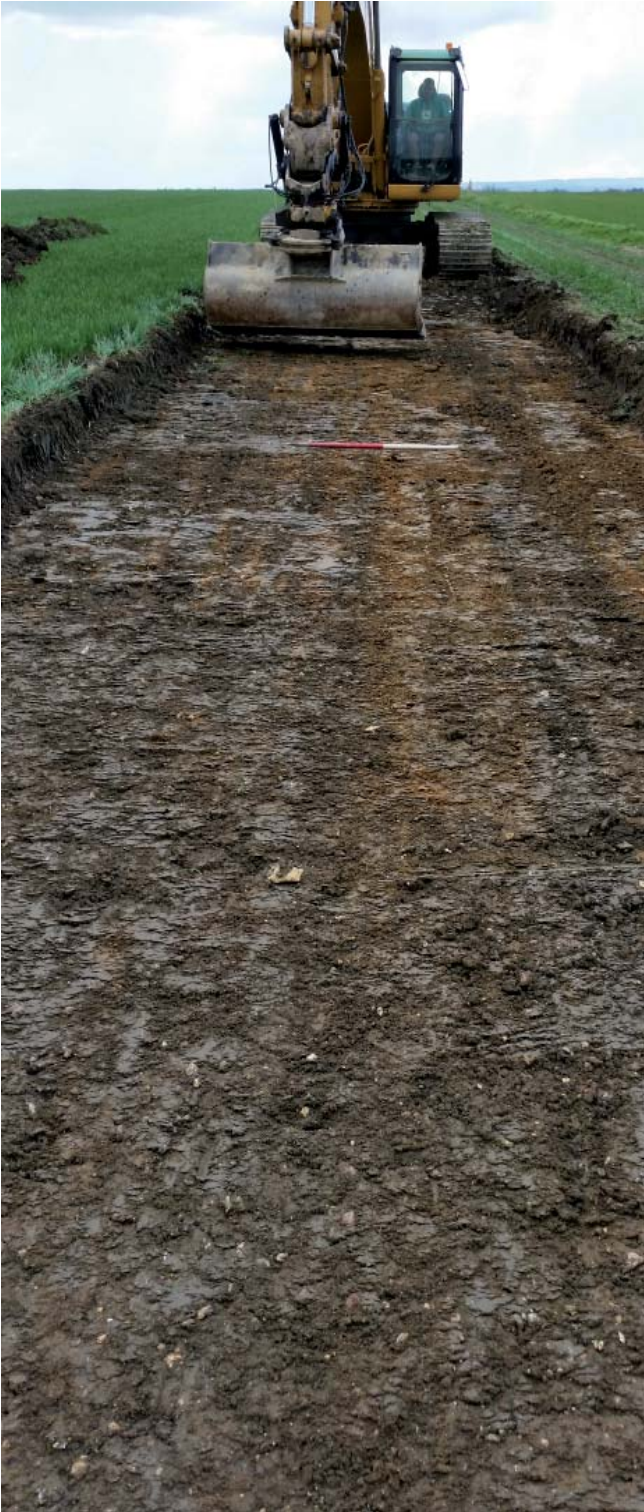
ILLUS 5

Photo showing stripping of trackway

An area of modern made-ground, (101), was observed in the area the topsoil stripping of the trackway, in the area around the gateway. This comprised a dark grey-brown silty-loam with frequent stones and rubble, and was 0.2m in thickness. It is presumed that this originated from the construction of Edworth Road.

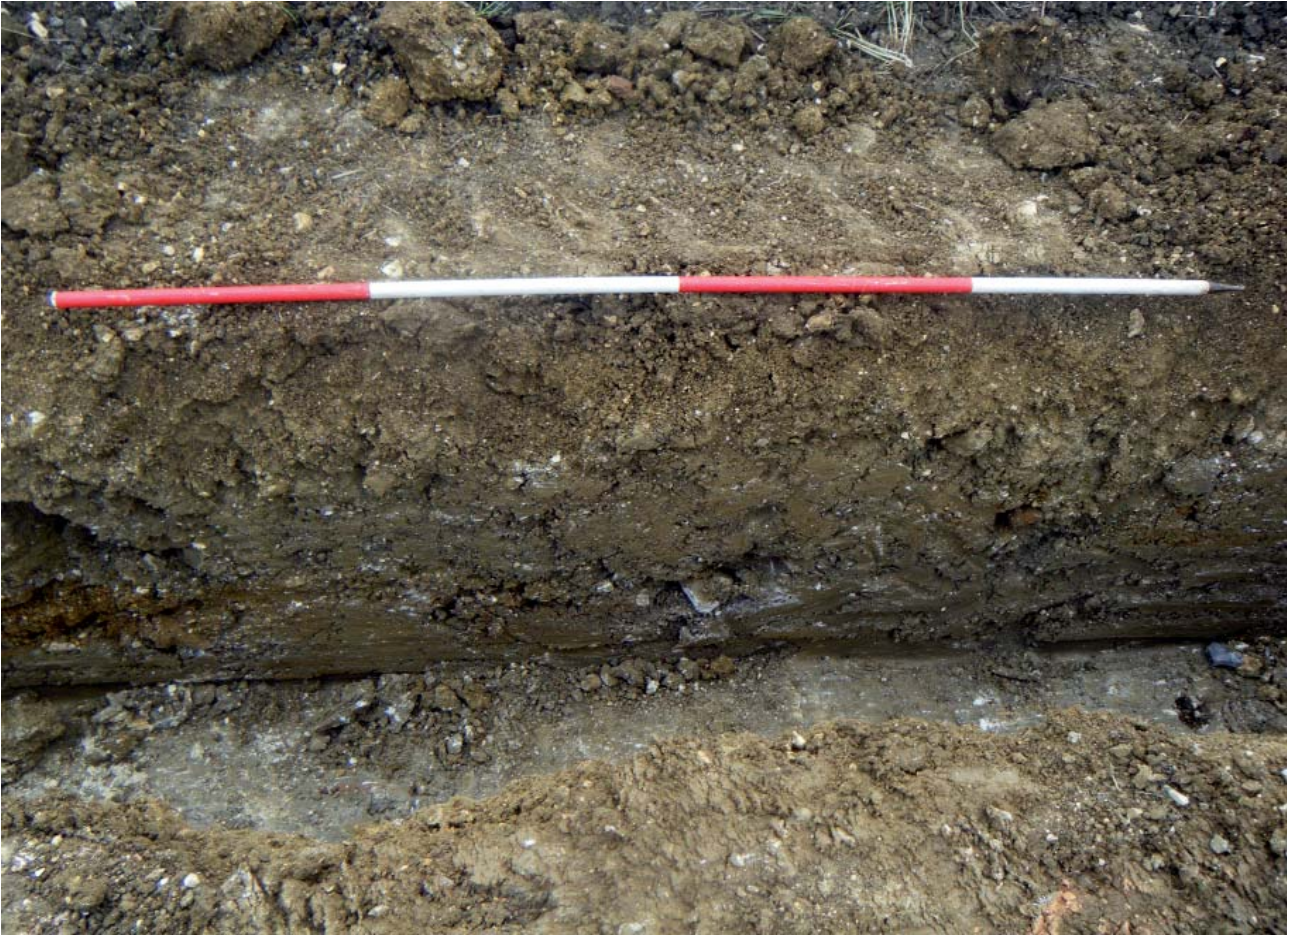
ILLUS 6

Photo showing alluvial deposits in cable trench

Alluvial deposits were observed in the cable trench towards the southern part of the DA: (113) / (114) / (115) / (116). These comprised a mixture of stiff orange-brown clay and blue-grey clay, with infrequent small stones. These were observed down the slope in the lowest part of the DA.
