LAND AT THE HILL, HARLOW, ESSEX

Evaluation Report

HW/PL/14/00037

August 2014

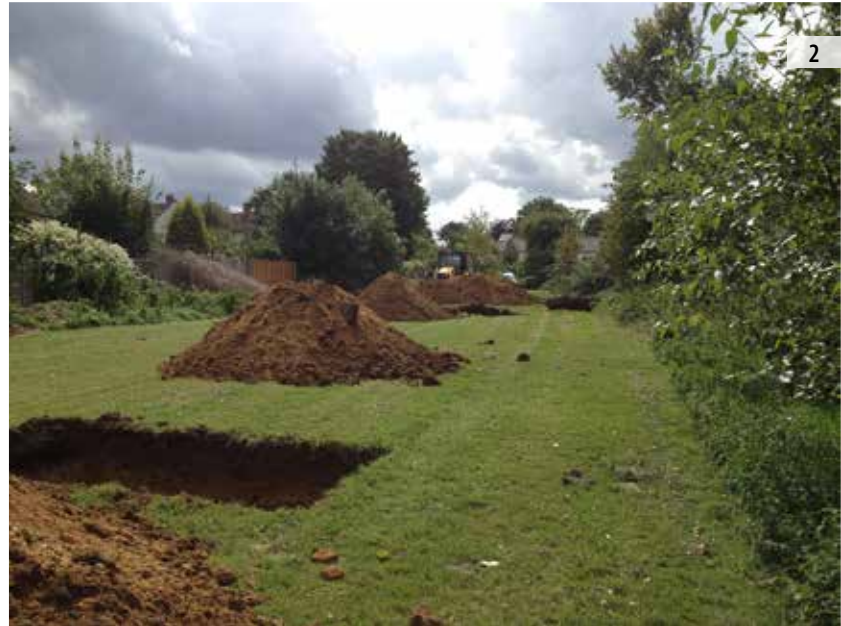
ILLUS 2

Photo showing the site with excavated test pits, looking S

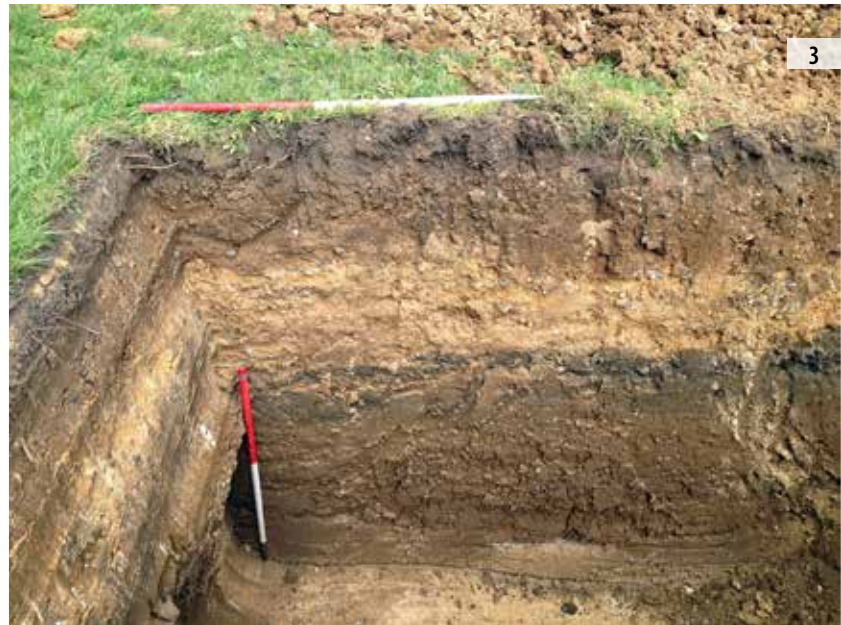
ILLUS 3

Modern levelling deposits were observed in all of the test pits directly beneath the concrete surface / turf and topsoil. This levelling deposit generally consisted of a compact brown / orange gravelly deposit, with some areas of black and grey clays. Small pieces of concrete and CBM were found within this deposit. The thickness of this deposit was between 0.25m (test pit 8) and 0.85m (test pit 6). Generally, thicker deposits were observed in the test pits on the western side of the DA (test pit 2, 4 and 6) – this is because of the natural sloping of the land down towards the west, such that greater quantities of fill material were needed to level the land.

A band of grey-brown silty deposit, between 0.1m and 0.3m in thickness, interpreted as the buried topsoil, was observed in the majority of the test-pits (except test pits 5 and 7). The levels at which this was found reflects the natural topography of the area (sloping down towards the west). It seems likely that the topsoil around test pits 5 and 7 (the south-eastern part of the DA) was stripped during the levelling works – this would have originally been the highest area within the DA, and so some preliminary work may have been done here before the importation of the fill material.

Beneath the buried topsoil was a thick deposit of light brown / orange silty-sand. The thickness of this varied from between 0.3m (test pit 3) to 1m+ (test pit 6). This is interpreted as the previous

S facing section of test pit 2

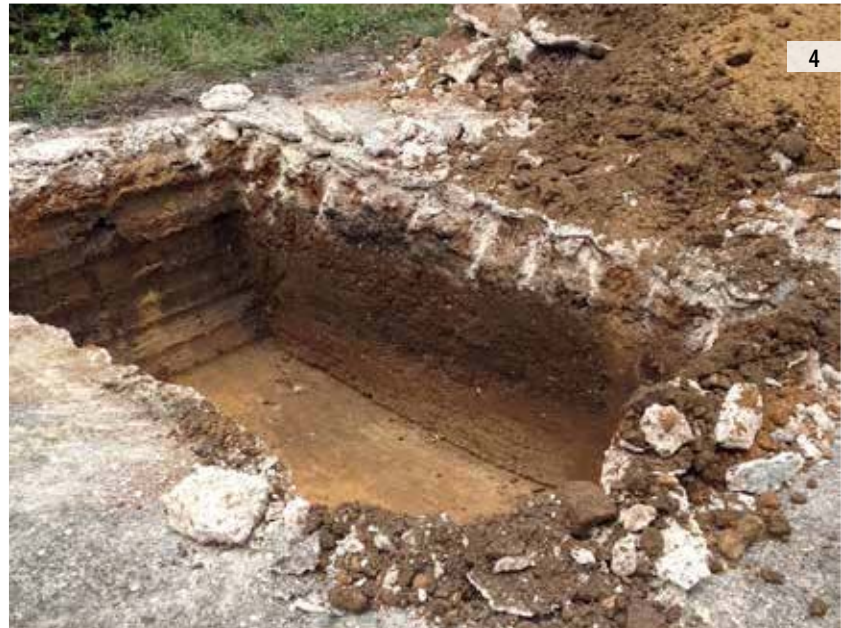
ILLUS 4

Photo of test pit 7, looking NW

subsoil, or potentially the upper levels of the Boulder Clay. Interestingly, this deposit was not observed in test pit 7, where the modern levelling deposits directly overlay the natural sand deposit – possibly the subsoil deposit was stripped away in this area during the 20th century ground remodelling.
