LAND OFF MILL ROAD, HERTFORD

Archaeological Evaluation

3/14/0590/FP

February 2015

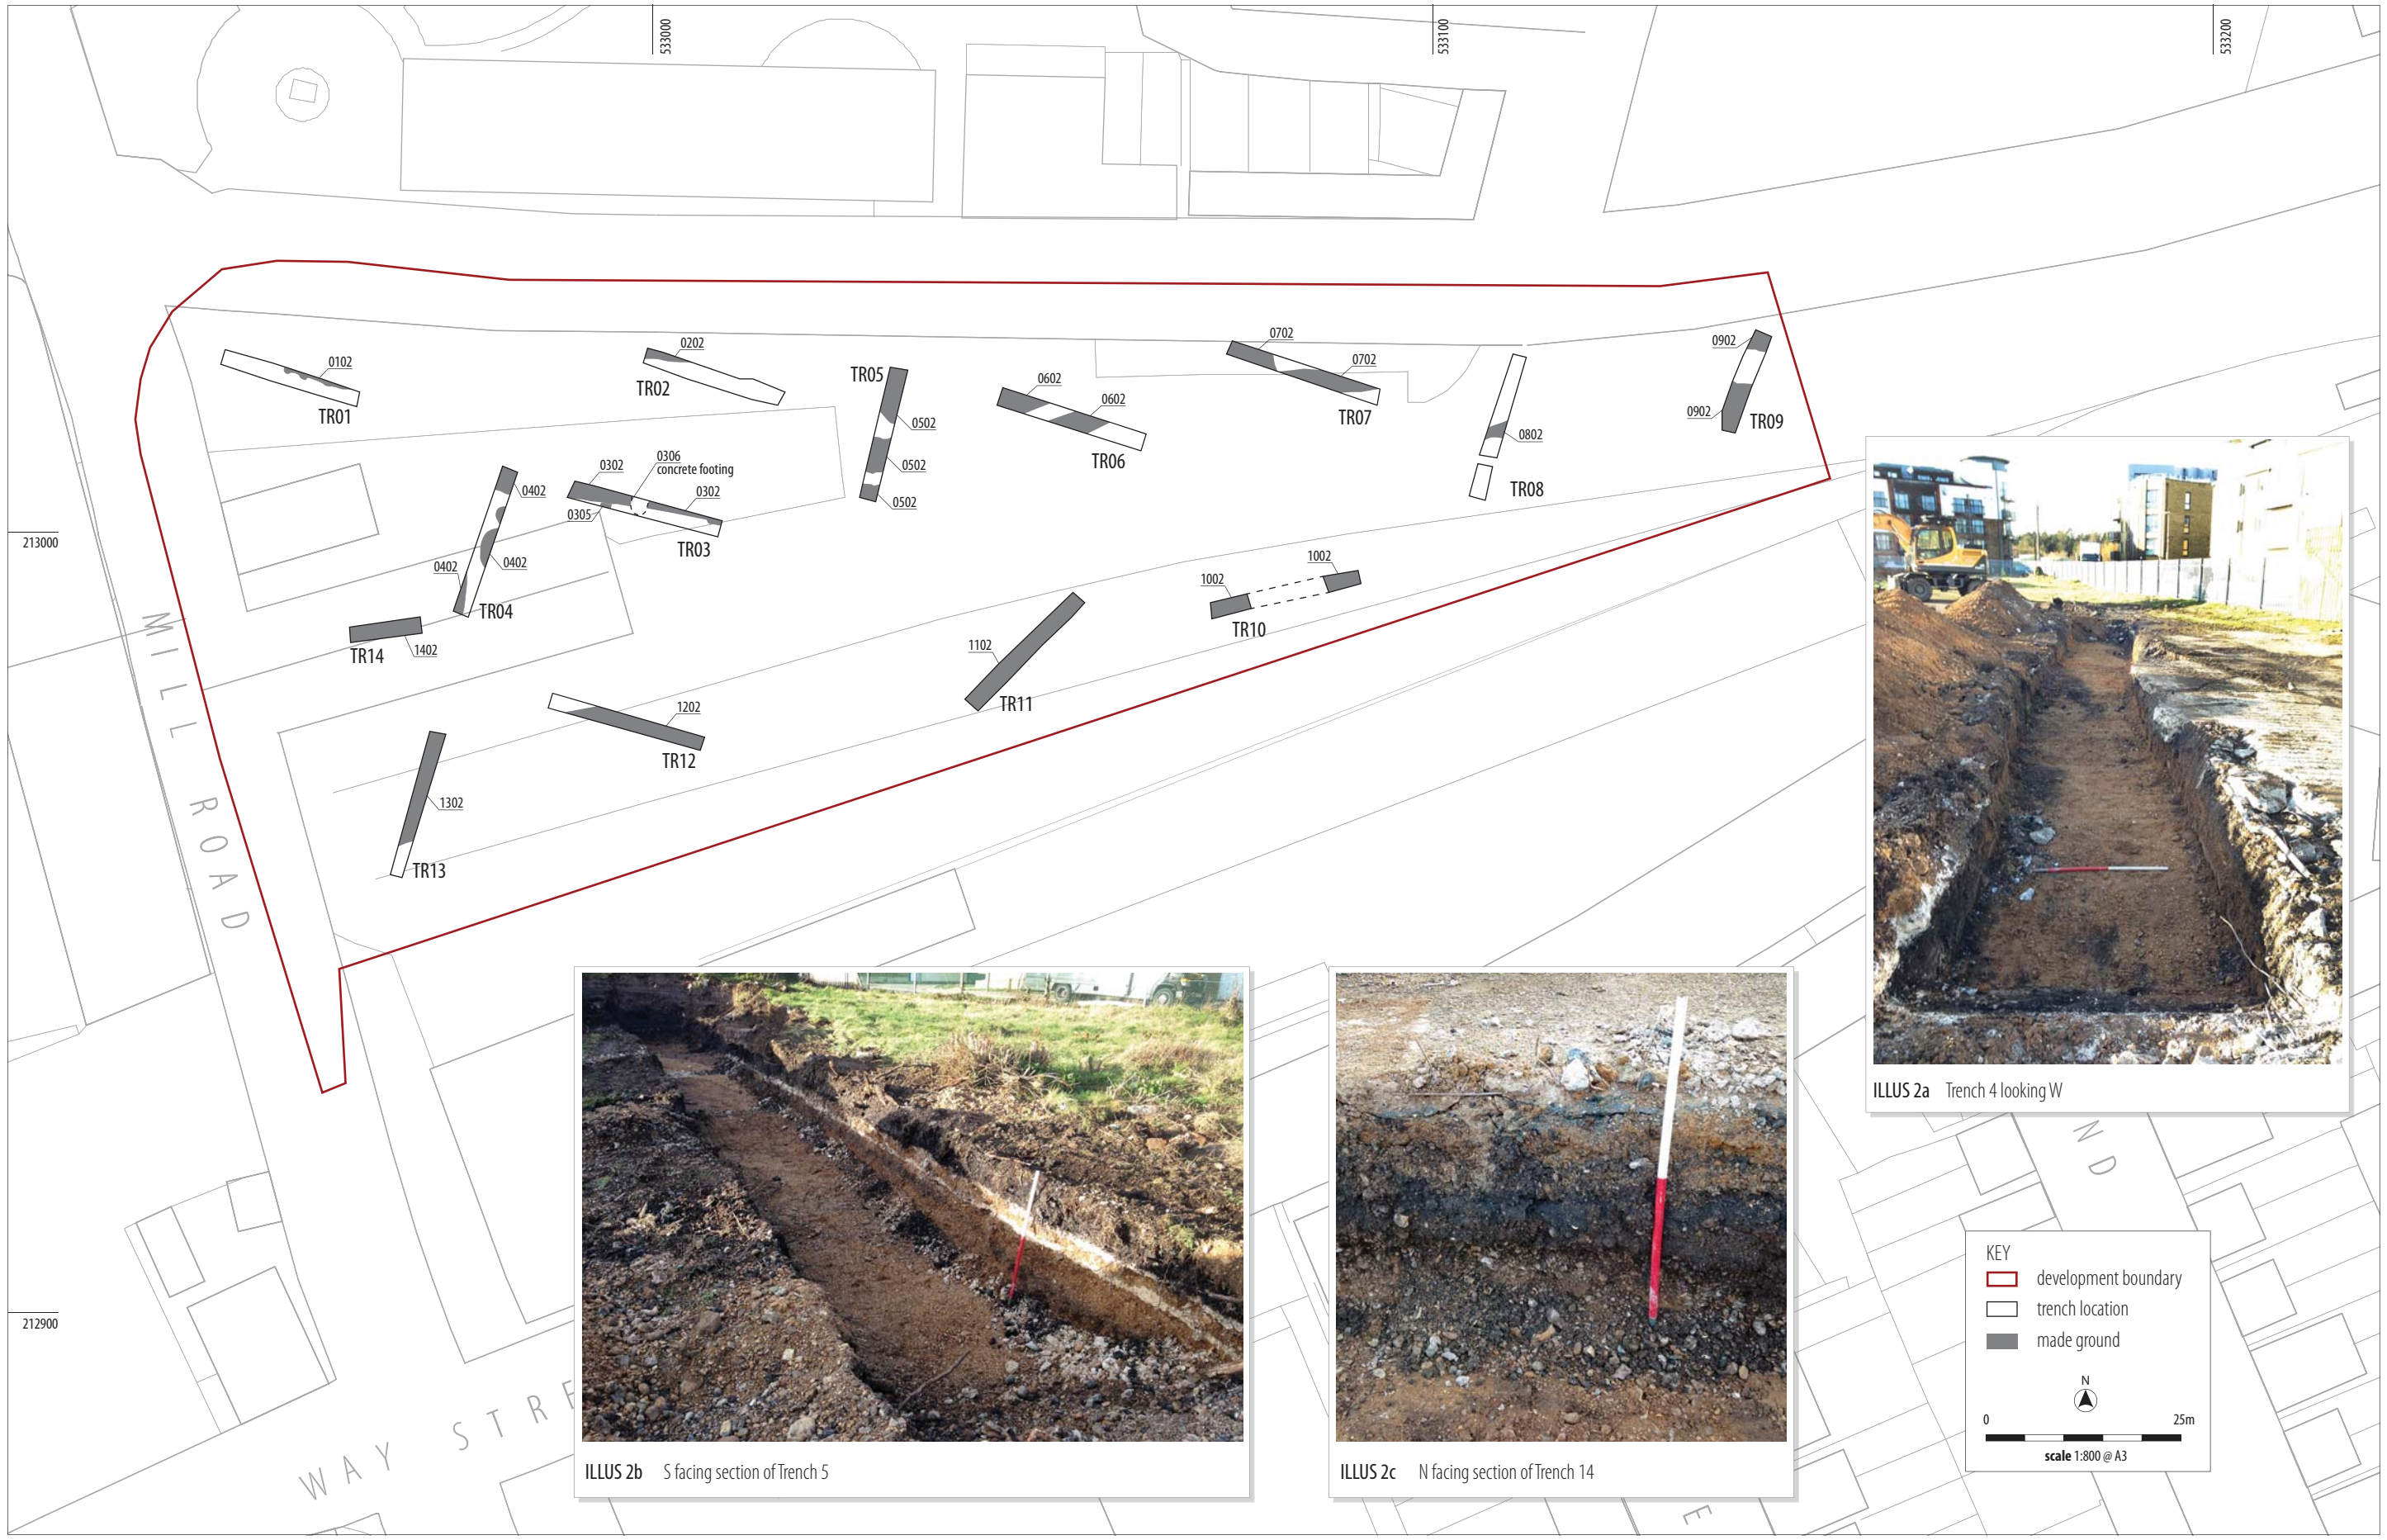
Undisturbed natural deposits were observed in places in all trenches. This generally comprised a yellow-orange-brown sandy-gravel, with patches of chalk and clay in places (the Kempton Park Gravels recorded on BGS). The level of the natural deposit varied, from between 0.5m beneath the present ground-surface to 1.2m beneath the present ground-surface. This was because of the differing thickness of made-ground observed across the site. It should also be noted that there were many areas where the natural deposit was not observed, with patches of modern made-ground (representing pits, railway sidings, and other modern intrusions) being cut through the natural deposit.

No subsoil was observed in any of the trenches across the DA (it has been removed as part of the modern development of the site). Instead, made-ground was found in all trenches directly beneath the topsoil. This comprised a mixture of deposits, mainly sandy-gravels and clay-silts, but with some flecks of chalk. Fragments of CBM and plaster were recorded in places. The depths of these made-ground deposits varied from 0.1 to 0.95m thick, with no apparent patterning in where the thicker deposits of made-ground were found across the DA. It is thought that these made-ground deposits were used for the modern levelling the site (potentially after the removal of the railway).

In some trenches there were obvious cuts, filled with made-ground deposits, through the natural. For example, in Trench 2 there was a linear cut at the northern end of the trench; made-ground infilled a cut along the northern part of Trench 3; Trench 6 had two parallel bands of made-ground; Trench 7 had a single band infilled with made-ground; and Trench 8 had a cut along the centre of the trench filled with made-ground deposits. It is thought that these may represent the railway sidings shown on the 1898 OS map (CgMs 2014, Figure 7), particularly as the cuts were aligned broadly northeast to southwest. The fact that the two bands in Trench 6 were parallel to each other supports this interpretation further.

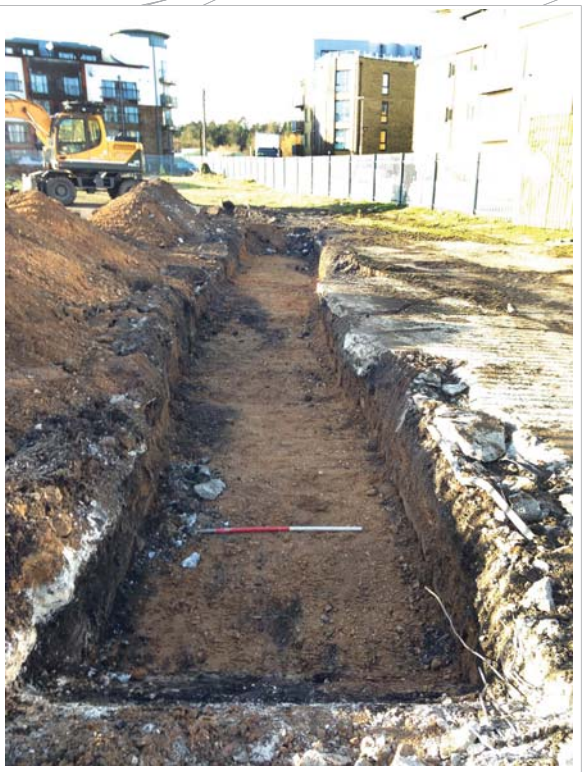
ILLUS 2a Trench 4 looking W

These made-ground deposits were observed cutting into the natural deposit in the base of all of the trenches. In some cases, this was in the form of irregularly-shaped pits / pockets (e.g. Trench 1, 4, 5, and 7). In other cases, the majority of the base of the trench consisted of made-ground deposits, with the natural deposit essentially just poking through (Trenches 9–14). In Trench 3 a concrete footing was recorded in the centre of the trench at the level of the natural deposit. This is all associated with the modern landscaping and activity associated with the late 19th–20th century railway.

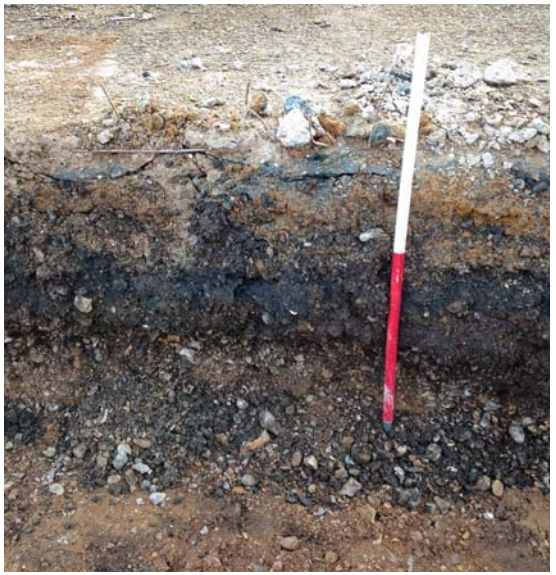
ILLUS 2c N facing section of Trench 14

A modern concrete surface, with underlying make-up layer, was observed in Trenches 2, 3, 4, and 14 – the north-western part of the DA (where the former Speedy Hire office and car-park were located). The concrete surface was between 0.13 and 0.25m thick, with the underlying make-up layer being between 0.05 and 0.25m thick. Trenches 5 and 12 had a demolition spread covering their surfaces, (dark orange-brown silt with concrete slabs in), 0.3–0.55m thick. These trenches were positioned towards the edges of the modern concrete area, and so are presumably associated with this in some way. Trenches were positioned over the locations of previous railway tracks, such as those in the southern part of the site shown on the 1898 OS Map, however these had been removed by the time of the evaluation. They were, however, visible as linear earthworks (see [ILLUS 4](#)).

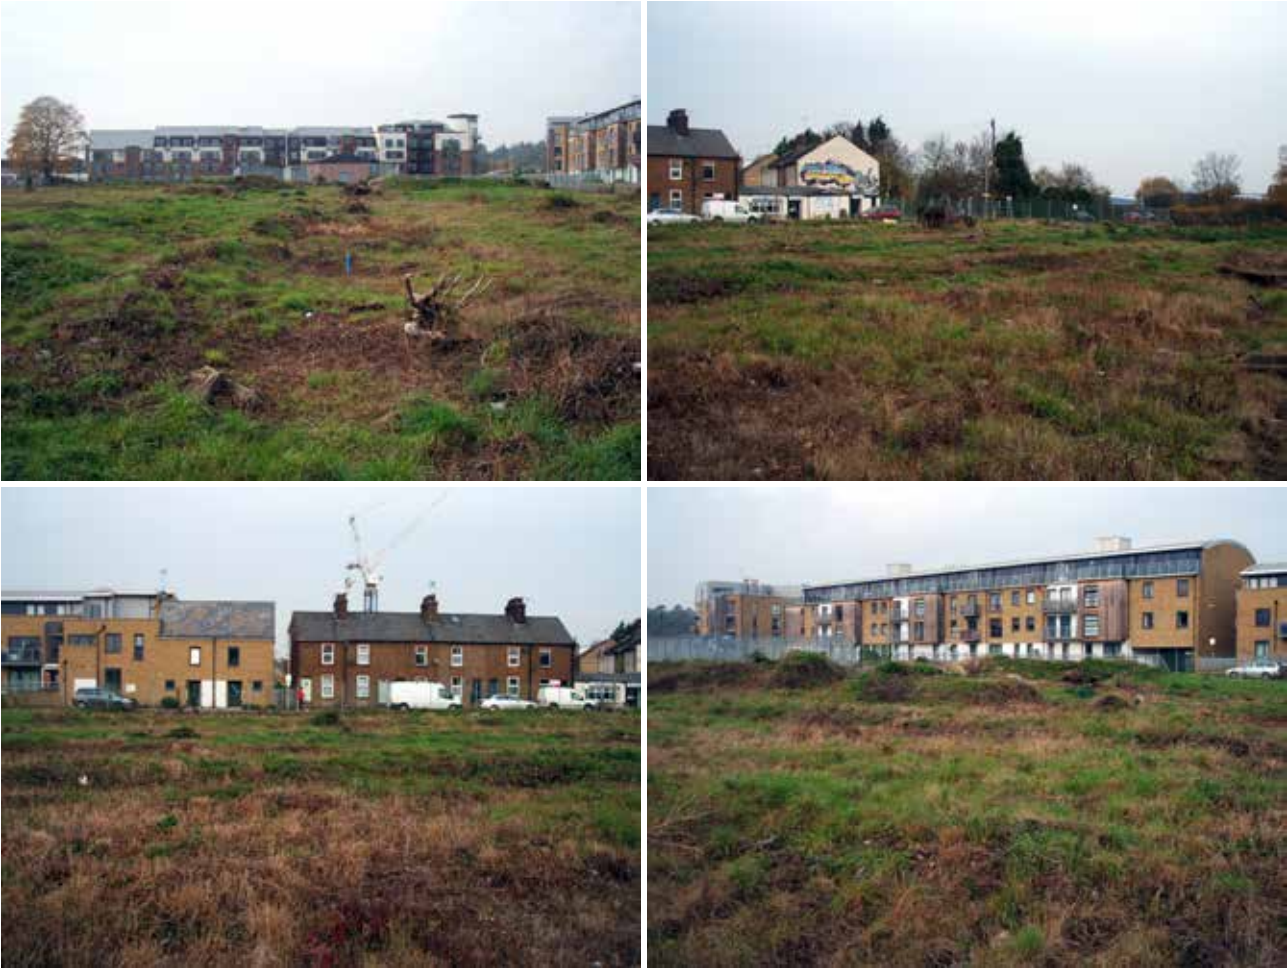
ILLUS 4

Photographs of the linear earthworks, previous trackbeds, in the southern part of the site

HA1 consists of the remains directly associated with the later 20th century railway which ran across the northern part of the DA. The remains of railway sidings depicted on the 1898 OS Map (CgMs 2014, Figure 7), survived as linear cuts through the natural deposit, infilled with made-ground deposits, in some trenches. This is considered to have negligible archaeological significance.
