LAND AT WESTINGHOUSE SPORTS GROUND, CHIPPENHAM

Archaeological Evaluation

commissioned by The Environmental Dimension Partnership
on behalf of Linden Homes Ltd

January 2015

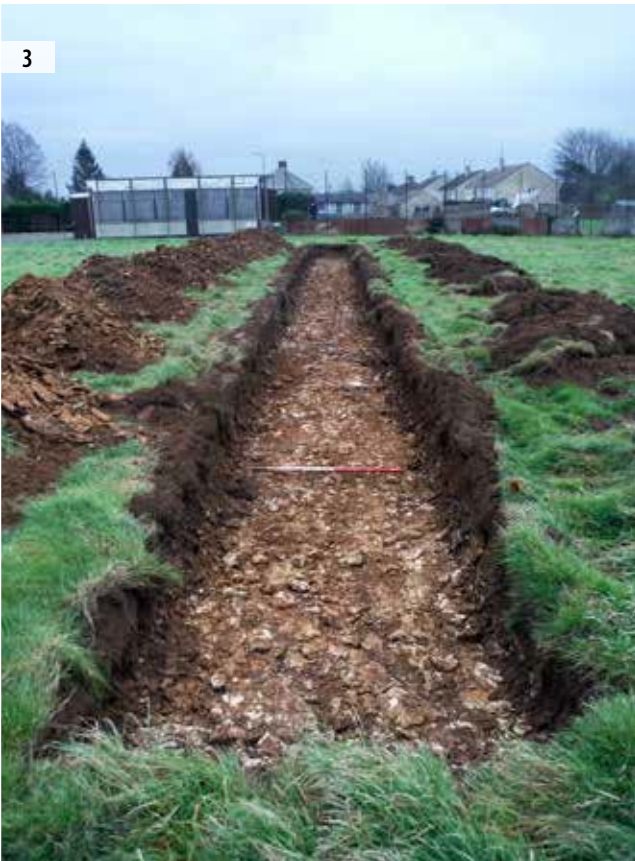
ILLUS 3

Photo showing the geological deposit in Trench 4, looking SE

The geological horizon mainly comprised medium-large sub-angular / angular stones (part of the Great Oolite Group), set within an orange-grey-brown clayey-sand matrix. This was observed in Trenches 1, 4, 5, and 6, at between 0.3 and 0.6m beneath the ground-surface (the differences being accounted for by modern landscaping changes, as with Trench 6, see discussion below). Further excavation in Trench 1 revealed solid rock at around 0.8m beneath the present ground-surface.

401	Topsoil – dark grey-brown, silty-sand, loose, very occasional small stones, rooting.	0.0-0.2
402	Subsoil – mid orange-brown, clayey-sand, loose, very frequent sub-angular / angular stones.	0.2-0.3
403	Undisturbed geology – medium-large sub-angular / angular stones, within a loose orange / grey-brown clayey-sand.	0.3-0.45
404	Undisturbed geology – compact rock.	0.45+

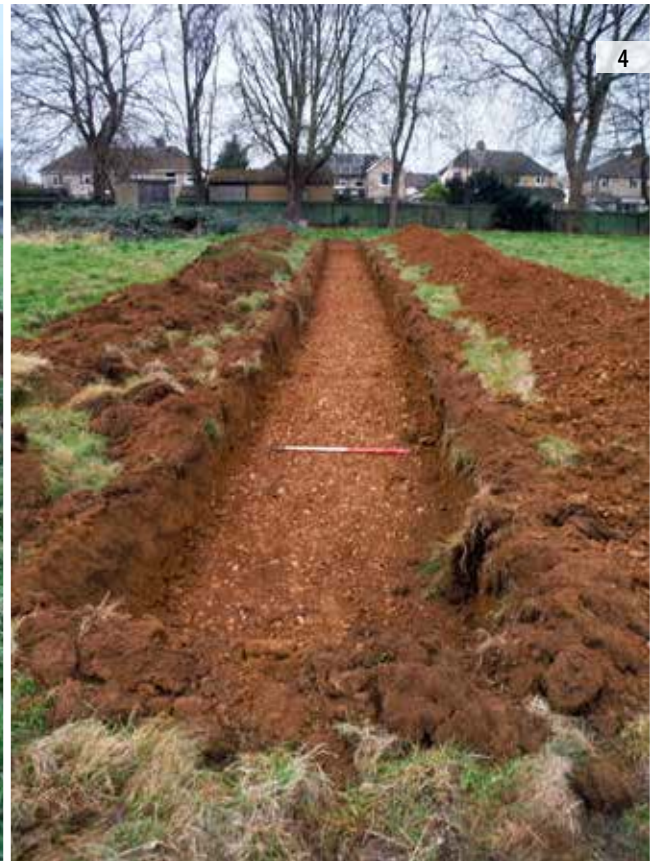
ILLUS 4

Photo showing the geological deposit in Trench 2, looking NW

The geological material in Trenches 2 and 3 was slightly different. In Trench 2, it consisted of a firm orange-brown clayey-sand with frequent pieces of small gravel. This deposit was also observed towards the north-eastern end of Trench 3. Elsewhere in Trench 3, the geology comprised a yellow-brown silty-clay, with some friable sandy patches. Deeper excavation into these two different types of deposit in Trench 3 revealed a yellow silty-sandy-clay, at around 0.8m beneath the present ground-surface.

201	Topsoil – dark grey-brown, silty-sand, loose, very occasional small stones, rooting.	0.0-0.15
202	Subsoil – light brown-orange, clayey-sand, loose, very occasional small stones.	0.15-0.35
203	Undisturbed geology – mid orange / red-brown, clayey-sand, firm, frequent small / medium gravel pieces.	0.35+

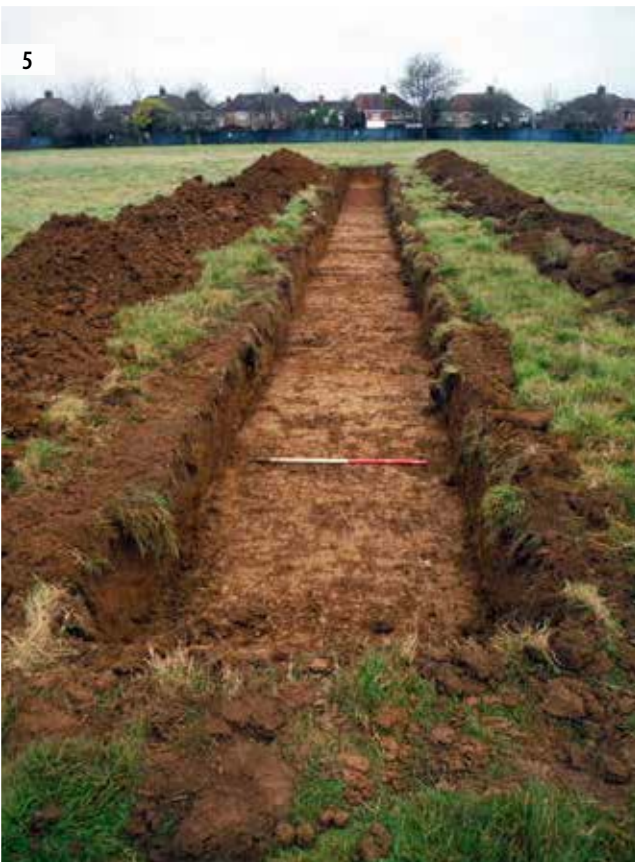
ILLUS 5

Photo showing the geological deposit in the southwestern part of Trench 3, looking NE

301	Topsoil – dark grey-brown, silty-sand, loose, very occasional small stones, rooting.	0.0-0.25
302	Subsoil – light brown-orange, clayey-sand, loose, very occasional small stones.	0.25-0.55
303	Undisturbed geology – light orange-brown, silty-clay, compact, occasional friable sandy patches. Different at north-eastern end of trench: red-brown, sandy-clay, firm, frequent small gravel pieces.	0.55-0.8
304	Undisturbed geology – yellow, silty-sandy-clay, compact.	0.8+

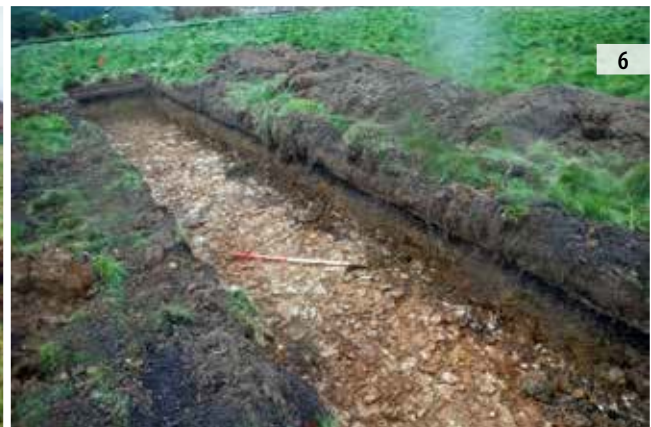
ILLUS 6

Photo showing section in Trench 6 looking SW and showing the previous surface in section

The exception to this was Trench 6, where evidence for a previous surface (potentially for a tennis court or similar) was observed. This lay directly under the topsoil and consisted of a black tarmac / hard-core layer (0.08m thick), overlying a dirty yellow silty-clay make-up deposit (0.2m thick). The subsoil deposit (the same as in other trenches across the site), was observed under this.

601	Topsoil – dark grey-brown, silty-sand, loose, rooting.	0.0-0.25m
602	Previous surface – black, compact, pieces of tarmac and hard-core.	0.25-0.33
603	Make-up for previous surface – yellow, dirty, silty-clay, compact, with patches of dirty grey clay.	0.33-0.53
604	Subsoil – orange-brown, clayey-sand, loose, frequent small-medium stones.	0.53-0.65
605	Undisturbed geology – medium-large sub-angular / angular stones, within a loose orange / grey-brown clayey-sand.	0.65+
