The former St Luke's Hospital, Woodside Avenue, Muswell Hill

Archaeological Evaluation Report

**Archaeological Evaluation on land at the former St Luke's Hospital,
Woodside Avenue, Muswell Hill**

Evaluation Report

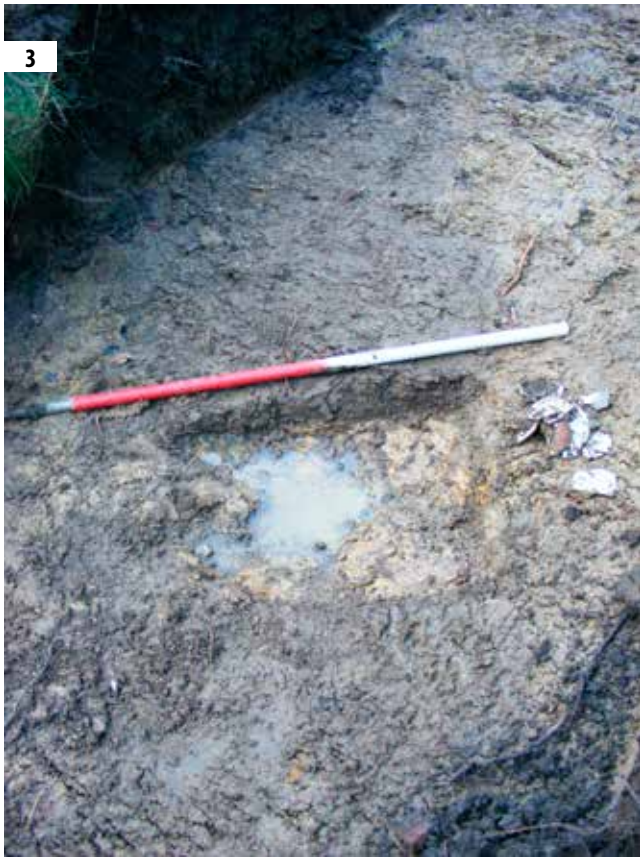
ILLUS 3

Photo of ditch [0703], looking N

Two shallow truncated ditches were observed in Trenches 5 and 7. The ditch in Trench 5, [0505], was aligned northeast to southwest, had a U-shaped profile and irregular sides, and measured 1m in width by 0.4m in depth. In Trench 7, [0703], was aligned north-south, had irregular sides and an irregular base, and measured 0.5m in length by 0.08m in depth. Both had single fills with post-medieval / modern pottery, clay-pipe, and glass and they would have functioned as agricultural field boundaries or drainage ditches.

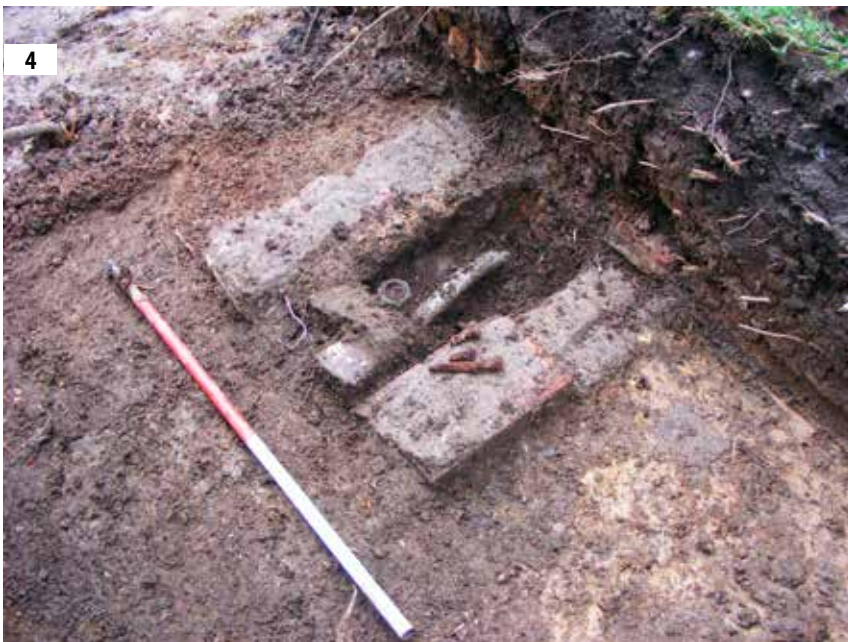
ILLUS 4

Photo of brick-structure [1205], looking NW

A rectangular brick-built structure with a 1-inch lead water-pipe was observed towards the southern end of Trench 12. The bricks measured 0.22m by 0.11m by 0.7m, were bonded with a hard mortar, and formed a structure measuring approximately 0.8m by 0.6m by 0.7m in depth. It is notable that these bricks are similar in type to those observed within 'Norton Lees'. The 1-inch lead water-pipe was positioned within this rectangular brick structure and appeared to project upwards with some sort of opening / spout. This structure was cut through the buried soil horizon (1202), which is thought to have formed part of the garden soil of the late 19th century gardens. It is therefore thought that this may have formed a water feature, possibly a fountain or similar, positioned within the gardens of Norton Lees. Finds recovered from the fill of this feature included modern pottery, CBM, and iron pieces, which were broadly dated c.1800 to the present, fitting with the interpretation of them as part of the late 19th century houses.

Other finds include a clay pipe stem, bottle and window glass sherds. These also appear to be of 19th century or later date. A large iron strap and three bolts found in brick structure [1205] are probably structural fittings relating to the construction, repair or use of this structure. There were also a number of fragments of various ceramic building materials scattered through several features. The size of these precludes fine dating.

1205	12	Rectangular brick-built structure, bonded with mortar, and with a 1inch water-pipe within it. Bricks measure 0.22m by 0.11m by 0.7m, and are similar to those in Norton Lees. Mortar is hard with black charcoal inclusions. Cut through buried soil horizon (1202); natural (1206) observed under it. Possible water feature associated with Norton Lees.	0.8m X 0.6m X 0.7m.
1206	12	Mouldable buff sandy-clay. London Clay deposit.	0.65m+
1301	13	Dark brown silty-clay with stones and brick. Turf and topsoil.	0-0.3m
1302	13	Mouldable buff sandy-clay. London Clay deposit.	0.3m+

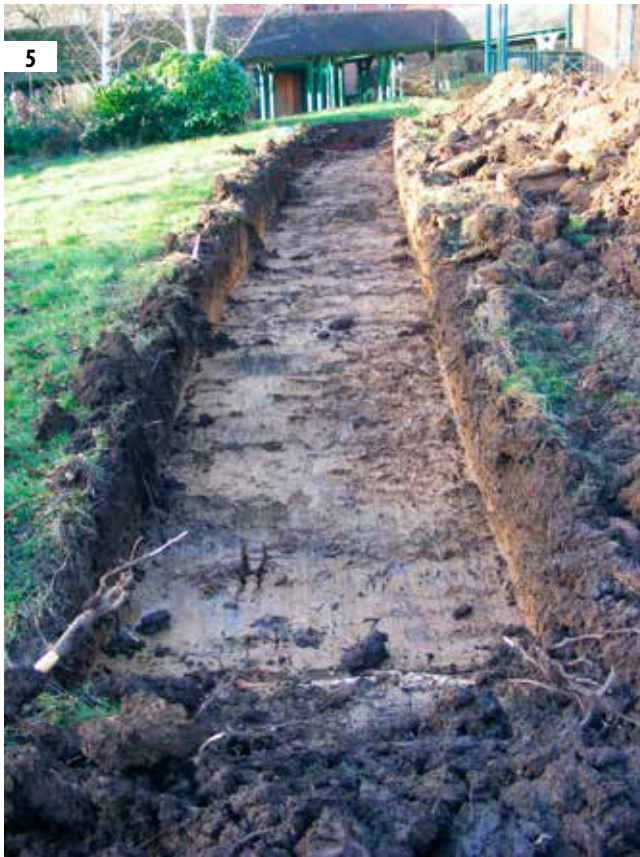
ILLUS 5

Photo of Trench 6, looking W and showing the natural clay deposit

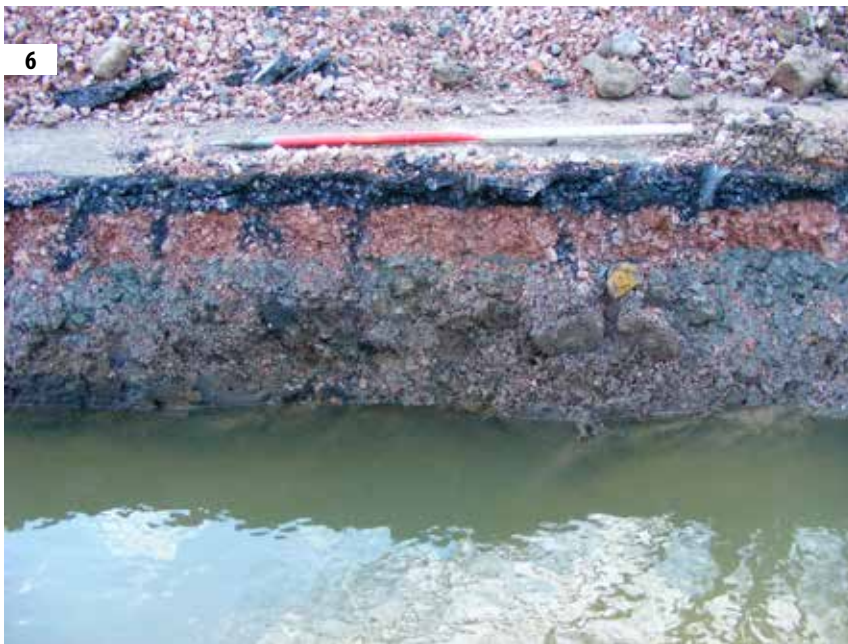
ILLUS 6

Photo of section in Trench 1, looking S and showing the modern made-ground and construction deposits

Three sets of concrete foundations were observed in Trench 1. Two of these, [0104] and [0105], were aligned north-south towards the western end of the trench and were positioned approximately 6m apart. The third, [0106], was aligned broadly east-west, ran into the section to the west and terminated at a line of red brickwork [0107] to the east. These were all underlain by a gravel and pea-grit layer thought to be a levelling layer for the foundations, and were overlain by mixed modern made-ground deposits. It is clear that these are modern foundations, associated with the 20th century development of the DA.
