# ACCESS ROAD, DUNSBURY HILL FARM, LEIGH PARK, HAMPSHIRE

## Archaeological Evaluation Report

commissioned by CgMs Consulting  
on behalf of Peter Brett Associates

February 2015

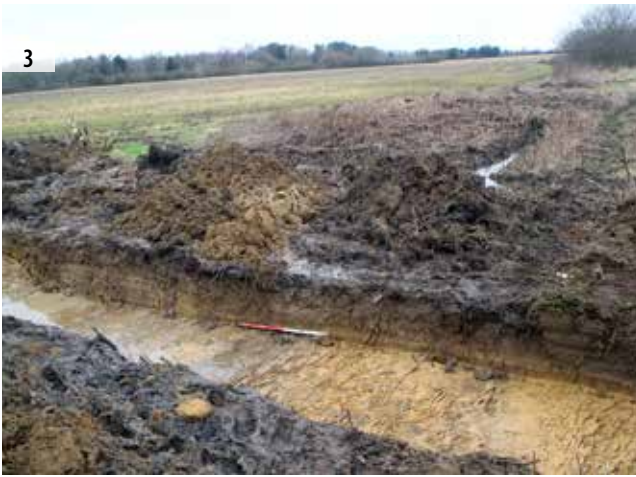
**ILLUS 3**

3.2.1 A north-south aligned ditch, with a gully either side of it, was observed in Trench 16 (Illus 2 and 3). The line of this was identified on the geophysical survey as a linear trend. The ditch, [1604], measured 1m in width, was cut through the subsoil, and contained a single firm grey silty-clay fill. The gullies, [1606] and [1608], measured between 0.28 and 0.3m in width and 0.08m in depth, were positioned 2–3m away from the central ditch, and also contained a single compact grey silty-clay fill. No finds were recovered from any of these features.

NW view of ditch [1604] and gullies [1606] and [1608] (hedgerow and adjacent drainage gullies) and showing the hedgerow

3.2.2 The ditch and adjacent gullies were on the line of a field boundary running to the north of Trench 16. This consisted of a large hedge, interspersed with trees, with drainage gullies on either side. The southern-most part of this, where Trench 16 crossed it, had been removed very recently (presumably in association with this development), as could be seen by the rough nature of this area with the remnants of recently-cut vegetation. This field boundary is of very recent date as it is not on the 1992 OS Map, however it is shown on 21st century google earth imaging.

3.2.3 The ditch and adjacent gullies identified in Trench 16 during this evaluation are the remains of this modern field boundary, with the central ditch being for the

hedge itself and the two adjacent gullies functioning as drainage gullies.

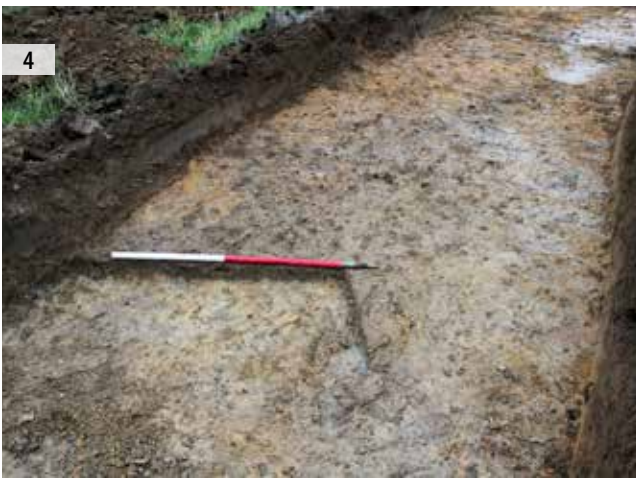
**ILLUS 4**

View of tree-throw [1705]

3.3.1 Two tree-throws were recorded in the eastern part of the DA (Illus 2 and 4). They fall within an area of ferrous responses on the geophysical survey, within an area with pit-like features. That in Trench 17 was excavated, [1705]. It measured 5m in length by at least 2m in width by 0.68m in depth. It was irregularly-shaped with a central bowl and three tangents branching off it, and contained a single orange-brown clayey-silt fill. The other, in Trench 19, was not excavated but measured at least 2m in length by 1.8m in width.

3.3.2 The presence of tree-throws across the DA demonstrates the point that this area was, at one point in the past, wooded. This may have been in the post-medieval period when the area consisted of a number of fields, with 20th century OS Maps depicting a number of individual trees in this area. However it is also possible that they are associated with the earlier landscape, potentially from the medieval period when the land was part of Bedhampton Park, or even earlier when the area was presumably broadly open.

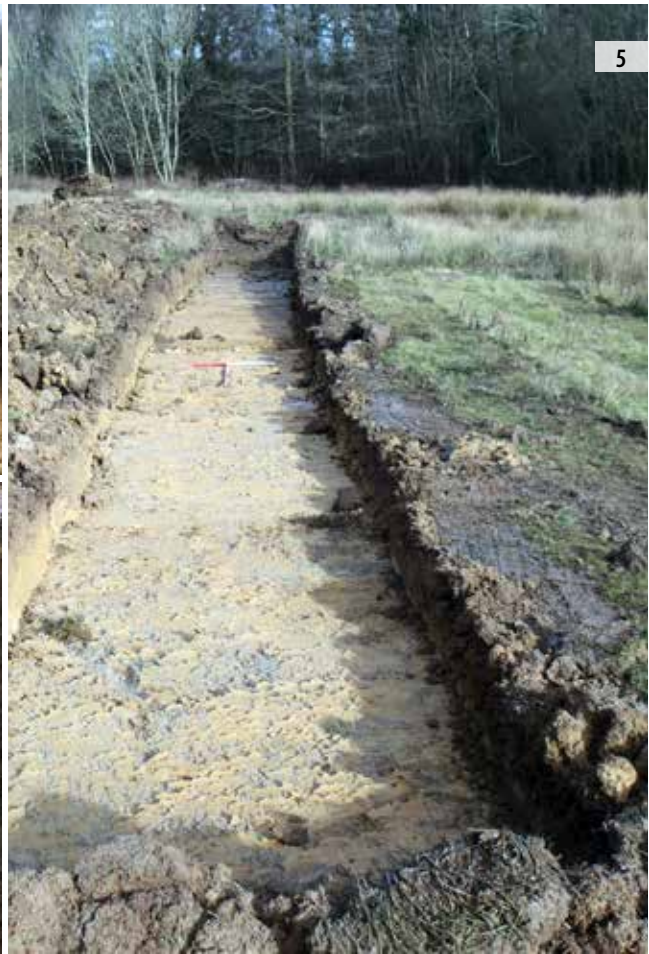
**ILLUS 5**

- 3.1.2 Undisturbed natural deposits comprised a compact yellow-brown silty-clay, with patches of grey clay, mottling, flints, iron panning, and rooting, in the western part of the DA (**Illus 5**). This is the London Clay deposit, and was generally observed between 0.2 and 0.4m beneath the ground-surface (between 17.6mOD and 22.75mOD). This deposit was observed at deeper depths where made-ground deposits were observed (0.55m beneath the ground-surface in Trench 6, 17.25mOD; and between 0.7 and 1.1m beneath the ground-surface in Trench 8, 17.1–17.5mOD). Natural sand deposits (yellow-orange-cream-brown sands) were observed in the trenches on the higher ground towards the centre of the DA (Trenches 13, 14, and 15 (**Illus 6**)). These were part of the Bagshot Sand Formation and were observed 0.4m beneath the modern ground-surface (26.1–26.6mOD). A yellow-grey sandy-clay deposit was observed in the trenches in the eastern part of the site, part of the head deposits overlying the Bagshot Sand. These were observed between 0.5 and 0.85m beneath the present ground-surface (around 26.5mOD).

View of Trench 5, showing natural silty-clay deposit

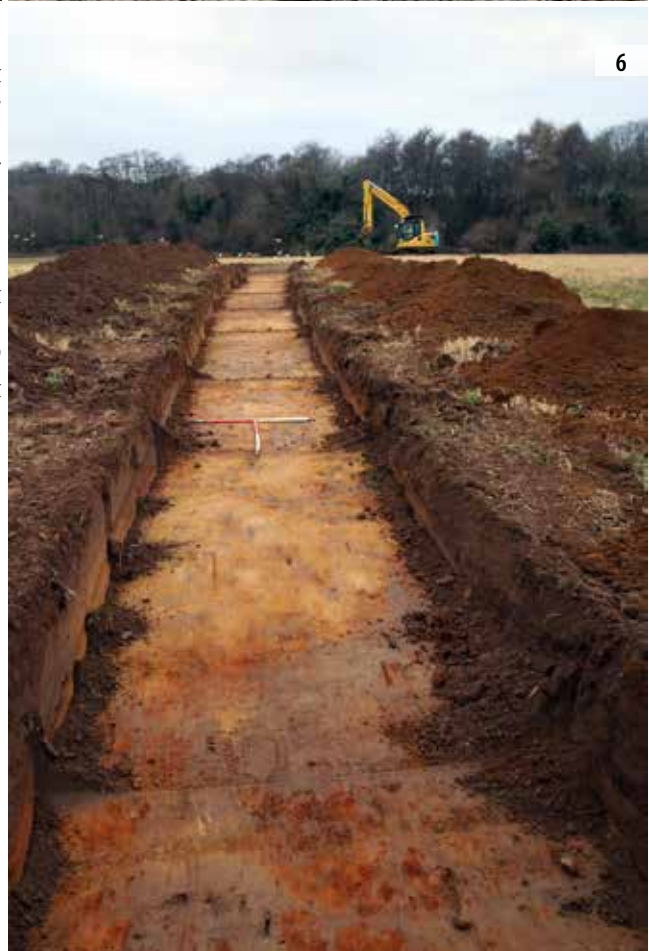
**ILLUS 6**

View of Trench 13, showing natural sand deposit
