## **Archaeological Watching Brief of site preparation works**

**Hornsey Gas Works, Haringey, Greater London**

**Archaeological Watching Brief of site preparation works  
at Hornsey Gas Works, Haringey**

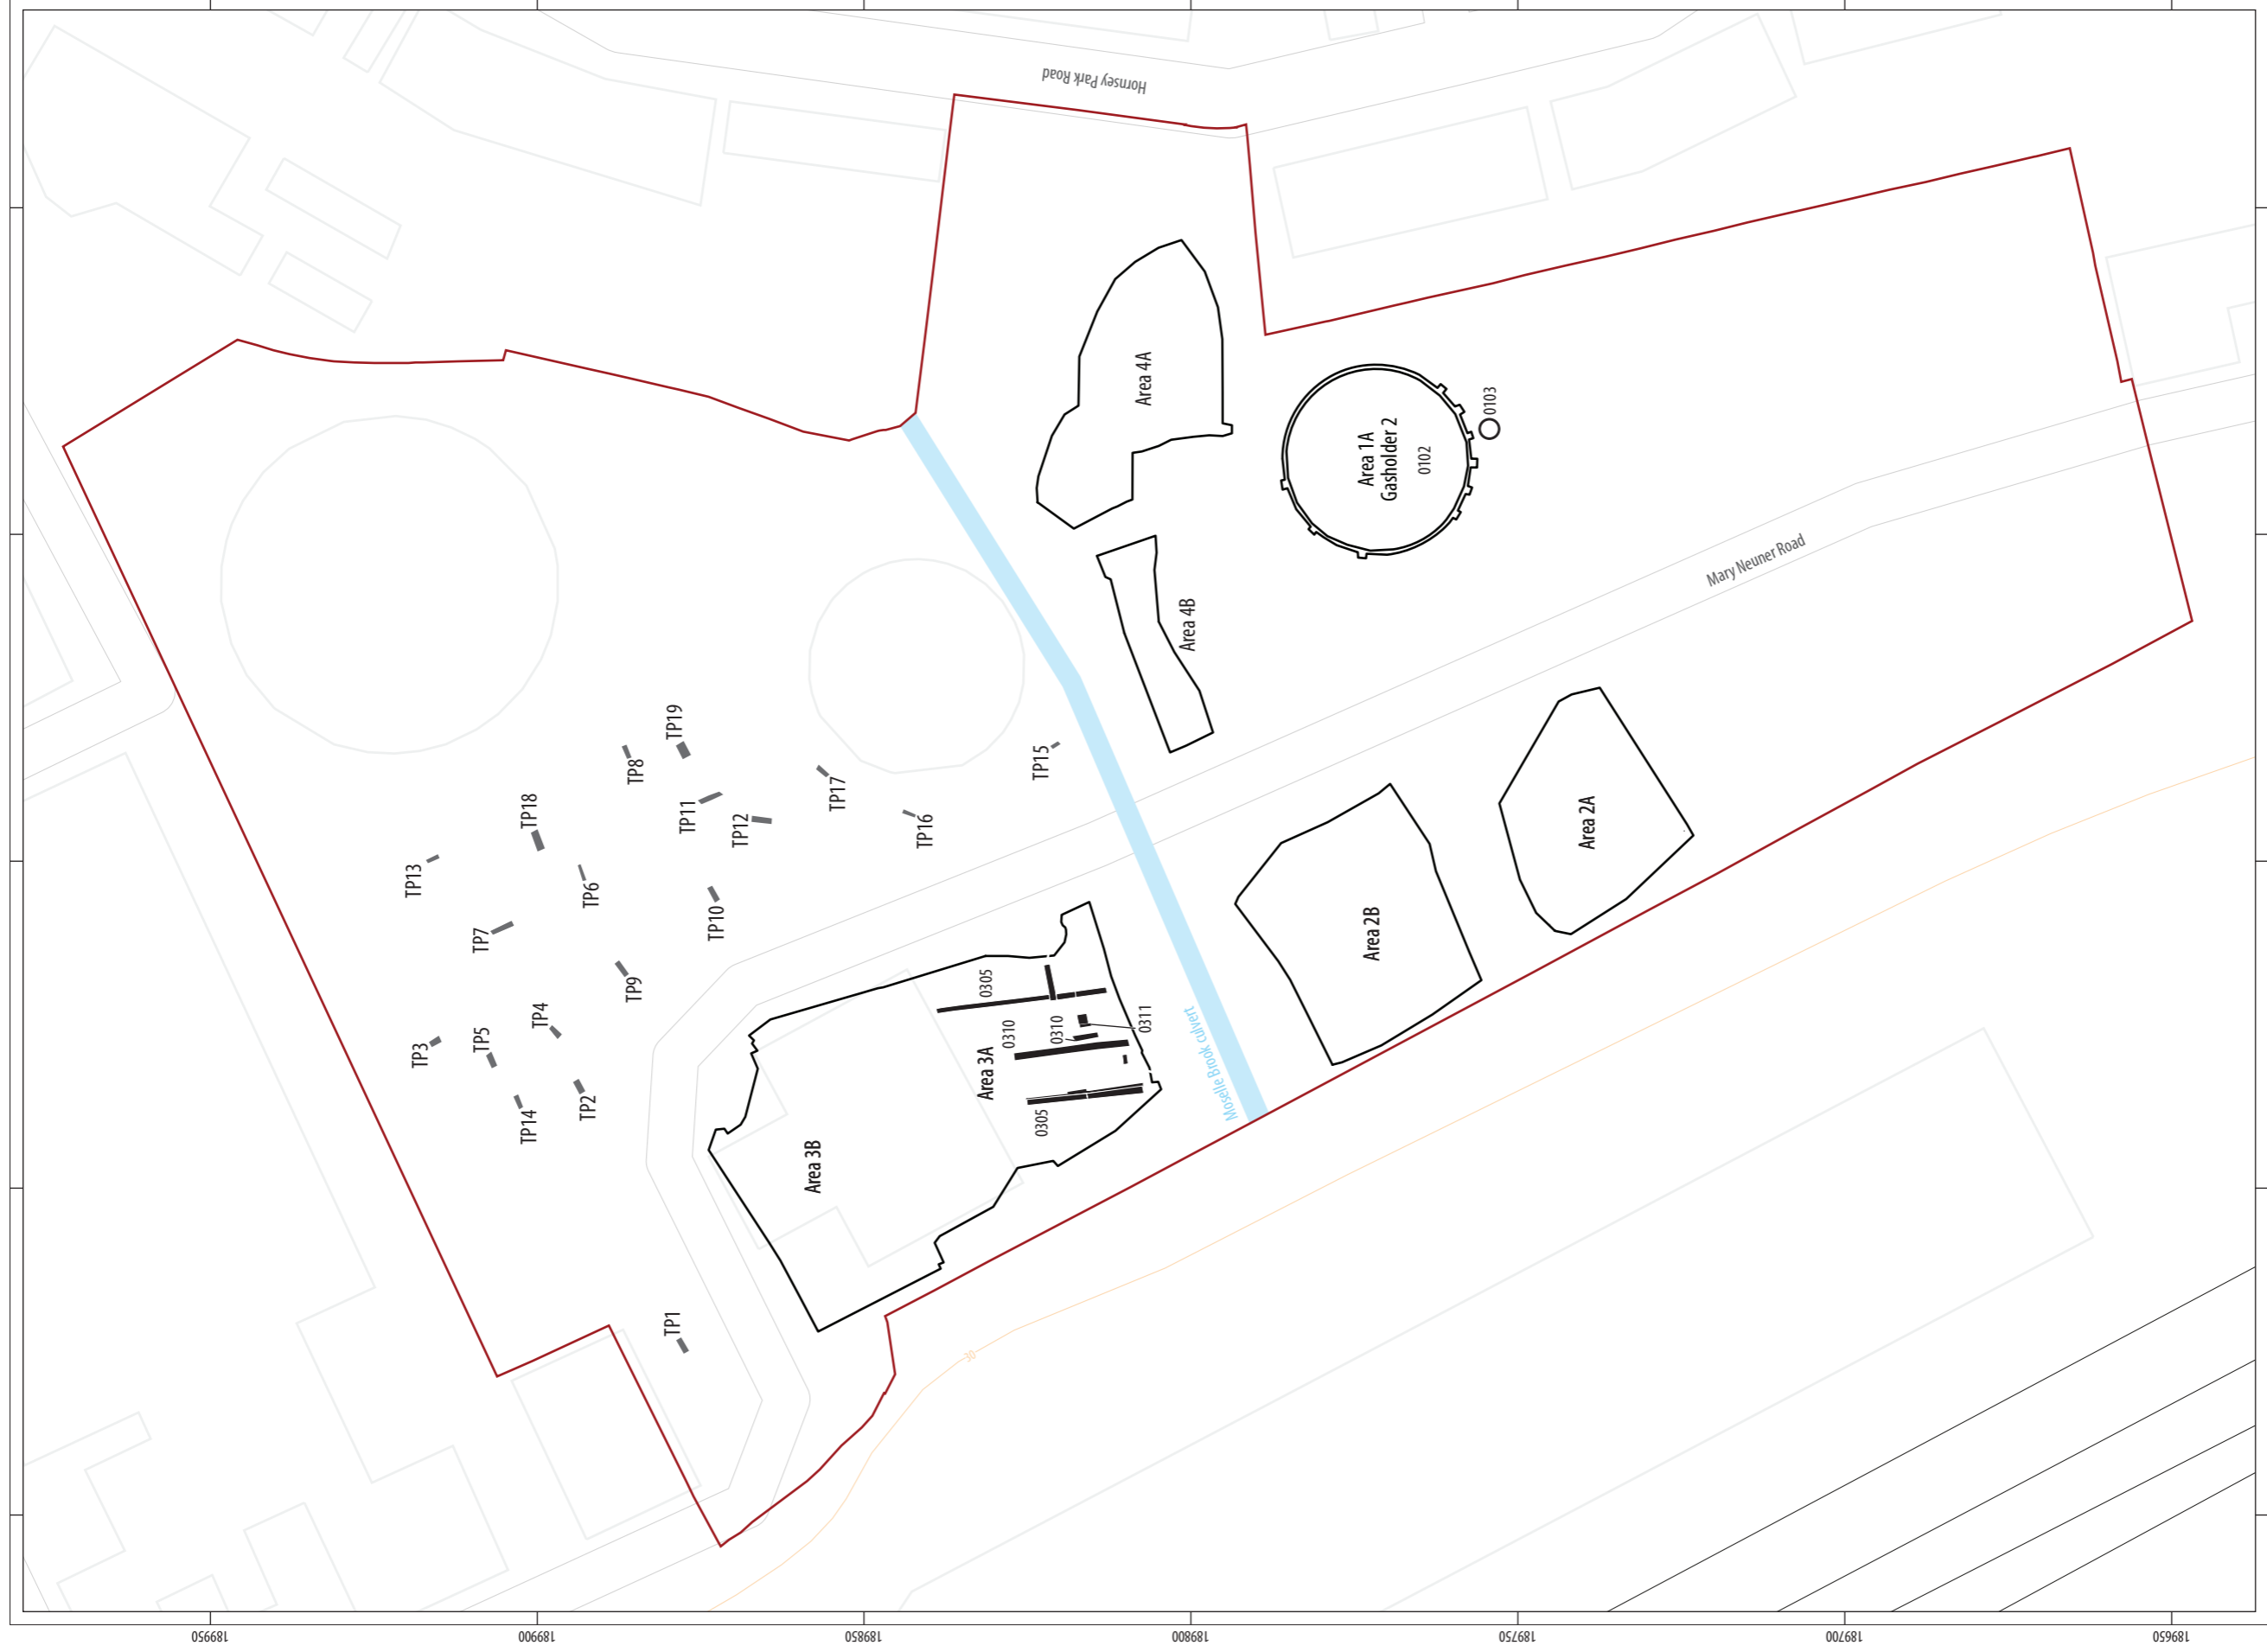
ILLUS 2 Detail plan showing areas and trial pit locations

Archaeological monitoring was undertaken over the course of several visits between 15<sup>th</sup> March 2017 and 29<sup>th</sup> August 2017. This observed the lifting of concrete footings and brick foundations of the demolished call centre and earlier buildings associated with the defunct gas works, the excavation of heavily contaminated soils within seven target areas to complete the demolition and remediation works, as well as the excavation of 19 trial pits, see Illus 2.

In total seven remediation target areas were excavated within the DA and 19 trial pits (see Illus 2).

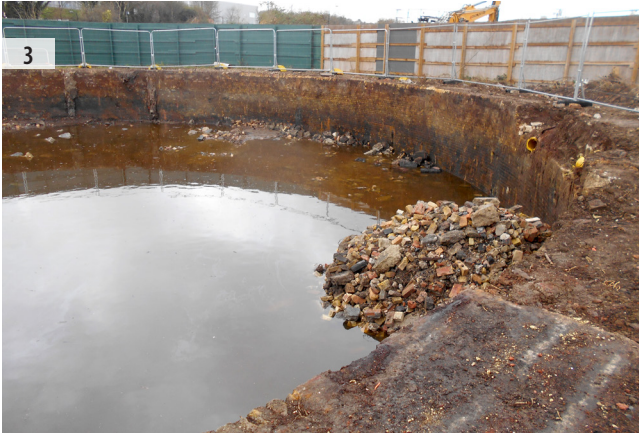
**ILLUS 3** Gasholder 2 (0102) looking NW

A gasholder tank was exposed as area 1A. This circular structure was located to the south of gasholder 1 and is consistent with various records dating the gasholder from 1868, aerial photographs and OS maps dating from before 1970 by which time the gasholder had been dismantled and filled in with asbestos contaminated rubble from formerly associated buildings and structures. The red brick tank measures 30m in diameter and has 6m of the inside depth exposed; it is estimated that there are another 4m to reach the base (Illus 3). The walls consist of red bricks arranged in English cross bond courses and are approximately 0.50m thick directly lining the natural substrate. Every 3m alternating concrete and brick remains of guide-frame bases can still be observed (Illus 4&5).

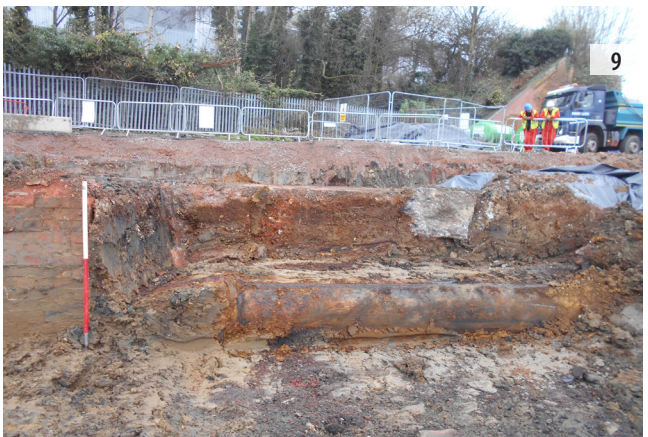
Foundations (0305) consisted of three parallel red brick foundations located in area 3A and a perpendicular segment orientated north-northwest to south-southeast (Illus 8). The foundations lay approximately 7m apart and were 0.9m thick. The westernmost foundation measured 25m in length whilst the other two were respectively 17.5m and 18m long. The foundation and surviving wall face appeared to be of English cross alternate courses made of red bricks measuring 0.25m by 0.11m by 0.07m. The foundations and shallow wall remnants align with the historical survey of the purifiers and oxide sheds related to the gas works. The easternmost foundation was also used as a conduit for large quantities of water and had a wide pipe in a brick casing running against its face. (Illus 2 & 9)

**ILLUS 6** Gasholder 3 looking N    **ILLUS 7** Gasholder 1 looking NW    **ILLUS 8** Foundation (0305) looking NNW    **ILLUS 9** Foundations (0305) and water conduit looking WNW    **ILLUS 10** Tar tank at west of area 2A

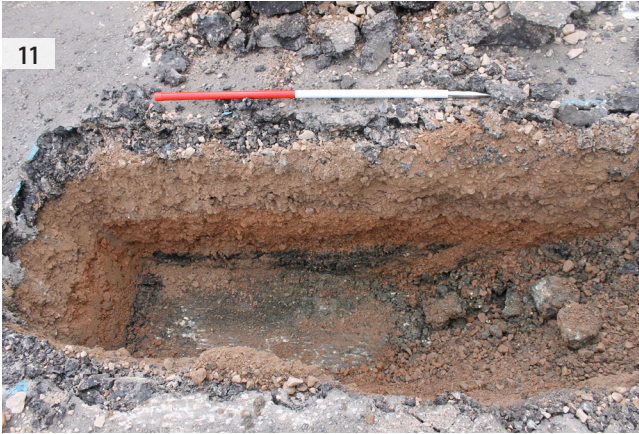
Area 2A & B exposed remains of brick foundations as well as remains of clay sealed tar tanks and purifiers which related to various phases of development of the Hornsey gas works. The tar tanks and purifiers were of various sizes throughout the DA, and access was extremely limited for safety reasons. Those structures were filled with highly contaminated rubble and were only photographed and briefly described. (Illus 10)
