**Dunstable Baptist Church, St. Mary's Gate, Dunstable**

**Archaeological Monitoring**

*Prepared for Dunstable Baptist Church*

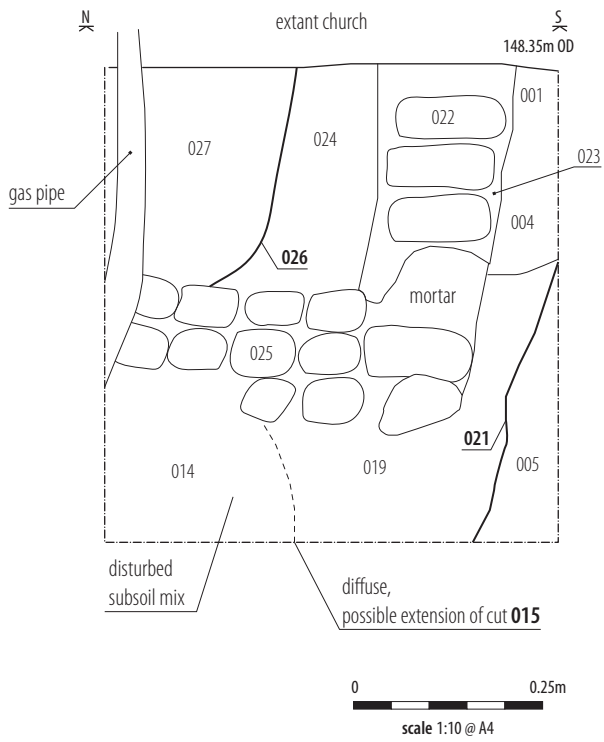
**ILLUS 4**

A subsoil deposit, a light brownish grey clayey silt (004) containing frequent charcoal and chalk fragments and occasional brick fragments, was observed to the west of the foundation trenches. The deposit had been heavily denuded in proximity to the extant church hall building and was greater in depth, up to 0.25m, to the west. Greater survival of the subsoil was observed and recorded to the extreme northwest corner of the development (Illustrations 2 & 4).

A red brick wall foundation (022) and foundation trench cut [023] were exposed in the section of the northern foundation trenches (Illustration 4). The observed bricks measured 0.18 x 0.08m and were a mix of headers and stretchers. A mixture of a cement based and yellow brown gritty sand mortar with charcoal fragments formed the bonding material of the bricks. These may have been associated with the original (pre-1849) church.

W facing section showing wall foundations

The red brick wall foundation [023] appears to be associated with elements of the original (pre-1849) church. In contrast, the wall foundation [016] was relatively insubstantial and so may instead have related to a more ephemeral structure added on, or additional to, the original church building. It may potentially be connected with the small structure indicated on the 1841 Tithe map.

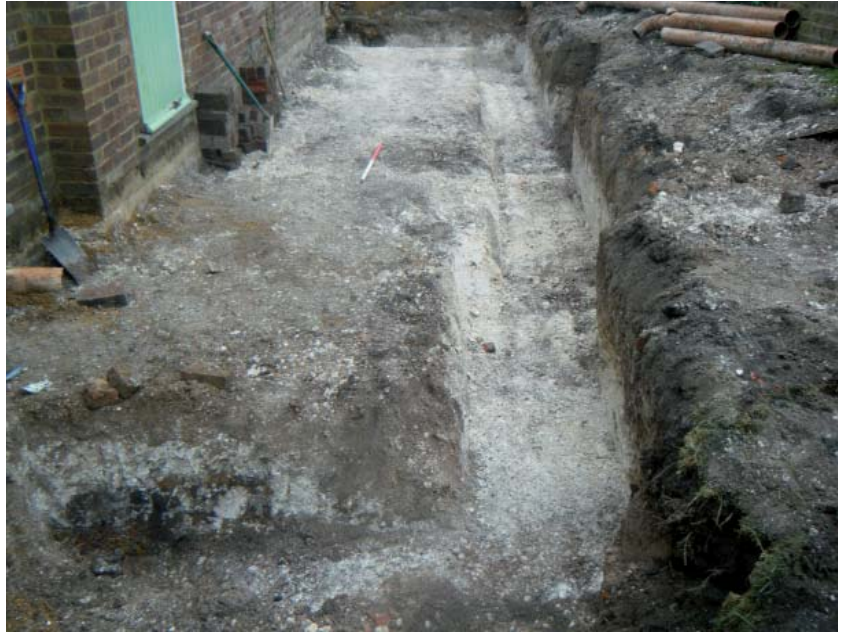
ILLUS 6

General view of site on completion of groundworks

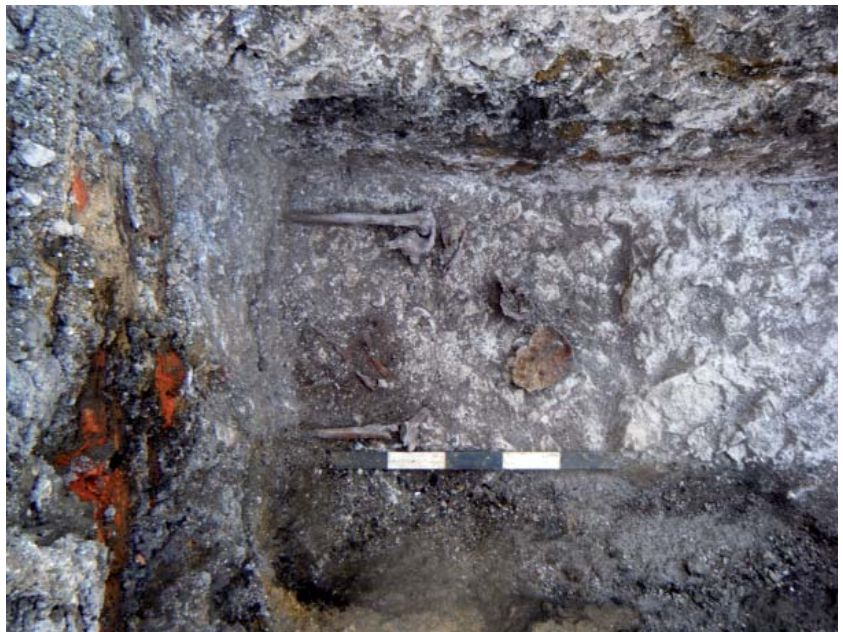
ILLUS 7

Human Remains: The fragmentary remains of a single skeleton were recovered from cut [021]. Parts of the skull, humeri and scapulae were present *in situ* along with parts of a rib. A further rib fragment was recovered from the grave backfill (019) and the skull fragments from (014) were shown to join with the *in situ* skull. The individual was an adult female, of slight build, probably under about 35 years-of-age at death. No significant pathological lesions were observed. Fragmentation and distortion of the bone by earth-pressure precluded obtaining any standard measurements.

Burial (020)
