**An assessment of the archaeological strip, map and sample excavation and monitoring
at Penn and Tylers Green Football Club, Penn, Buckinghamshire.**

PENN AND TYLER'S GREEN FOOTBALL CLUB, PENN, BUCKINGHAMSHIRE

Programme of Archaeological Works

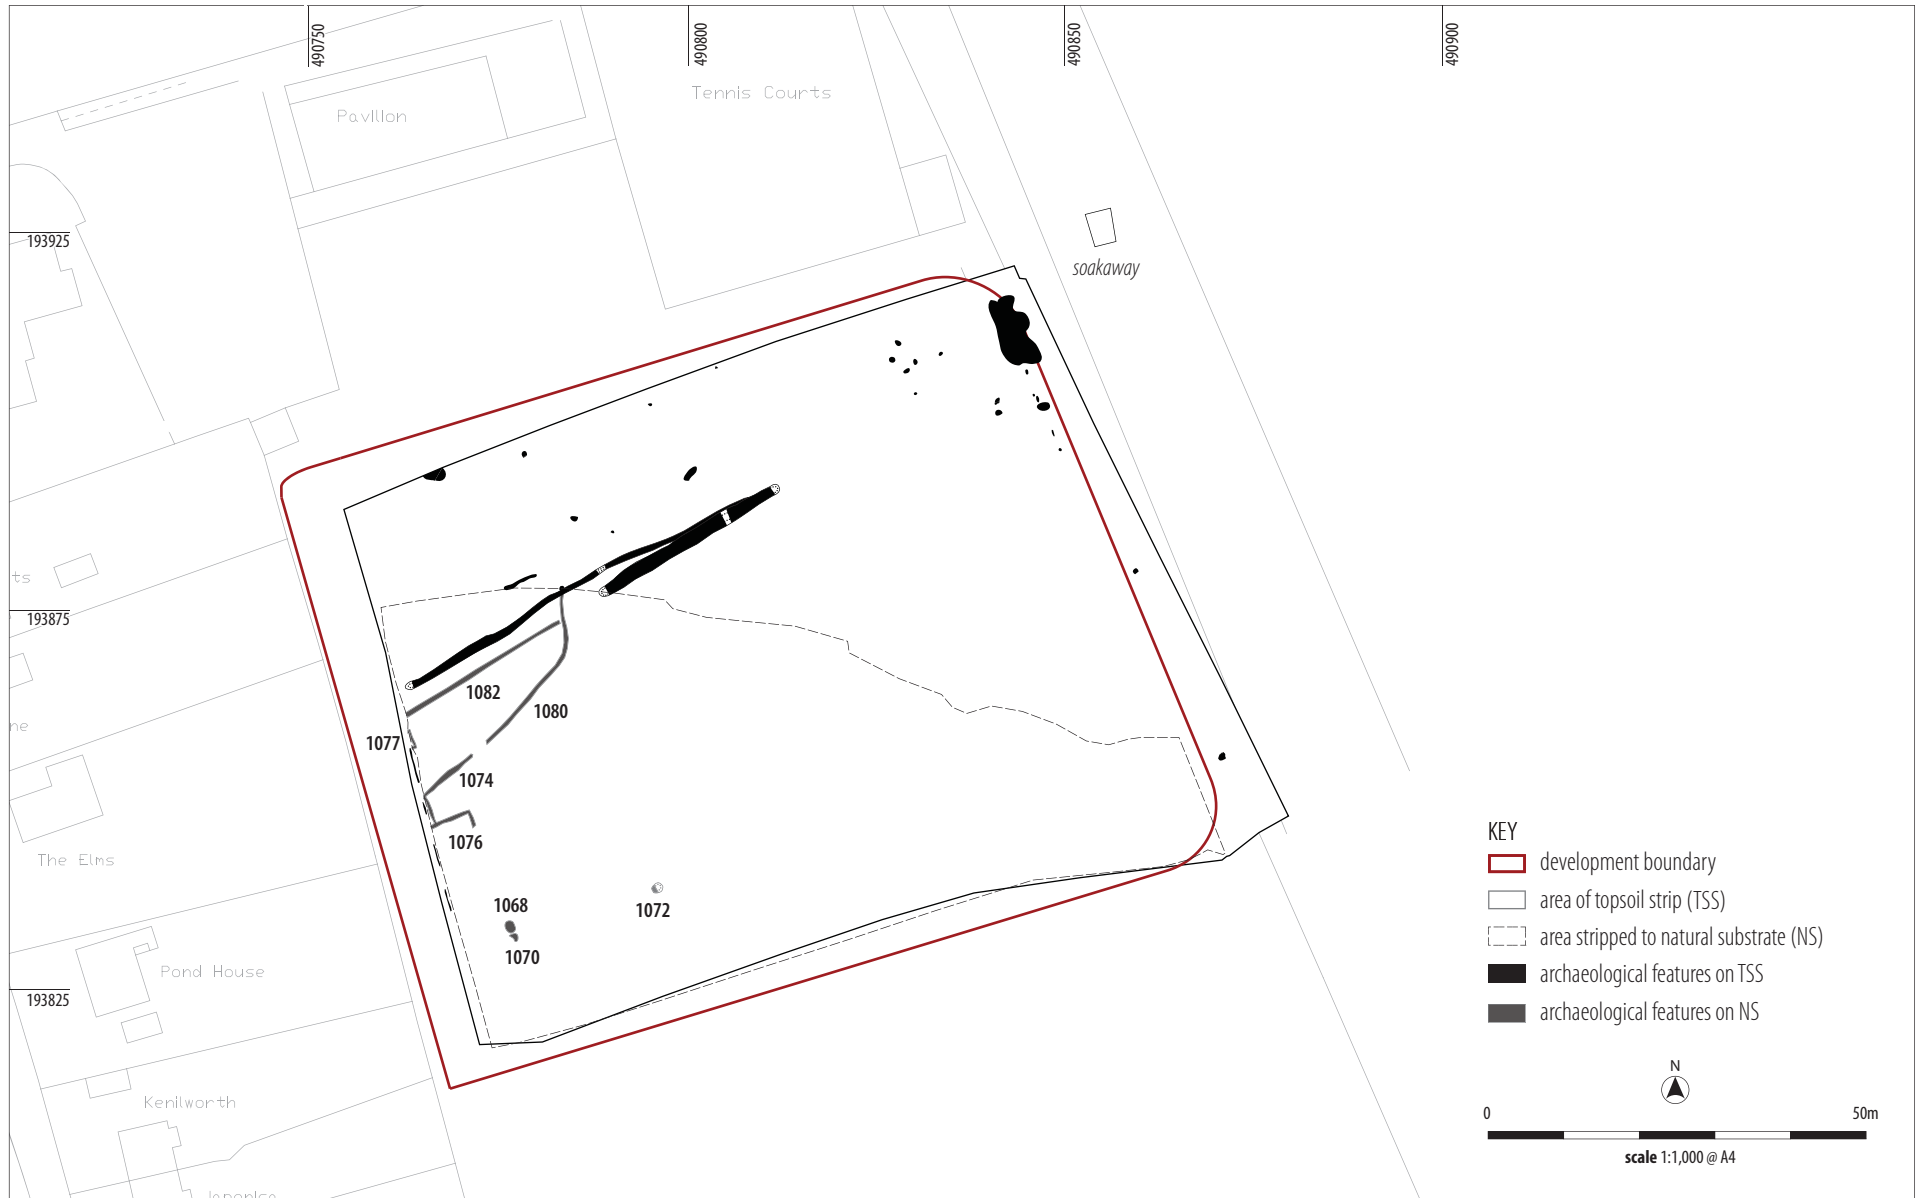
ILLUS 3
 Area stripped to natural with archaeological features

Features were revealed during both stripping of topsoil (Illus. 2) and stripping of subsoil (Illus. 3). The majority of the features revealed during the topsoil strip consisted of rubbish pits containing modern material but also included 2 ditches, the concrete footings for floodlights and the trench for a modern pipe. The majority of the features revealed during the excavation of subsoil consisted of the foundations of structures relating to the recreation grounds.

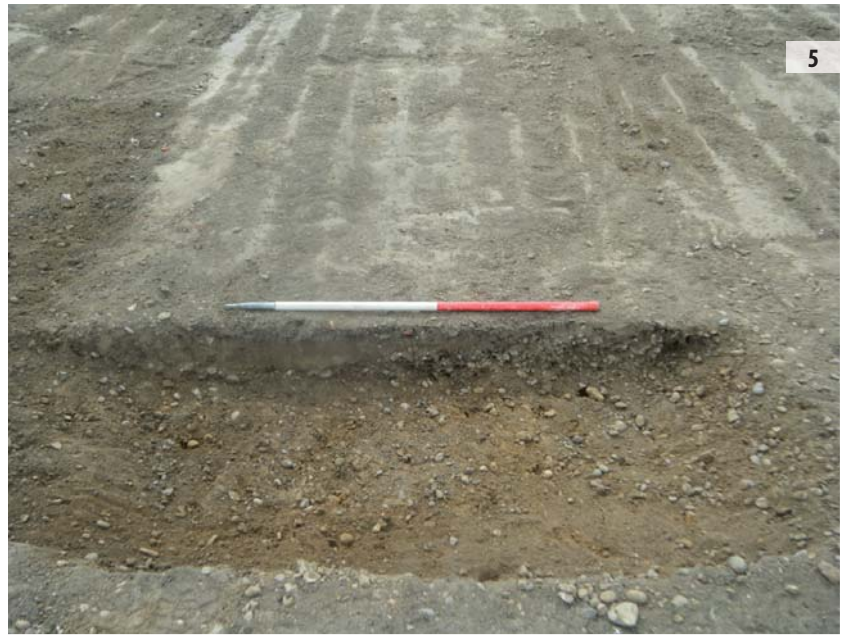
ILLUS 5
NE facing view of ditches [1050] and [1052]

Two NE-SW aligned ditches [1050] & [1052] were investigated, corresponding with feature A identified in the geophysical survey (Illus. 4 & 5). Ditch [1052] extended from the W side of the excavation area, on a NE-SW orientation across the site. It had very steep sides, with a slightly concave base and was 51.5m long, 0.7m wide and 0.2m deep. It was filled by brown grey clayey silt. This ditch was cut into the subsoil overlying foundation trench [1080].

Ditch [1050] was located slightly north of the centre of the site, cutting ditch [1052]. It had gently sloping sides and a flat base, and was 28m long, 1.9m wide and 0.2m deep. It was filled by grey brown silty clay. It contained ten sherds (69g) of post medieval and modern pottery, and metalwork. Six of the sherds were transfer printed ware, three Glazed Red Earthenware (GRE) and one sherd of stoneware. The GRE, and stoneware were probably residual material into a later silting ditch, occurring during the 19th century or 20th century. The ditch was also collecting slate, glass and cinder, acting as a convenient dump for domestic waste/residue of nearby building remodelling or maintenance.

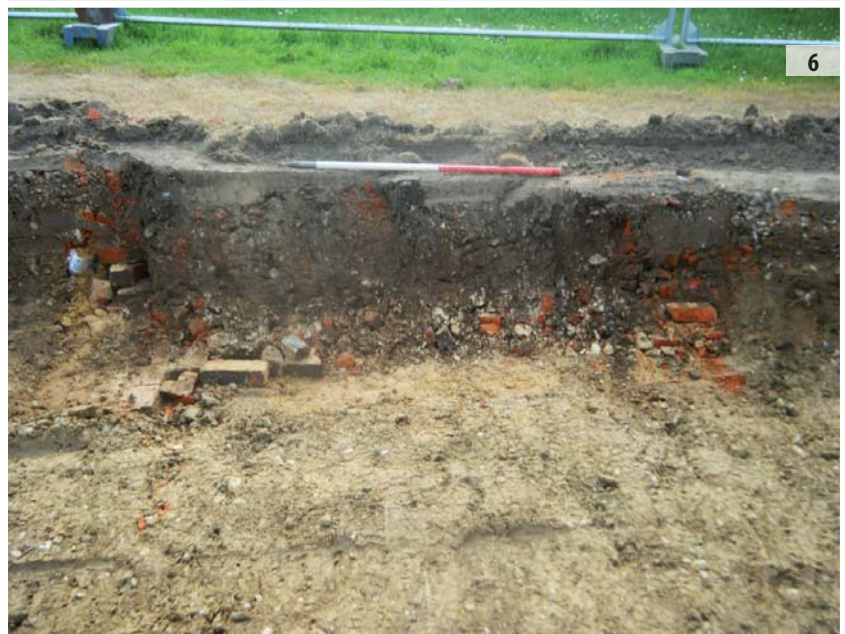
ILLUS 6
Remains of structure [1077]

Between foundation trenches [1074] and [1082] was a wall [1077] with 2 returns at right-angles which continued beyond the limits of excavation (Illus. 6). The wall was of regularly coursed bricks, each measuring 0.2m x 0.11m x 0.05m in size, with sand bonding.

The series of foundation trenches and walls most likely represent the remnant of stands for spectators.

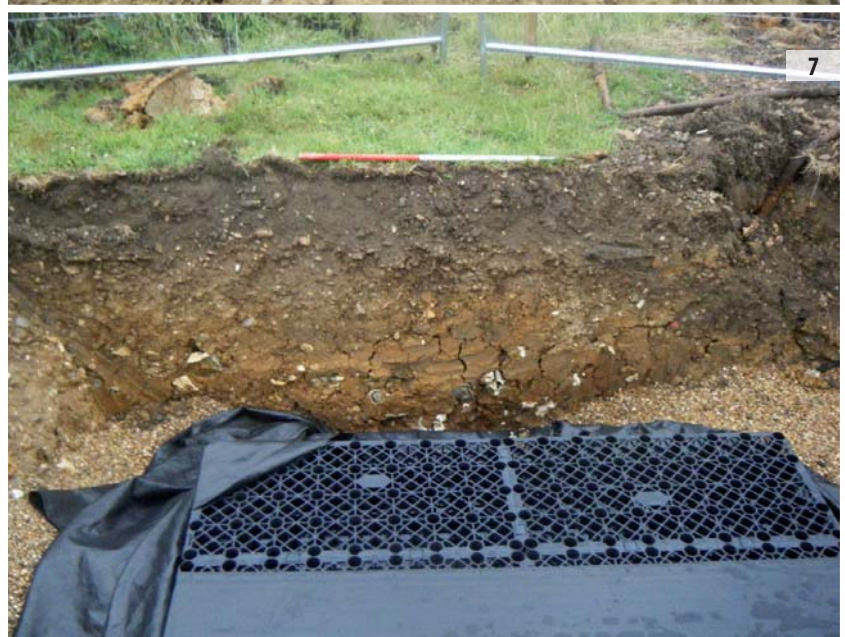
ILLUS 7
SW facing view of soakaway section

No archaeological remains were identified through the recording of the excavated soakaway (Illus. 7).
