Grange Farm, Bickenhill, Warwickshire

Archaeological Monitoring

GRANGE FARM, BICKENHILL, SOLIHULL, WARWICKSHIRE

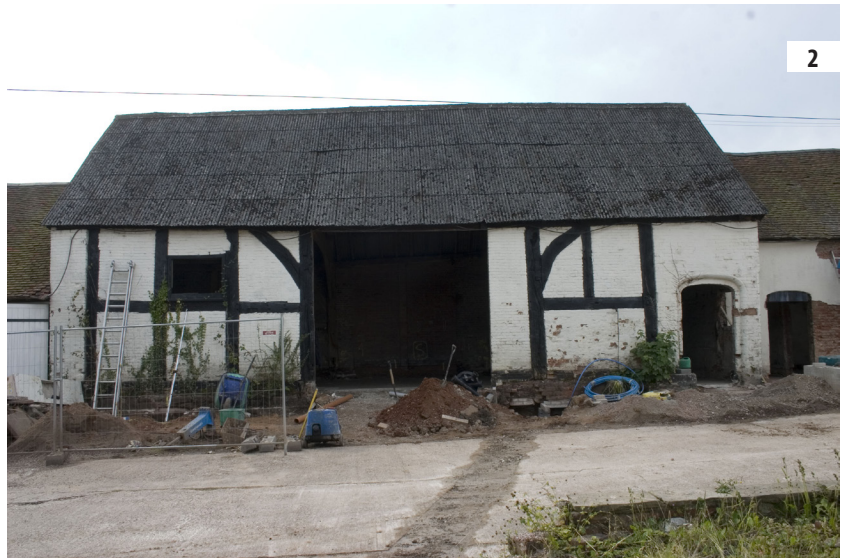
ILLUS 2

SW facing image of the exterior of Barn A

The land on which the DA sits is at 110mOD. The current use of the DA is two barns and an outbuilding surrounded by arable fields, see Illus 2 and 3.

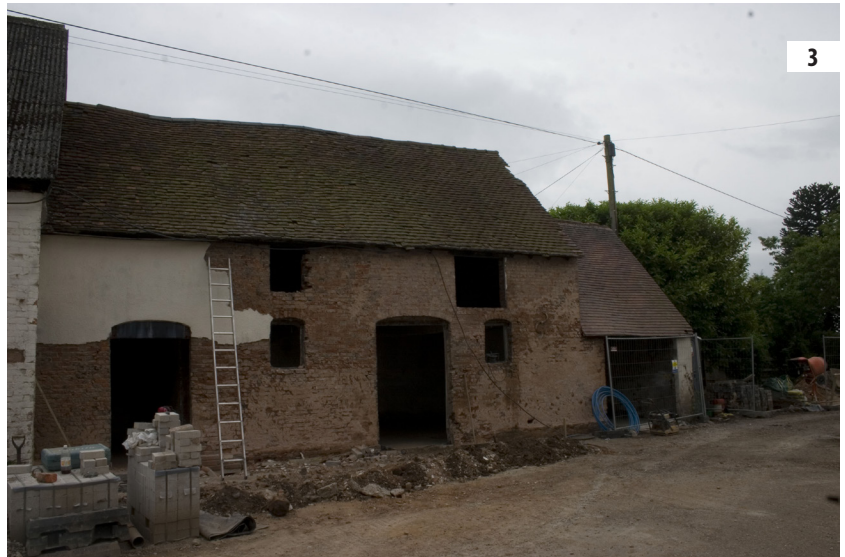
ILLUS 3

S facing image of the exterior of B and the associated outbuilding

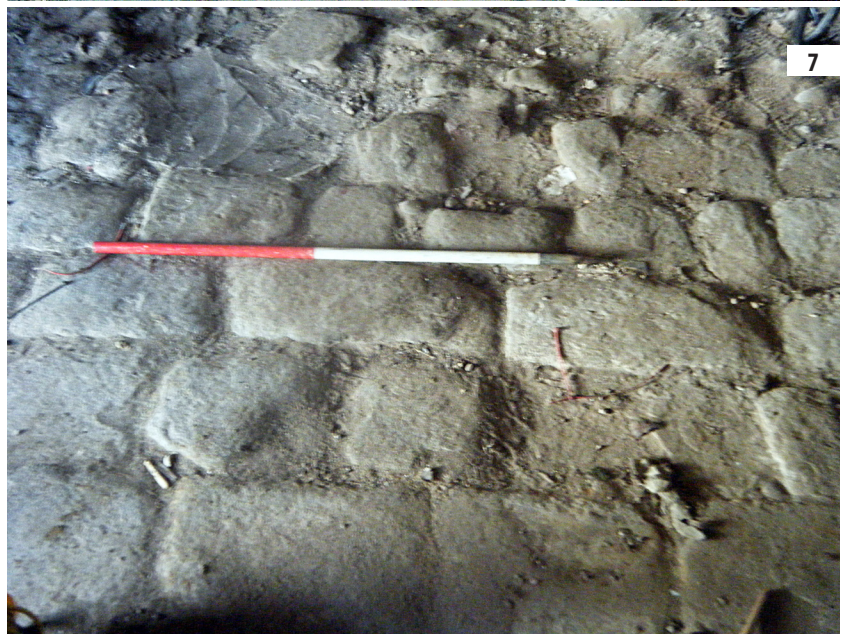
ILLUS 7

NE facing view of floor [003] in Barn A Room 2

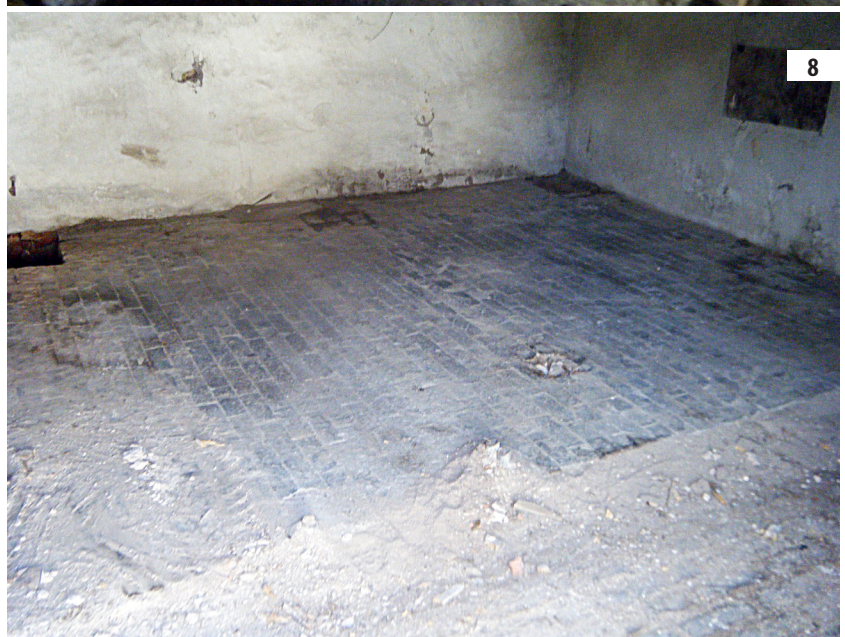
ILLUS 8

S facing shot of floors [009] and [010] in Barn B Room 2

Two postholes [049] and [051], relating to a dividing wall in the largest room of Barn B were investigated and recorded. Both were square in shape filled with a single context which comprised modern backfill. These postholes were positioned along the divide between floors [009] and [010], metal fixtures that once formed part of the divide were visible on the northeast and southwest facing interiors of wall [015].

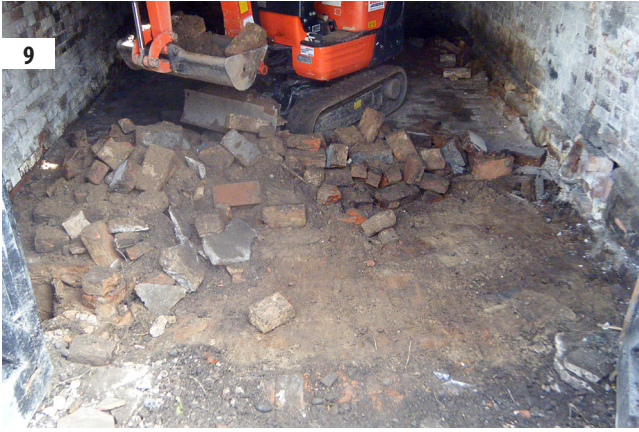
ILLUS 9

SE facing shot of floor [011] in the associated storage outbuilding

Brick floor [001] see Illus 6, was an even regular coursed floor bonded with a lime based mortar, it was the original floor at the northeastern end of Barn A Room 1 later cut by [021] to form the foundation for the concrete floor (002). Bricks from [001] were incorporated into the foundation deposit (020) for floor (002). Barn A Room 2 comprised five different floor surfaces; stone floor [003] see Illus 7, made up of irregular sized stones with some regularity in coursing but no overall pattern; this floor was re-laid at a later date. A replacement floor was added where the doorway is situated on the northeastern wall of the room, brick floor [007] comprised regular coursing bonded with mortar; stone floor [004] believed to be the original floor was made up of irregular sized stones however coursed in an even and regular pattern, it was repaired over time with more regular stones. The southwest end of the room was later replaced with a concrete floor (005) and a concrete pad (006) was also added to the eastern corner of the room. Barn B Room 2 was made up of two brick floors, [010] see Illus 8, was the original floor with an even, regular course bonded by sand, it covered 60% of the room; 40% of the room was covered by brick floor [009], the bricks appear to match [010] suggesting it was laid at the same time or later than [010]. [011] see Illus 9, was a regular coursed brick floor comprising the associated outbuilding floor.

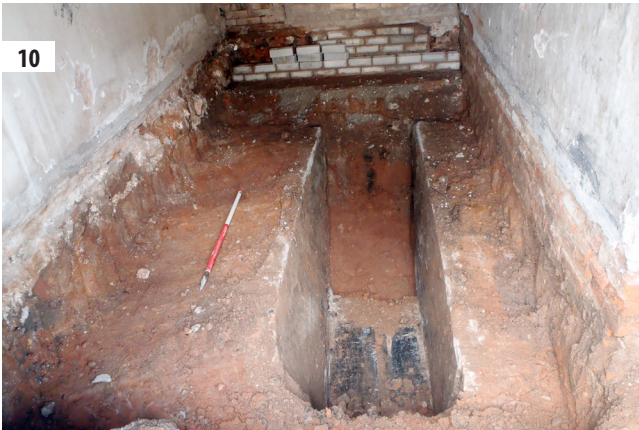
ILLUS 10

Barn B Room 1 consisted concrete floor [008] with a pit in the centre of it. The pit [044] (see Illus 10) measured 3.8m x 0.9m x 1.25m, and was located opposite the entrance in the northwest wall [015] and a filled in doorway in the southeast wall [015]. Two sheets of concrete measuring 2.6m x 0.01m x 1.95m formed the northeast and southwest edges of the pit, whilst the southeast and northwest edges were not bordered. The

purpose of pit [044] is unknown, the rectangular shape and positioning between two doorways could suggest it was either for agricultural use or functioned as a garage pit enabling mechanics to work underneath vehicles. As it is modern it is therefore considered to have no archaeological significance.

SE facing shot of pit [044] in Barn B Room 1

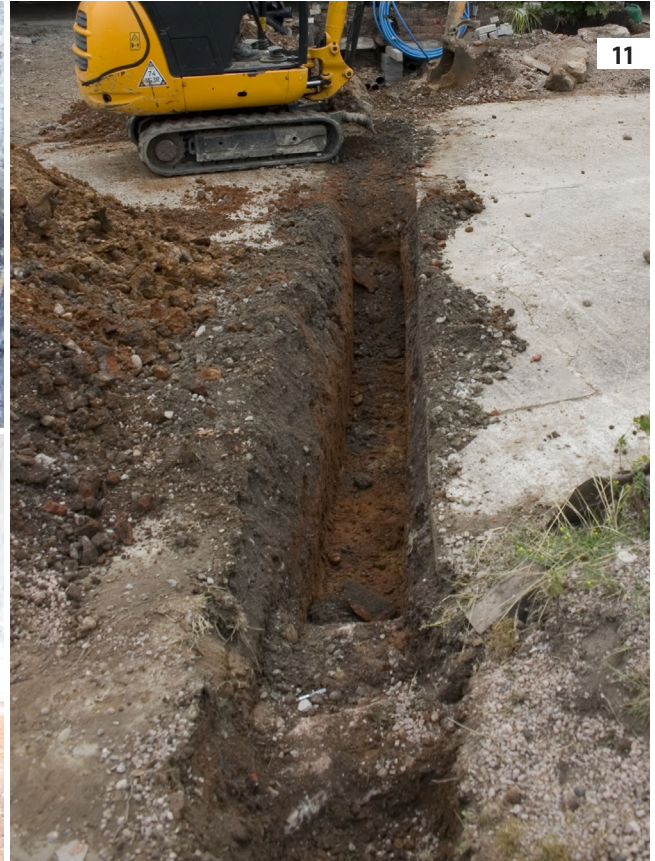
ILLUS 11

No archaeological deposits or remains were noted during the excavation of the drainage trenches entering Barn A, see Illus 11.

S facing image of the excavation of the drainage trench entering Barn A
