BORDON GARRISON, HAMPSHIRE

*Level 1-2 Building Recording of subterranean bunkers, SEME Sergeant's and
Warrant Officer's Mess and Sandhurst Block*

*for Amec Foster Wheeler on behalf of Whitehill and Bordon Regeneration
Company*

November 2016

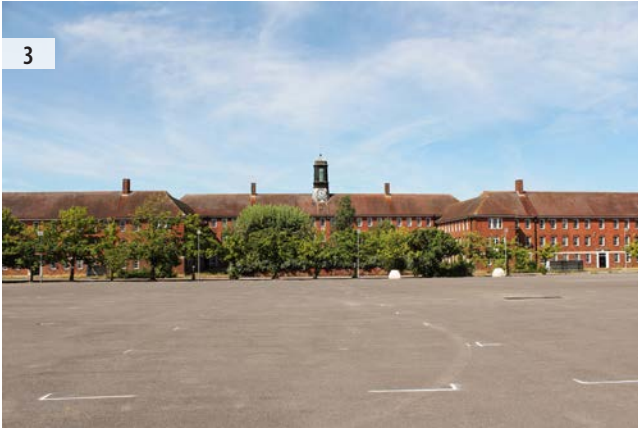
The exterior of the original Sandhurst Block is faced in brown-red textured brick in stretcher bond (Illus 3). On the ground floor, up to the height of the top of the windows, there are seven recessed string courses. On the projecting corners of the U blocks there are short sections of recessed string courses in place of quoins. A Portland stone band had been used decoratively along the top of the ground floor string course and as a foundation course around the entire block.

Over the original Sandhurst Block is a steeply pitched hipped roof with ceramic tiles (Illus 3). The apex of the roofs on the northeast and southwest projecting corners of the U blocks are at right angles to the main roof. Two brick chimneys are positioned at either end of the roof of each north-south block. A central clock tower with weathervane is mounted on the apex of the central block and is visible over much of the garrison.

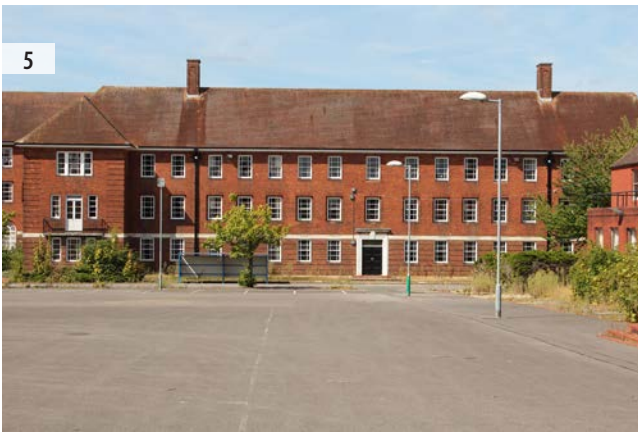
On the east façade there are three entrances, located centrally to each of the blocks. The main entrance in the central block is within a single storey projecting porch (Illus 4). The wooden six panel blue double doors are mounted on white painted wood frames with a fanlight window above. The door is surrounded by Portland stone Tuscan style pilasters and arch over the fanlight (Anon, 2010, 60, 97, 130).

On the ground floor of the central block the windows are large arched casements, four on either side of the main entrance (Illus 4). The panes follow the same proportion as the sashes and arch echoes the fanlight over the main entrance. They are wooden framed with brick jambs and arch, Portland stone sill and keystone.

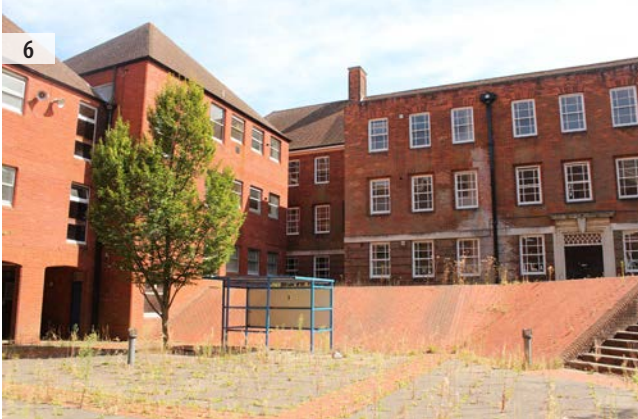
The remaining two doors on the east façade are the same as the four found in line to the west opening onto the courtyards of the U blocks (Illus 5). These are eight panel wooden double doors, painted black, in white wooden frames with a rectangular fanlight above. This window had a white diamond pattern across it. The door surround is Portland stone with a projecting keystone echoing the arched main entrance. The surround of the northern door on the east façade had been painted white.

Across the U blocks and upper floors of the central block the windows are white painted, wood framed horned sashes. Of six over six pane arrangement, the panes are of unequal size with the central panes being twice as wide as those down the sides. These windows are recessed into brick jambs with brick sills and, on the upper floors, decorative brick lintels. The ground floor lintel is formed by the Portland stone band. On the east and west facing projecting corners of the U blocks the windows have a different layout on each floor. On the ground floor the standard sash is flanked by two half-width sashes separated by the length of a brick. On the first floor the central sash is replaced by a half-glazed double door leading onto a small concrete balcony with black iron railings. The second floor has the central sash with two half-width sashes separated only by wooden mullions, not brick (Illus 5).

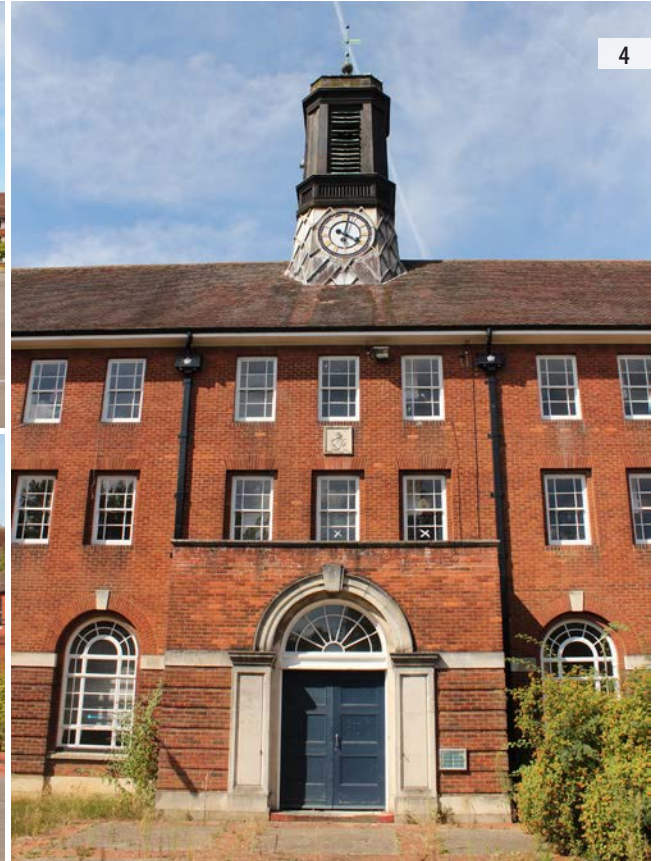
The courtyards of the U blocks are paved, with occasional trees (Illus 6). The southeastern side is at a higher level and a raised terrace, also paved with sloping sides of orange-red brick has been added to access the door, presumably replacing an earlier terrace or steps.

The northwestern façades of the original building have a projecting central bay housing the ablution rooms (Illus 6). These are identical in form to the rest of the building except that they are flat roofed and have bricked up windows on their north and south elevations.

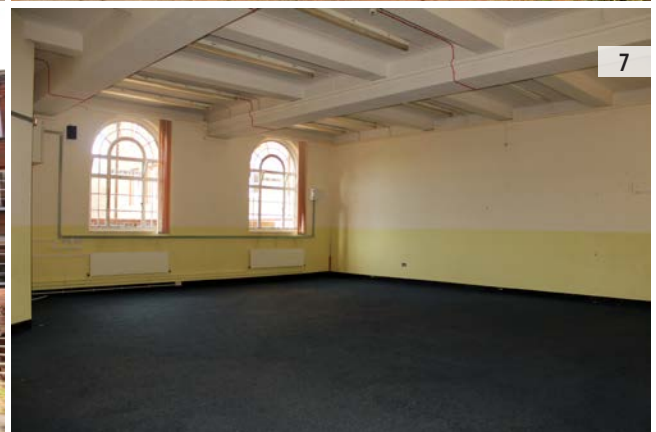
ILLUS 3 Southeast elevation of the Sandhurst Block viewed from across the parade ground **ILLUS 4** The main entrance and central block ground floor windows of the Sandhurst Block **ILLUS 5** The southeast elevation of the northern U block illustrating the doors and windows **ILLUS 6** The courtyard within the northern U block showing the rear door and ablution room bay with the modular extensions on the north side **ILLUS 7** The former Sandhurst Block library as an example of the central block ground floor rooms

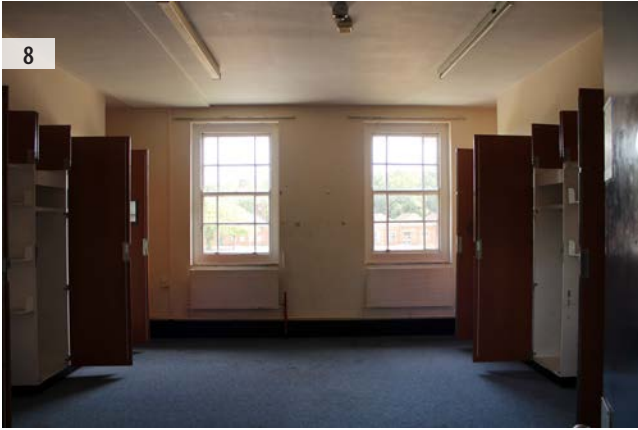
ILLUS 8 An example of the modern arrangement of the dormitories in the Sandhurst Block **ILLUS 9** An example of the red Modern style balustrades on the stairwells within the Sandhurst Block **ILLUS 10** The south façade of the Sergeant's Mess **ILLUS 11** The new main entrance, with SEME insignia, added to the west side of the original Sergeant's Mess building **ILLUS 12** The interior of the extensions, showing the dining area on the east side **ILLUS 13** The interior of the bar on the southeast corner of the original part of the Sergeant's Mess

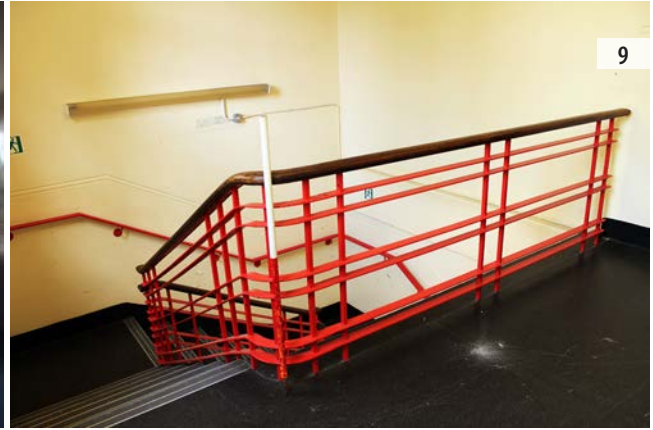
The west stairwell was also covered in brown tiles with bright red cast iron railings of a distinctive horizontal bar design and wooden handrails (Illus 9). Corresponding red metal handrails had been affixed to the walls. This stairwell gave access to the small modern extension of offices added to the west of the central block. It differed in level by half a storey and the stairs appeared to extend upwards despite there being no access to them and no current provision of access to the upper floors of the central block from the main entrance.

The stairwells for each of the accommodation blocks were broadly similar to that described for the central block (Illus 9). Those that connected to the modern extensions were dog leg form with tiled flooring and were wider with larger landings. Those within the original building were quite narrow and of square well form with bare concrete floors. All had the red iron railings.

Also of note on the interior of the Sandhurst Block are the stairs and balustrades for their clean lines and simplicity. Despite the exterior being Neo-Georgian in influence these owe more to the Modern style, usually reserved for the Army's technical buildings at this time. Modernism was partially based on a concept of utilitarianism and these stairways therefore represent a practical and appealing solution given that these barrack buildings were in part designed to encourage men to join the Army.

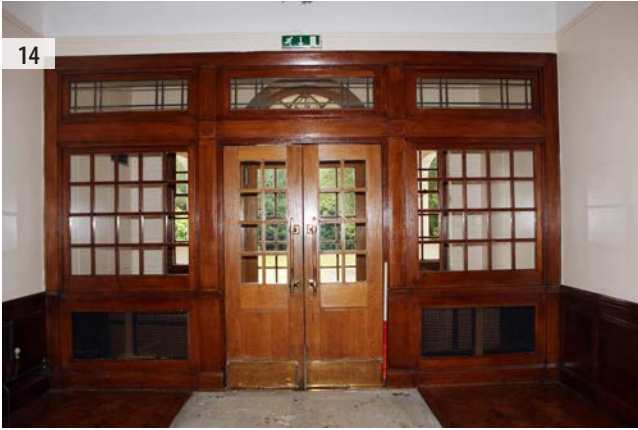
Within the former principal entrance lobby is a second set of double doors, half glazed with square panes and with brass handles (Illus 14). The doors are of a lighter colour than the surrounding woodwork and repaired patches next to the handles suggest neither are original to the decorative scheme. The geometric pattern in the rectangular fanlights above these doors and the elongated handles with horizontal banding are in a simplified Art Deco style. The lobby has dark wood panelling and parquet floor leading to a well stair with Art Deco stylised newel posts. The white plaster ceiling has a central circular rose repeating the overlapping leaf motif with a plain centre from which hangs an electric chandelier. On the half landing of the stair was an arched sash window of the same style as those on the south façade with six rectangular panes on each side of the sash separated by wooden mullions (Illus 15).

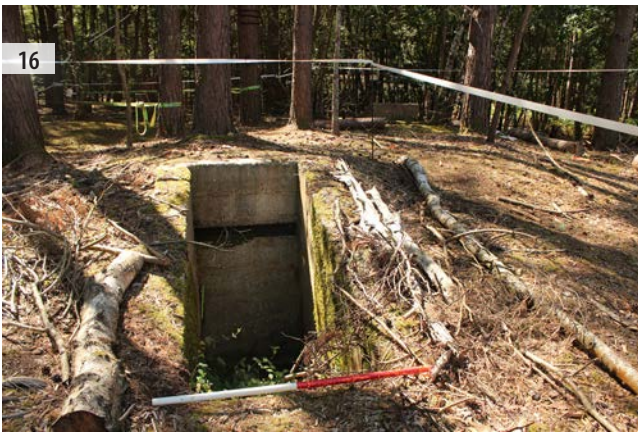
ILLUS 14 The dark wood interior of the former principle entrance of the Sergeant's Mess **ILLUS 15** The stairway in the original Sergeant's Mess building in context with its half landing window, the modern décor of the first floor accommodation and the modular extensions seen through the window **ILLUS 16** Bunker entrance 8 looking south towards entrance 6 **ILLUS 17** The interior of bunker 6–8 looking north **ILLUS 18** Possible bunker entrance 7 looking southeast with entrance 6 in the top right corner **ILLUS 19** The entrances of bunker 9–10 looking northeast

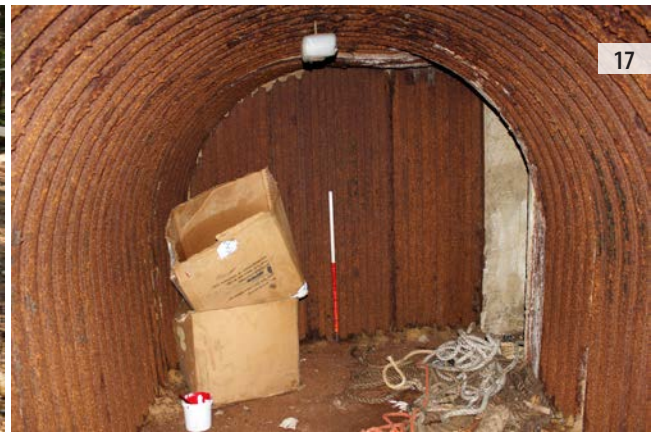
The third manhole style entrance was 1.45m² formed of a red brick edge and a central concrete cap, now sealed and barely visible in the low vegetation (Illus 18). There was no indication from the interior of the bunker that it connected to any entrance to the northwest and this manhole may be unrelated to the bunker.

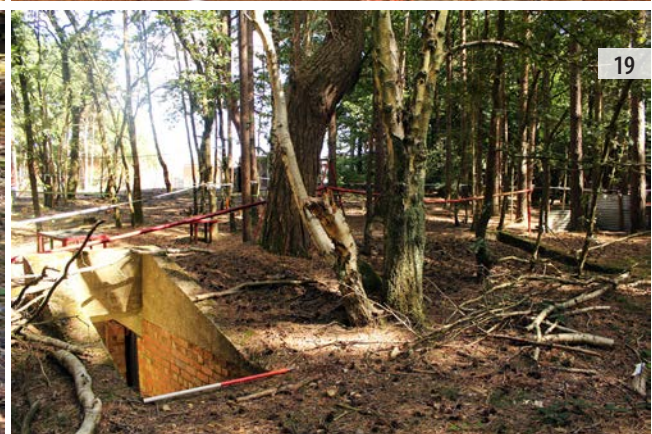
The bunker was accessed down ten concrete steps at each entrance. These were 0.96m wide and flanked by red brick walls in stretcher bond with cement mortar (Illus 19). The bricks were 0.25m long and 0.1m high and were very weathered in places. Collars 0.45m high on top of the brick walls protected the entrances and were constructed of concrete. Horizontal shuttering marks suggested they had been constructed *in situ*. The base of the steps and floor of the bunker was covered in vegetation and other debris obscuring any original flooring.

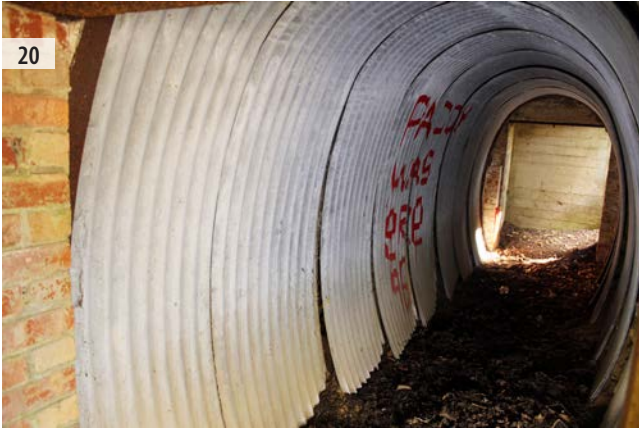
Between the two entrances bunker 9-10 was a tunnel 8.05m long, 1.4m wide and 1.90m high. Corrugated and galvanised iron or steel sheeting, with a round profile, was used to form the single span arch of the tunnel that was oval in section (Illus 20). The eight panels of sheeting had been overlapped slightly and set into a coarse yellow sand. At each end between the last panel and the base of the steps were steel lintels 0.1m wide and brick jambs 0.25m wide and 0.12m deep though there was no evidence remaining for a door. There was graffiti in red paint on the north side of the tunnel, dated 1996.

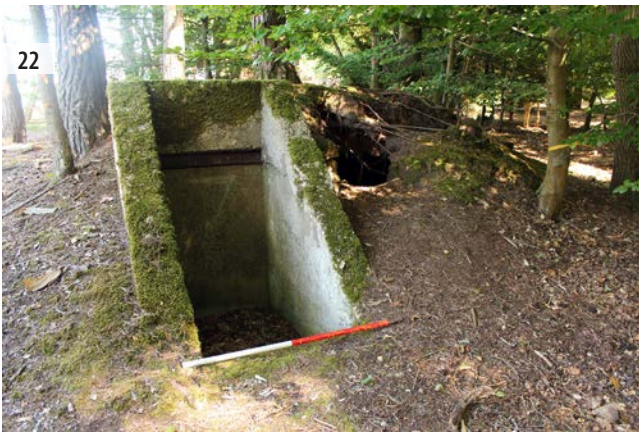
Bunker 11-12 was the most easterly of the group, located approximately 35m south of the entrance to the assault course area. It was orientated north to south with two entrances, one on the northeast corner facing north and one on the southwest corner facing south. This bunker was discernible above ground as a mound between the entrances (Illus 21).

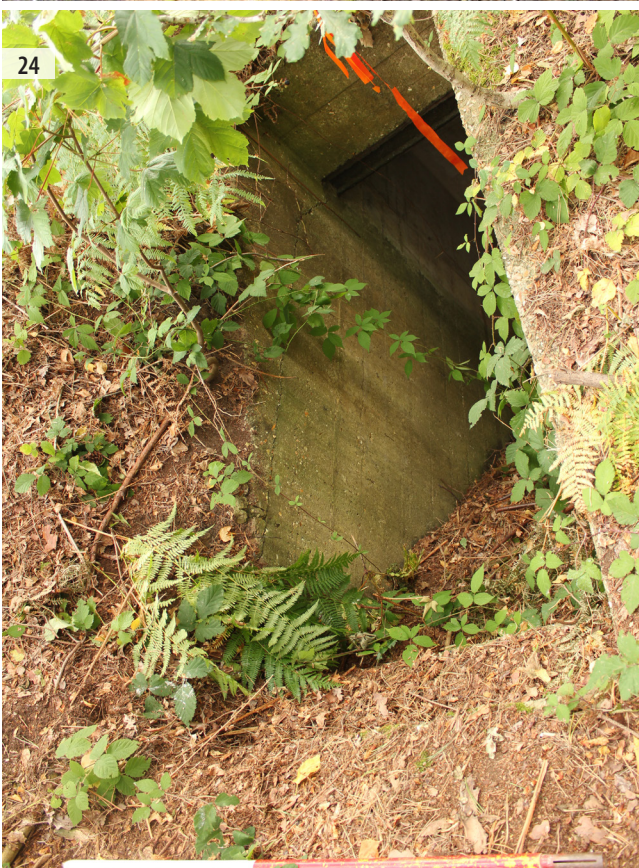
The concrete stepped entrances were similar though shorter in length than those observed on other bunkers and the northern entrance had been sealed by concrete blocks at the base of the steps, allowing it to fill up with debris. At the southern end, significant collapse and the growth of substantial tree roots had occurred such that safe access into the bunker was not possible and this entrance had also filled up with debris (Illus 22). Where the collapse allowed a view internally, it appeared to be comparable with bunker 6-8 with arched panels of square profile corrugated iron sheets. From surface measurements this bunker was approximately 12m long, including the entrances, which is consistent with the other bunkers.

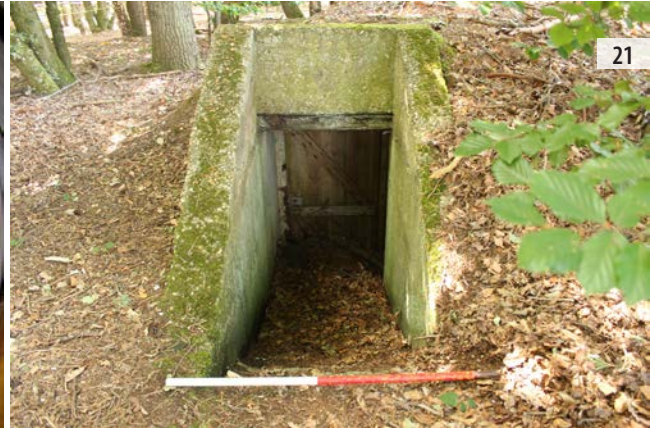
Bunker A-B was located in the westerly group of bunkers and orientated approximately north-northwest to south-southeast. It was only semi-subterranean and a large linear flat-topped mound 2-3m high could clearly be seen. The entrances were at either end of the bunker on the west facing side so that the bunker had a C shaped plan (Illus 23).

The entrances were formed of a light grey concrete with only a few small gravel inclusions and steel reinforcement. They were over 3m long and only 0.6m wide and both had been partially blocked by a wall of concrete blocks. This was probably at the base of some steps but a dense build-up of debris had completely covered any trace. This wall did not extend up to the ceiling at the southern end and so part of the internal space could be observed. Internally this bunker had a concrete floor, walls and ceiling and was rectangular in section. No debris or evidence of use was observed. External measurements indicate that bunker A-B was a maximum of 9m long.

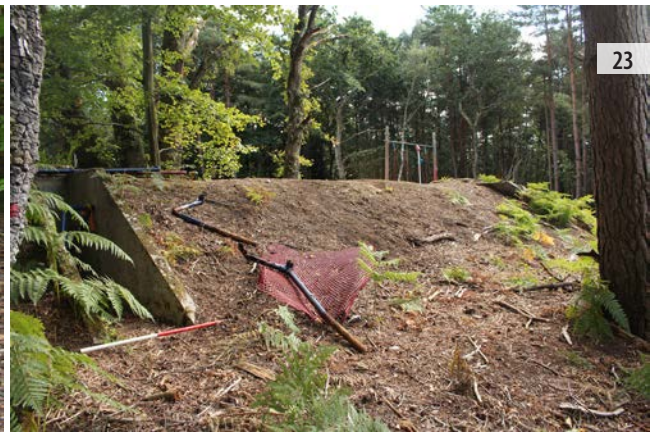
ILLUS 20 The interior of bunker 9–10 looking east **ILLUS 21** The short northern entrance 12 looking south **ILLUS 22** The blocked entrance 11 and the area of collapse over bunker 11–12 looking northeast **ILLUS 23** Bunker A–B was only partially subterranean with blocked west facing entrances **ILLUS 24** The almost completely hidden entrance D looking southeast **ILLUS 25** An example of the collapse and corrosion in the bunkers, in this case bunker C–D **ILLUS 26** The infilled north entrance F of bunker E–F with a view east towards bunker A–B

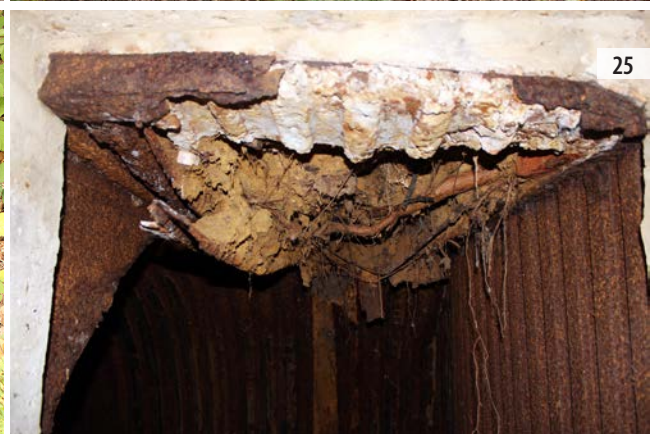
Internally bunker C-D was formed of single span arches of square profile corrugated wrought iron sheeting where the galvanising had either been absent or had failed. This was very heavily corroded with large areas of collapse and the sheets peeling inwards along the walls such that it was not safe to proceed very far into the space (Illus 25). The floor was concrete with a covering of gravel and debris.

The use of different types of corrugated metal sheeting and the colour and aggregation in the concrete suggests that not all the bunkers were built at the same time. However these materials in a military context are most frequently used in the first half of the 20th century and it is likely that these bunkers, whatever their intended use, were built around the time of the Second World War when the camp became a permanent garrison. The relatively good condition of the majority of the bunkers suggests frequent use since then though no major periods of repair were observed.

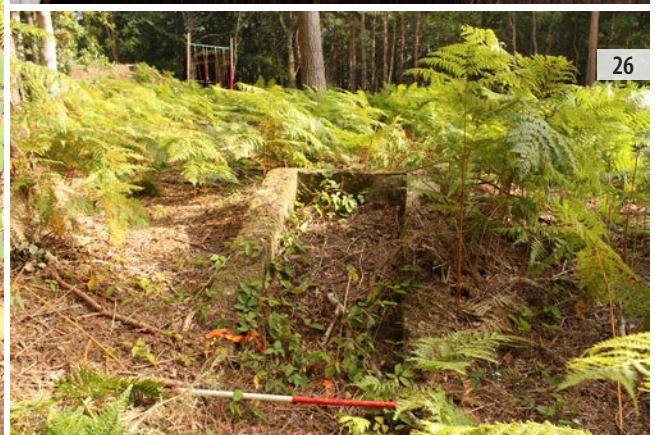
Bunker E-F was located on the western edge of the group and orientated approximately north-south. It was entirely subterranean with the concrete collars around the stepped entrances on the north and south ends only just visible in the tree clearance debris (Illus 26). The northern entrance had been blocked by a wall and a build-up of debris whilst the southern end was filled by vegetation and large fragments of corrugated metal sheeting such that there was no safe access to the interior. It is presumed from the surface layout, size and construction that this bunker is similar to 6-8, 11-12 and C-D.
