Archaeological Trial Trenching Evaluation: 9-13 Baldock Street, Royston, Hertfordshire

Client: Buzz Estates Ltd

9-13 BALDOCK STREET, ROYSTON

ARCHAEOLOGICAL EVALUATION

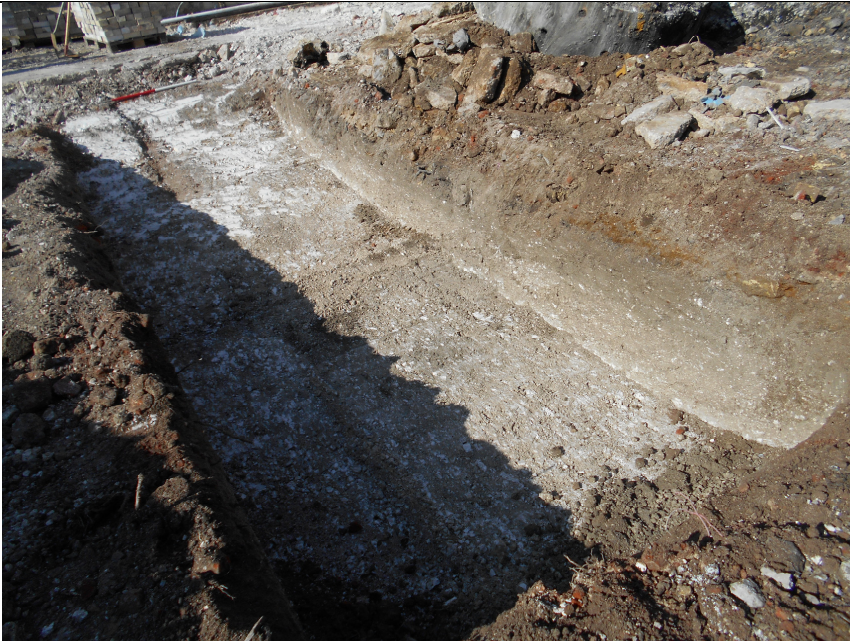
Trench Number	1

Trench 1 contained no archaeological features. The overburden comprised layers of made ground consisting of (101), a mid red brown silt with brick and concrete rubble; over (102), a mid grey brown silt with chalk fragments; over (103), a mid orange brown clayey silt with large amounts of weathered chalk (the redeposited natural geological deposit). This overlay the natural geology (104) made up of chalk and clayey silts, which was observed at 0.95m beneath the present ground-surface (Illus 2). There has therefore been a build-up of land in the northern part of the site, in an area which has been an external yard since at least the 1887 First Edition OS Map, presumably to level the ground.

Length	7.5 m	Width	2.5m		
Minimum Depth to Geological Deposit/level of archaeological significance	0.6 m	Maximum Depth to Geological Deposit/level of archaeological significance	0.95m		
Context No	Description (Layer, Cut, Fill)	Dimensions (as appropriate)			
		Diameter	Length	Width	Depth
(101)	Made Ground. Mid red brown sandy silt with large amount of concrete and brick rubble.				0-0.19m
(102)	Made ground. Mid grey brown silt with frequent chalk fragments.				0.19-0.4m
(103)	Weathered chalk layer. Mid orange brown clayey silt with large amount of weathered chalk. Possible made ground layer.				0.4-0.95m
(104)	Natural. Mid grey brown silt and weathered chalk.				0.95m+

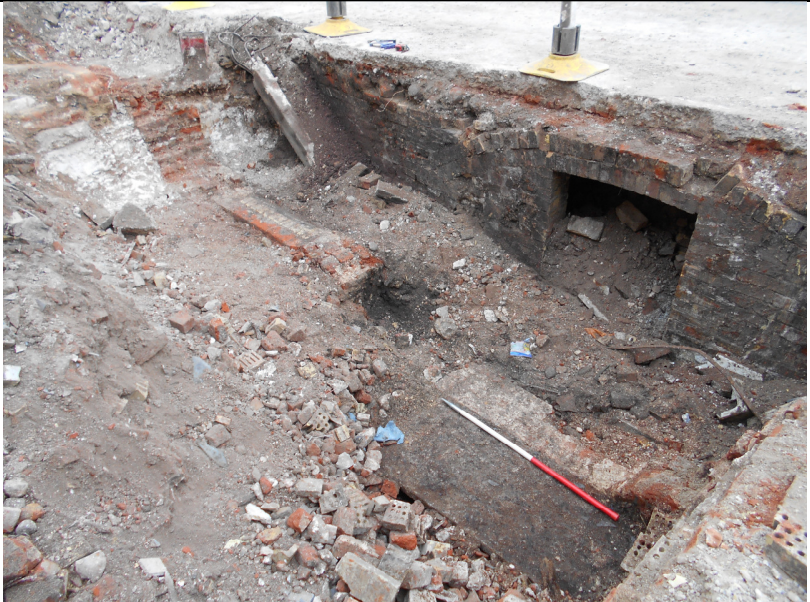
Trench Number	2

Wall [208] was aligned north-south through the centre of the trench, stepping to the east towards the southern end of the trench. A gap in this wall was observed towards the centre of the trench, suggesting that wall [208] formed an internal dividing wall within the cellar. This wall was 0.6m wide, at least 1.55m high, and made up of evenly coursed mortared red bricks approximately 225mm long, 105mm wide, and 64mm deep. Brick samples taken from this wall were considered to be of post-medieval - modern date. This wall was widened at some time with a layer of yellow bricks, approximately 228mm long, 110mm wide, and 70mm deep, probably to provide greater structural support to the building.

The natural geological chalk deposit was observed in the south-western part of the trench (outside the area of the cellar), at 0.35m beneath the present ground-level. The natural geological deposit therefore slopes upwards towards the southern part of the site (0.6m higher in the south than in the north), which makes sense with the road to the south being positioned on higher ground.

Length	7.5m	Width	2.1m to 3.28m		
Minimum Depth to Geological Deposit/level of archaeological significance	0.45m	Maximum Depth to Geological Deposit/level of archaeological significance	1.5m		
Context No	Description (Layer, Cut, Fill)	Dimensions (as appropriate)			
		Diameter	Length	Width	Depth

(201)	Concrete floor surface.				0-0.15m
(202)	Made ground. Mid red brown sandy silt with large amount of concrete and brick rubble.				0.15-0.35m
(203)	Cellar Wall. Evenly coursed brick and mortar wall. Opening to cellar.		5m+		0.2-2.35m+

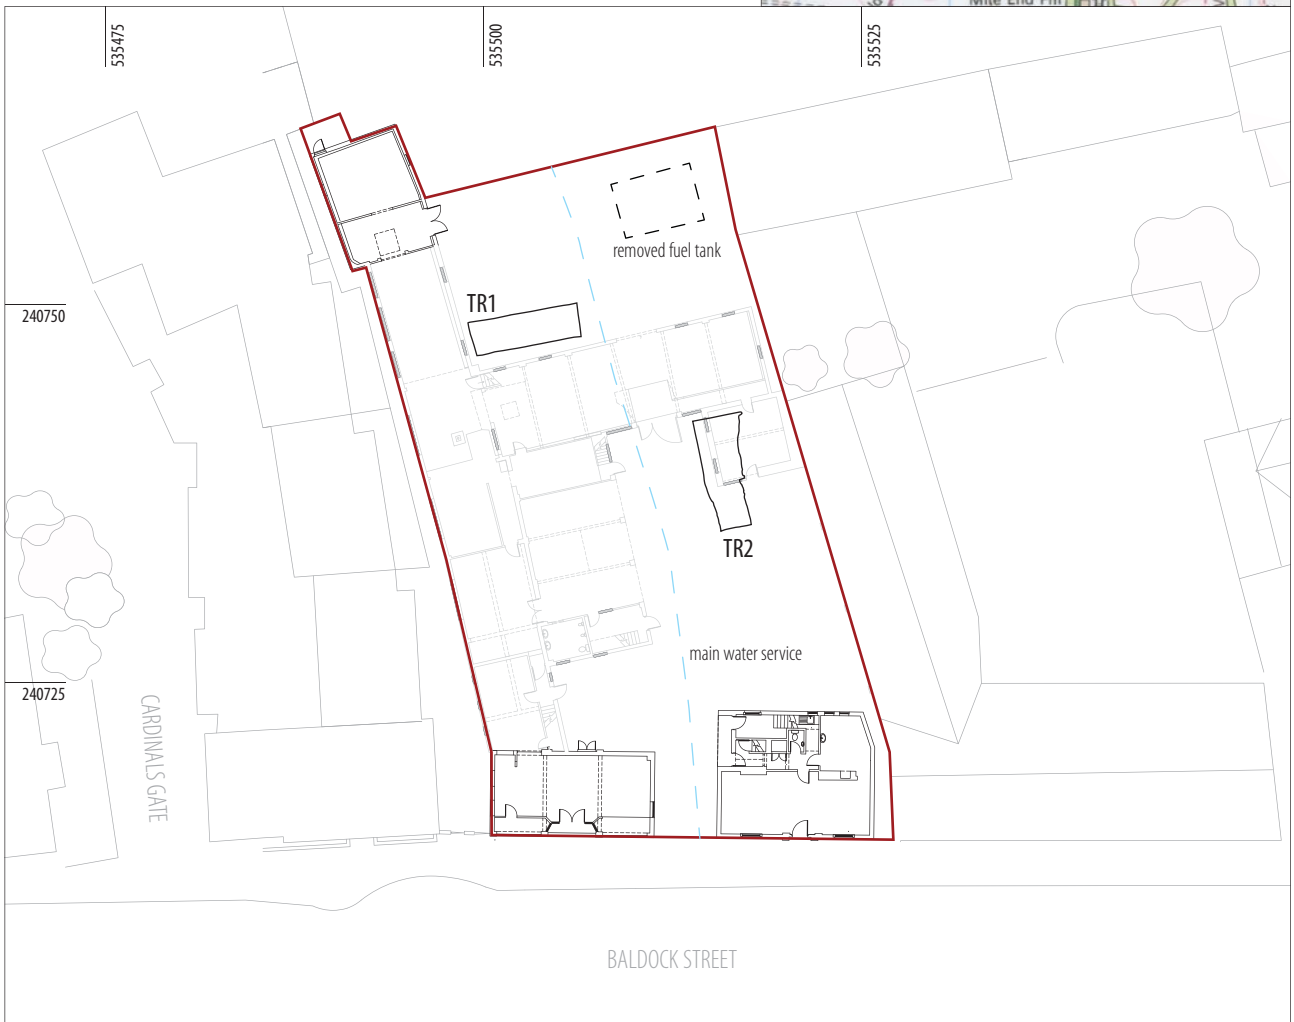
KEY
 [Red line] development boundary
 [Black line] trench location

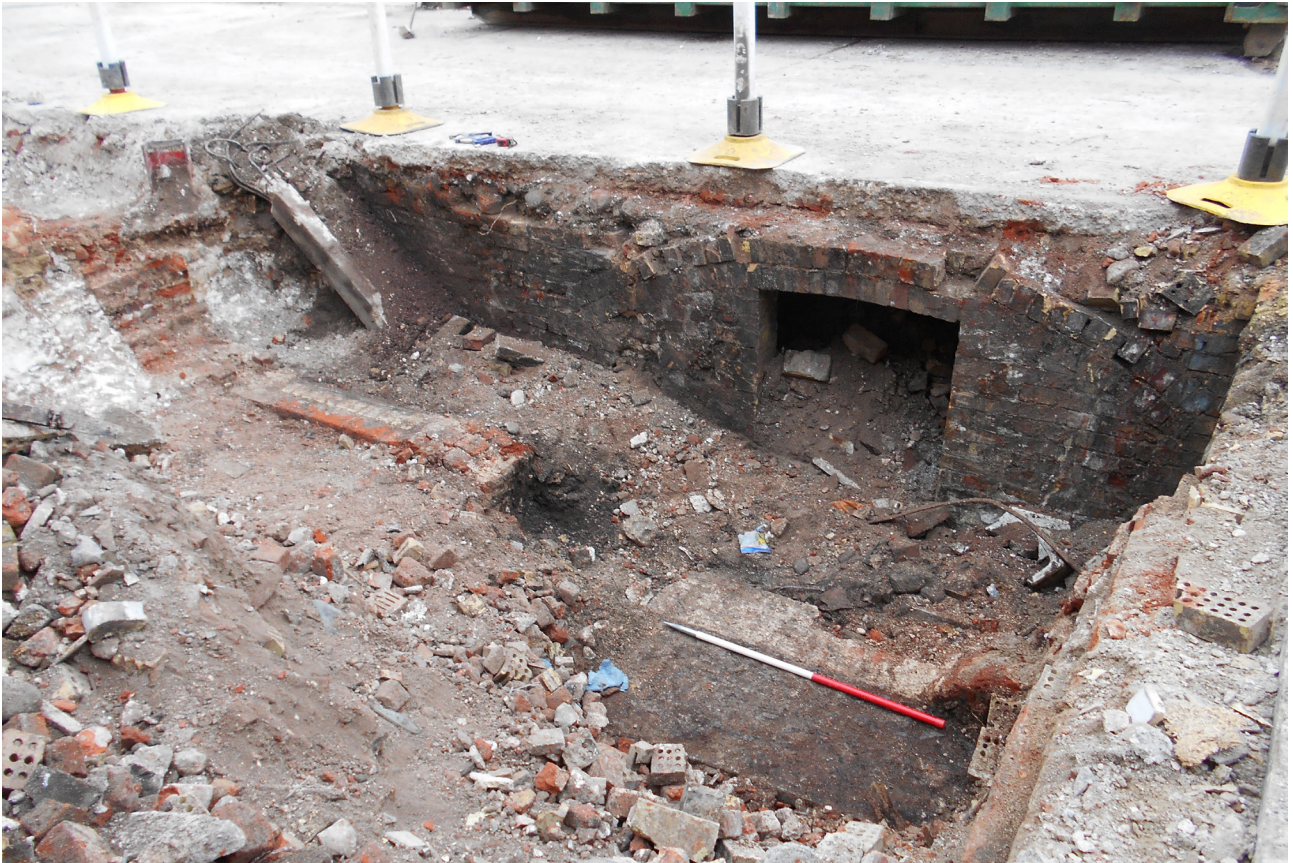
ILLUS 3 NE facing view of Trench 2

Trench 2 contained the remains of a cellar (Illus 3-5). The exposed parts of this cellar measured at least 7.5m north-south (continuing beyond the limit of excavation at both ends of the trench), by 2.5m+ wide at the northern end of the trench, stepping in to c.1.5m in width at the southern end of the trench. The fill of the cellar continued to 2.35m beneath the present ground-surface. This cellar corresponds to a building in the north-eastern part of the site shown on maps from at least the 1887 First Edition OS Map, up to the 1971 OS Map (demolished by the 1982 OS Map). This is supported by the brick samples

The exposed stratigraphy backfilling the cellar comprised a concrete surface (201) 0.15m deep; over a red brown sandy silt made ground and rubble deposit (202) 0.2m deep; over an orange brown sandy silt rubble (204) 1.2m deep; over a dark brown grey sandy silt and rubble deposit (211) 0.8m deep (Illus 3).

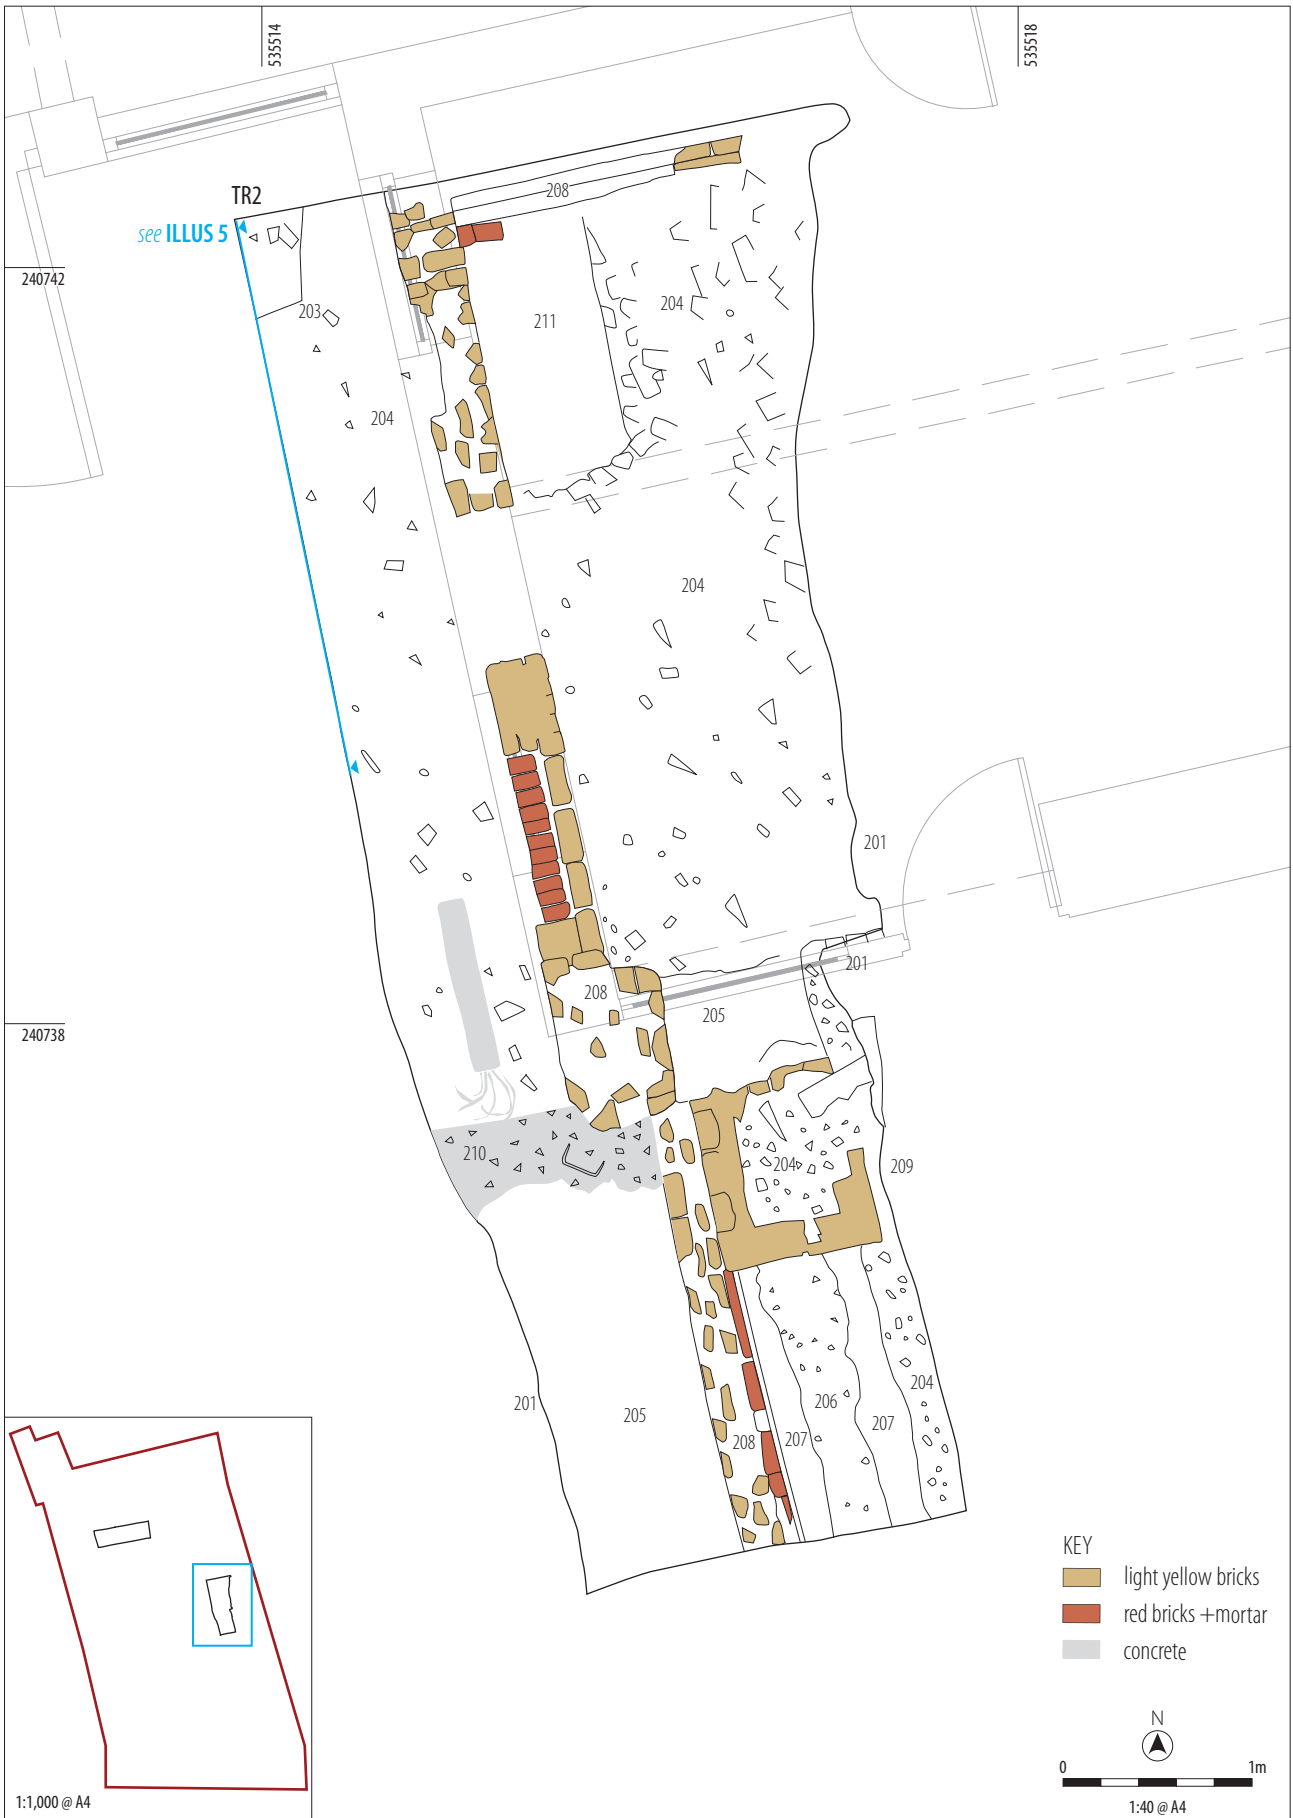
ILLUS 4 Plan of Trench 2

At the northern end of the trench, a concrete slab (211) lay against the wall, covering a void. There was also a manhole [209], 1m long and 0.85m wide and made up of evenly coursed red bricks, and 2 concrete footings (206) and (210), 0.45m wide and 0.5m wide respectively. Given their position, the manhole and concrete footings may have been associated with a modern service to the buildings.
