**9-13 Baldock Street, Royston
Cultural Heritage Assessment**

Prepared for Buzz Estates Ltd

Headland Archaeology carried out a cultural heritage assessment (comprising desk-based assessment and building assessment) of 9-13 Baldock Street, Royston, Hertfordshire. The purpose of this assessment was to inform a planning application for redevelopment of the site.

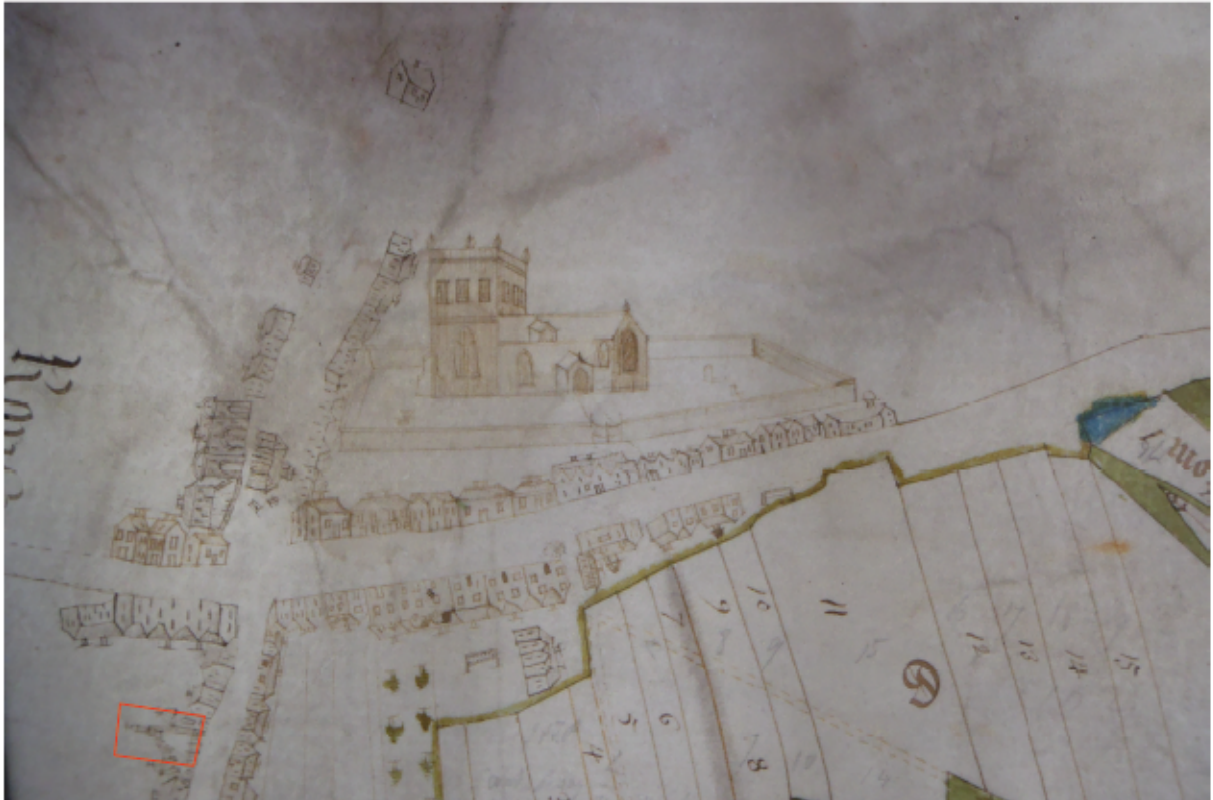
Figure 4: 1725 Map of Royston, approximate approximate location of PDA highlighted

The earliest map available for the study area is a manuscript map of 1725. This map (Figure 4) shows buildings lining the roads forming the crossroads in the centre of Royston. A group of buildings is shown in the location of the PDA but it is unclear if they are the same buildings as currently standing.

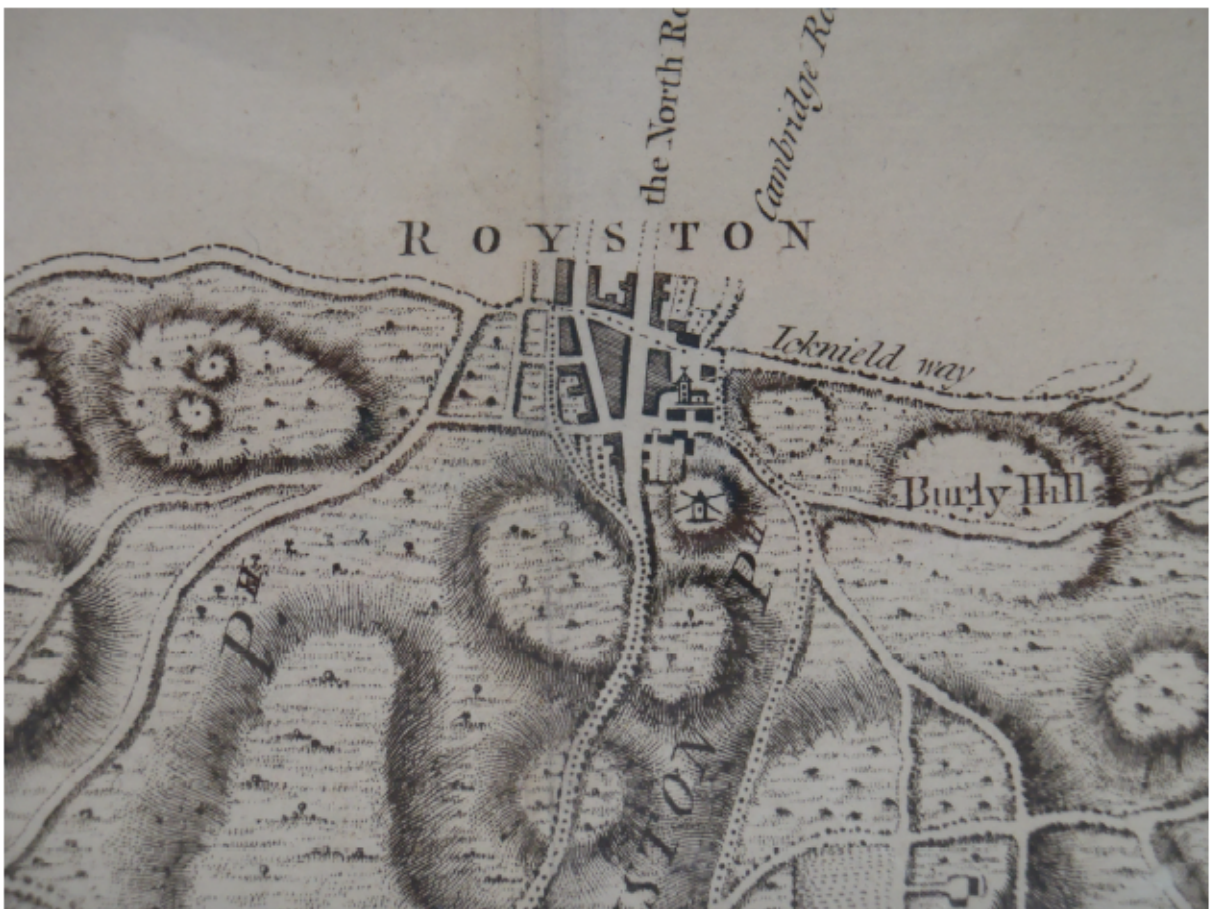
Figure 5: 1766 Drury and Andrews Map

The town of Royston is shown on the 1766 map by Drury and Andrews (Figure 5), again this shows buildings lining the crossroads, some further detail of the road network is shown and buildings are shown in the area of the PDA, but again it is unclear if these are the same buildings. Bryant's Map of 1820 shows no additional detail (Figure 6), nor does the 1851 Tithe Map (Figure 7) as the PDA was within the built up area.

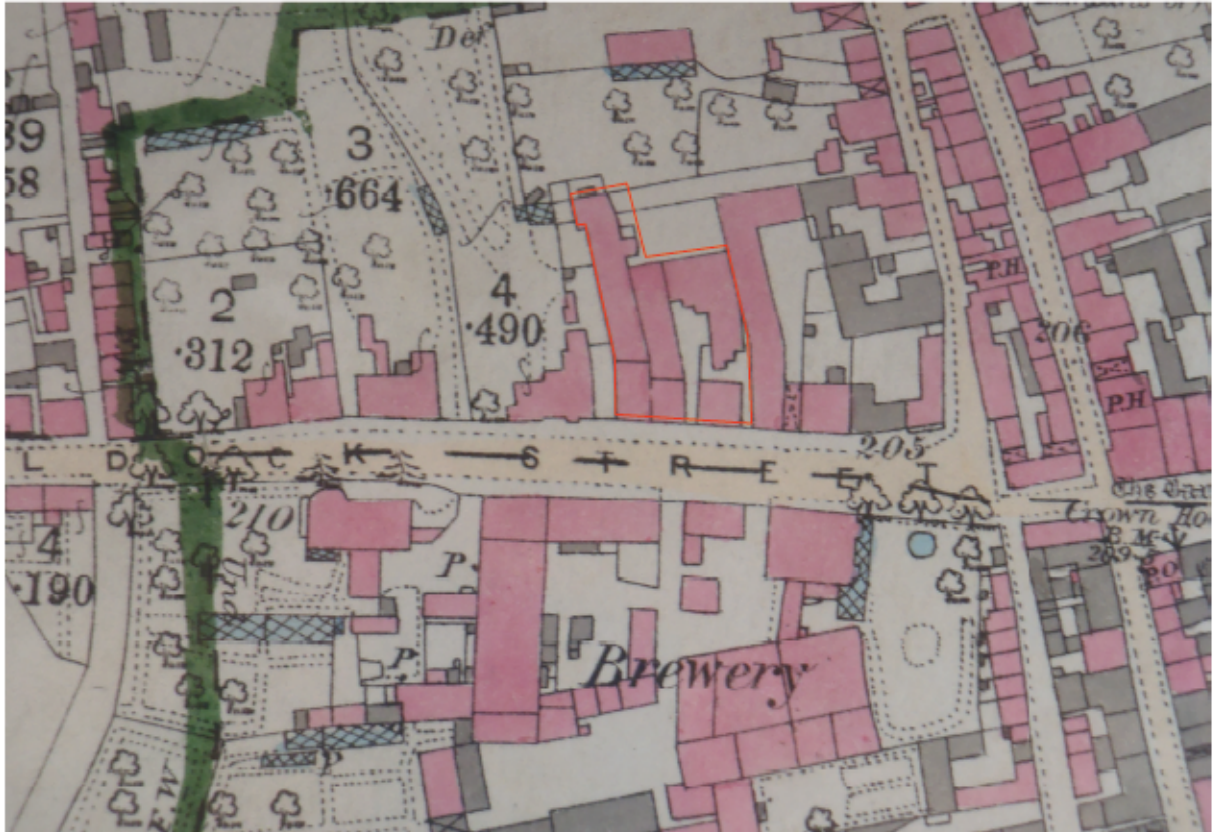
Figure 8: 1st Edition Ordnance Survey 1887

The first map to show the PDA in detail is the 1887 1st Edition Ordnance Survey map (Figure 8). The individual building plots are shown, with a single square building (9 Baldock Street) shown with a small alleyway between it and 7 Baldock Street to the east and a small yard to the rear – partially intruded on by a large, irregular shaped building to the north. An alley leading to a yard is shown between 9 and 11 Baldock Street. 11 Baldock Street is shown as two bays – the rearmost being much longer than that fronting the street. 13 Baldock Street is likewise shown as two bays – the front bay extending further north than that of 11 Baldock Street and the rearmost extending well beyond the rear bay of 11 Baldock Street and having projecting bays to the east and west as well as an additional small

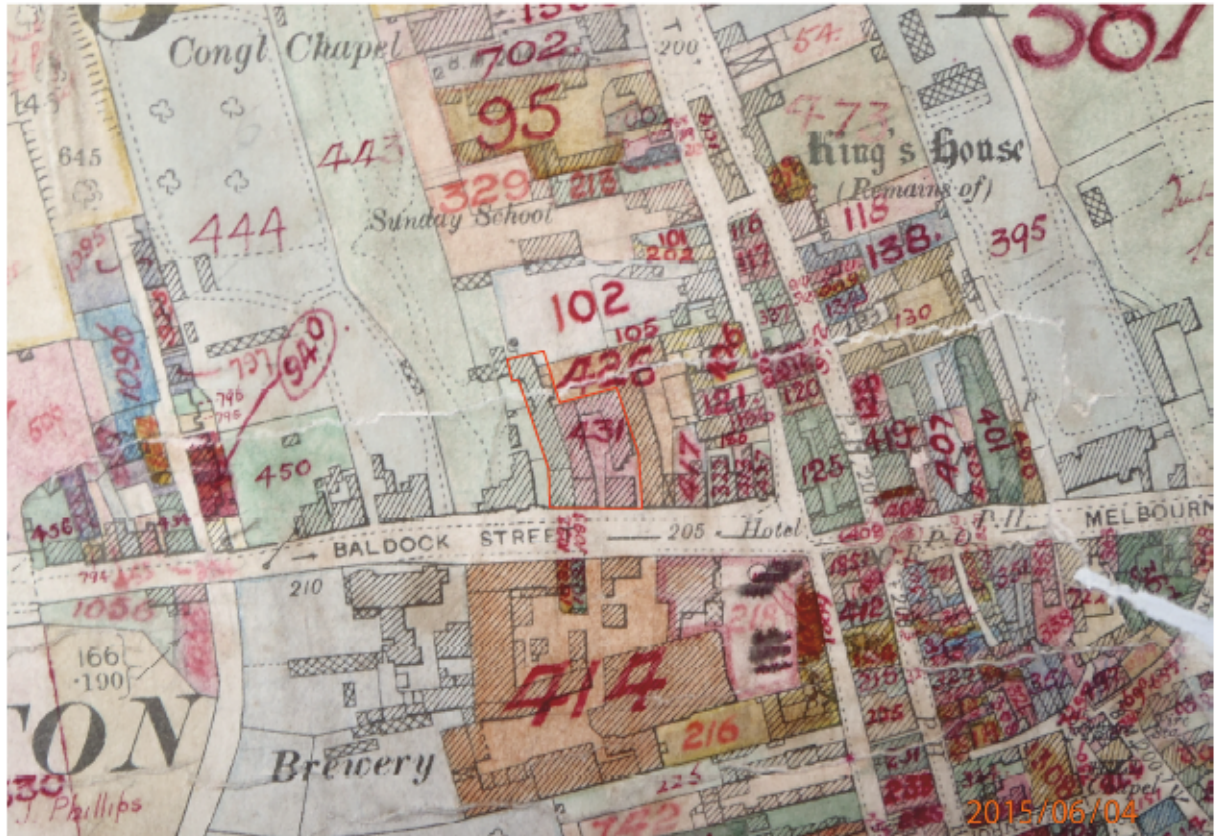
Figure 10: Special Edition Ordnance Survey 1912

There are no changes between 1898 and 1912, although the special edition Ordnance Survey (Figure 10) has been later re-coloured and numbered. It is unclear what these colours and numbers refer to but the different colouring given to 9-11 Baldock Street and 13 Baldock Street may indicate different ownership or uses. The buildings are again shown as unchanged in 1923 (Figure 11) and 1937 (Figure 12).

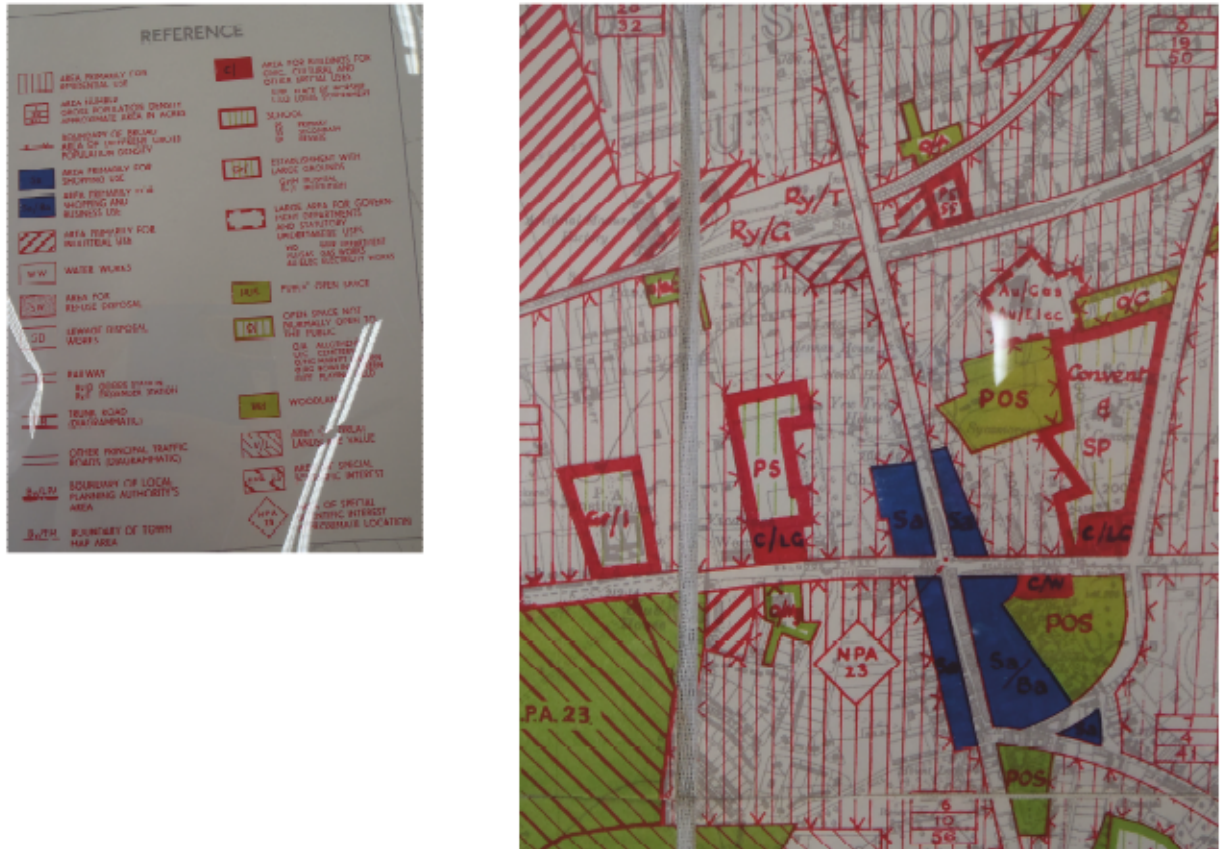
Figure 13: 1958 Town Map Royston and key

A town plan from 1958 indicates that there were plans to convert 11-13 Baldock Street into a school and other local government use (Figure 13). By 1971 (Figure 14) the Brewery to the south of Baldock Street was in use as a “sweets factory” and a number of the former brewery buildings had been demolished. The PDA is now labelled with the street numbers. The yard to the rear of 9 Baldock Street no longer has the rear l-shaped range of 11 Baldock Street jutting into it but is shown as smaller. A division is shown northwest-southeast across the yard/alley between 9 and 11 Baldock Street. The front bay of 11 Baldock Street is now shown as two separate bays with the rear being open to the east. Behind this, the long rear bay of 11 Baldock Street has been subdivided into four east-west bays, the remainder of this long range now being part of the l-shaped range that extends behind 9 Baldock Street. 13 Baldock Street is shown as unchanged from the previous maps.

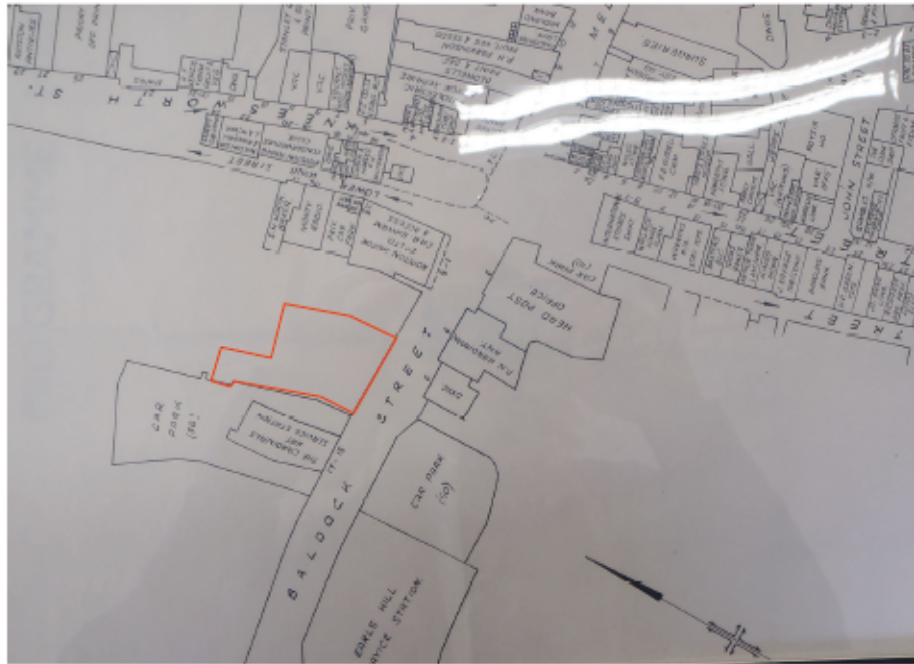
Figure 15: 1972 Goad Map – PDA highlighted

The PDA is not shown on the 1972 Goad Map (Figure 15) indicating that the buildings were not insured (although the reason for this is unknown it may be that they were not in use or that the owners felt that insurance was too expensive). By 1982 (Figure 16), the long eastern bay of the rear l-shaped range had been shortened and the rear parts of the frontage bays of 11 and 13 Baldock street had been removed. The frontage bay of 11 Baldock Street had also been incorporated into 13 Baldock Street as no division is shown and the whole frontage is numbered 13, it is possible that this front portion of 13 Baldock Street is a replacement building.

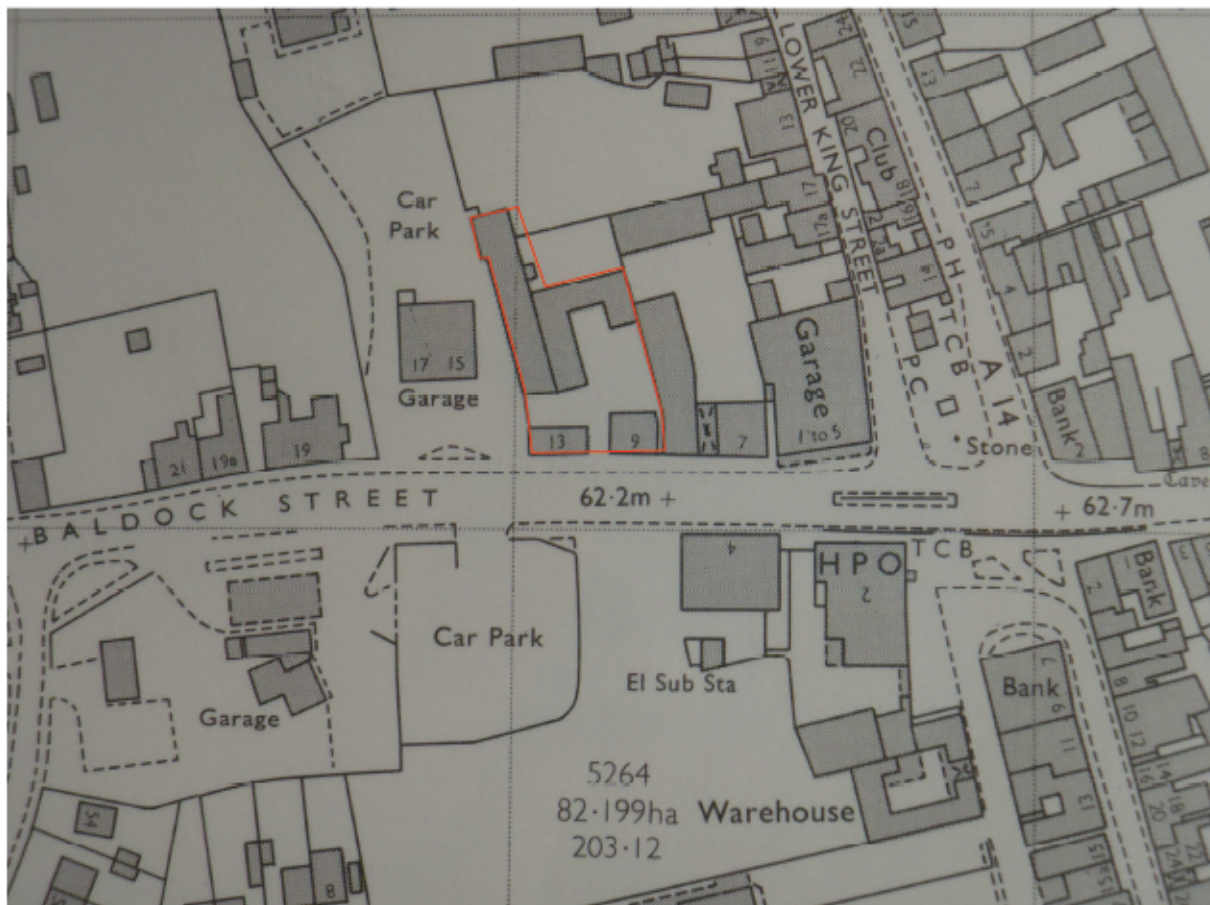
Figure 16: 1982 Ordnance Survey

It is unclear when 11 and 13 Baldock Street became a combined property, but it may have been in the 20th century when the rear ranges became separated from the frontage (Figure 16). For the purposes of this assessment a distinction is made between the surviving historic buildings at the rear (identified by double letter codes AA, BB etc.) and the modern l-shaped replacement building on the frontage (identified by triple letter codes AAA, BBB etc.)

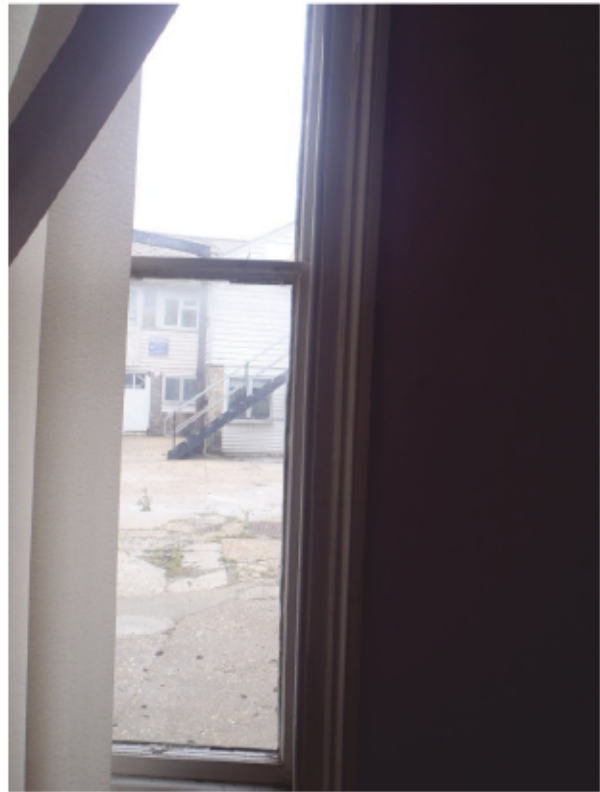
Plate 14

A part glazed timber door towards the rear of the left elevation of the building leads into a small entrance lobby with a door which formerly led into A (this door was locked and no key could be found) and stairs leading up to the first floor flat (Plate 13). A large sash window in the rear elevation is the only feature of architectural interest in this room (Plate 14).

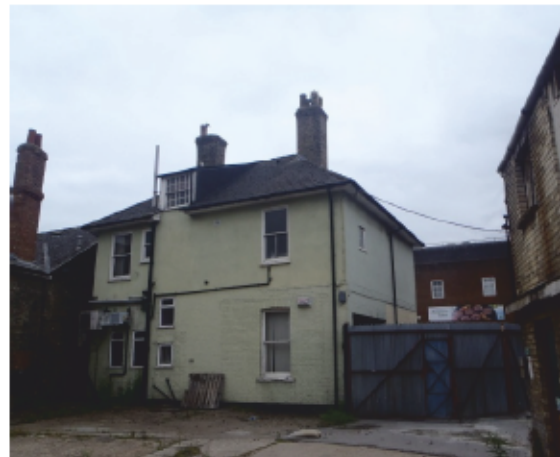
Plate 16

The upper floor of the left elevation and part of the rear elevation appear to be rendered (Plate 16), the remainder of the exterior is painted brick as noted in the listed building description.

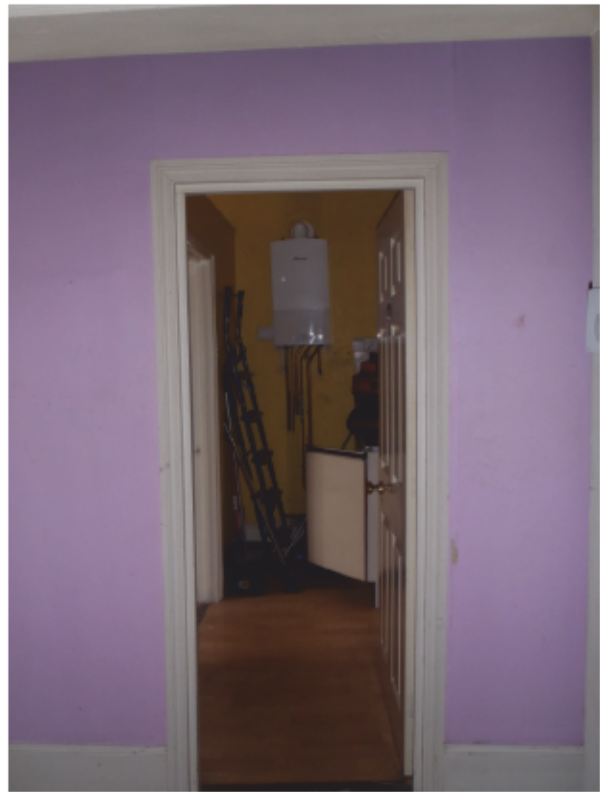
Plate 18:

The rear right of the upper floor is divided into two, accessed through a six panelled door (probably a modern replacement) in a simple architrave frame. The front portion contains floor mounted units and a sink as well a boiler (Plate 18). A partition wall (which does not extend the full height of the room) divides the front from the rear part which is used as a bathroom. A modern six panel door leads through this partition wall. A large sash window with textured glass almost fills the rear elevation (Plate 19). There are no other features of architectural or historic interest in this room.

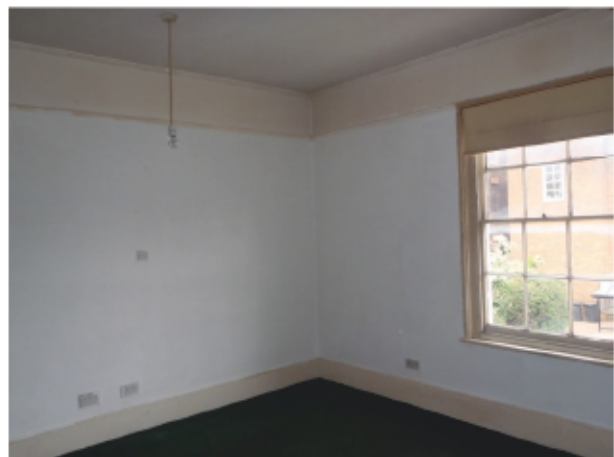
Plate 26:

The front left bay of the upper floor is a large square room with a sash window similar to that in the front right bay (H) (Plate 26). This room also has a picture rail and is accessed through a replacement six panel door in the original frame. No evidence of a chimney breast is apparent (Plate 27) but there is a door in the left side of the rear wall leading through a cupboard to a blocked door in the opposite wall (Plates 28 & 29).

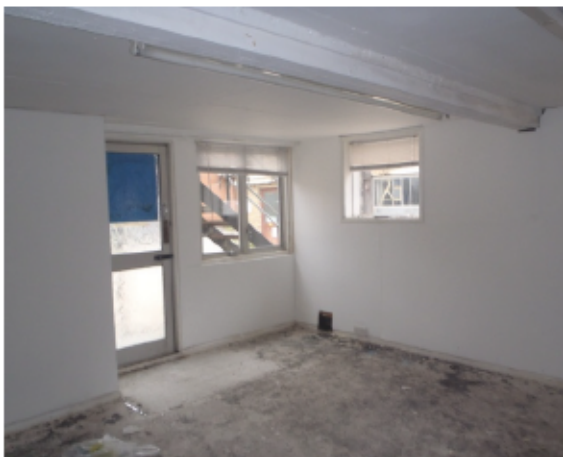
Plate 38:

This corridor leads from HH which is part of the historic section of 13 Baldock Street; it extends from two concrete stairs up from HH along the right hand side of the modern replacement bay to a staircase leading to the upper floor at the front of 11-13 Baldock Street (Plate 72). There is a small square window in the right elevation which is 2 over 2 lights with glazing bars in a timber frame. Forward of this is a modern plywood door leading to the yard (Plate 38). A doorway in the left elevation opposite this door leads into BBB.

into a previously smaller opening (Plate 38). The room is open to the rafters and there is a modern velux skylight window to the right side of the roof (Plate 109). Below and to the rear of this there is a small window near the floor level which has internal metal bars (Plate 110).

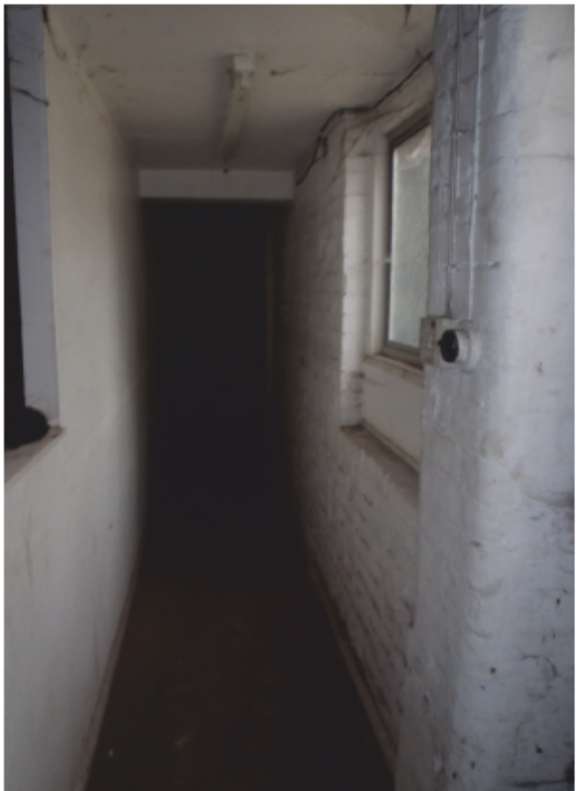
Plate 44:

dividing the corridor from CC is rendered (Plate 44). The front elevation has a metal framed window with textured glass over a tall sill (Plate 45).

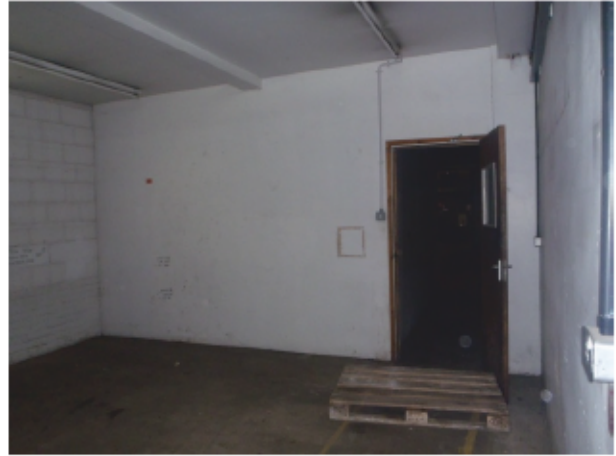
Plate 64

The front wall of HH marks the join between the historic parts of 11-13 Baldock Street in the rear and the modern replacement building in the front. Most of HH however appears to be of modern construction, the front wall is of modern red brick, whilst the front part of the left wall is also of modern red brick (Plate 62) the rear part being a combination of brick to the lower part and concrete blocks above. A wide window of three horizontally sliding panes in a metal frame is close to the ceiling in this elevation (Plate 63). An inserted partition wall divides HH from II which is accessed via a modern fire door with glazed panel (Plate 64).

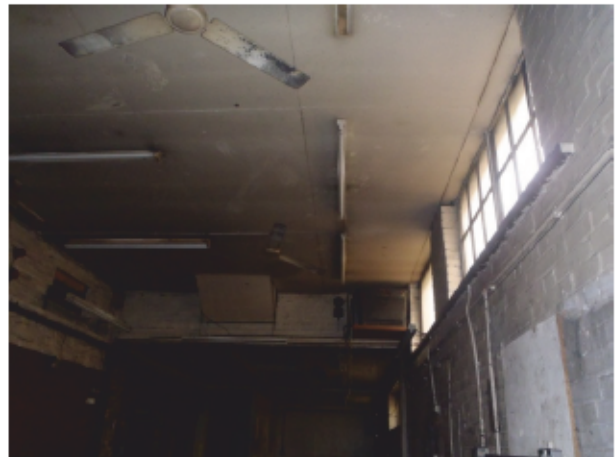
Plate 65

This room is of three long bays from north to south. The left elevation of this room is, like that of HH, a mix of brick and concrete blocks. A window identical to that in HH is close to the ceiling on the left elevation of the front bay (Plate 65). The right front of the front bay is divided by a single thickness partition wall with the door to HH at the south end. A narrow sliding door leads through the right elevation into DD as noted above. A second high level window identical to the first is in the middle bay, a wide sliding door opposite this in the gault brick built right wall leads into CC (Plate 65). A modern plywood door next to this sliding door leads to stairs leading to the upper floor.

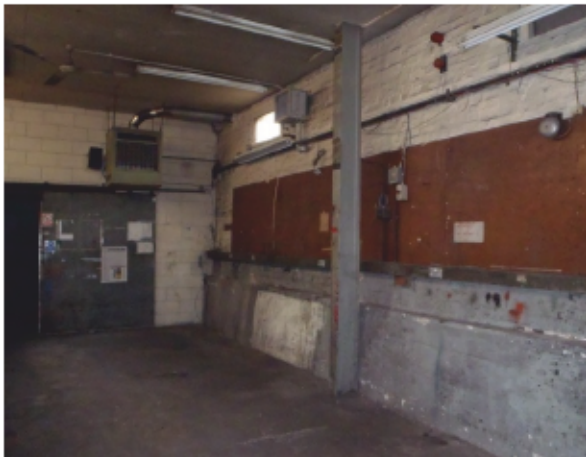
Plate 66

(Plate 66). The right elevation is of concrete with painted brick above and contains a blocked window opening and a window near the ceiling (Plate 67).

The rear/north wall of this bay is of concrete blocks; a large opening with a metal sliding door leads into II (Plate 66).

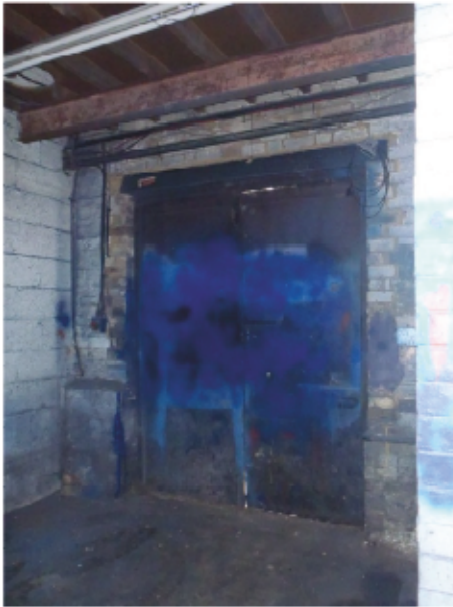
Plate 68

This small room has a concrete rendered left elevation, and a concrete block rear wall (Plate 68). The right elevation is of brick and has a pair of large doors leading to the rear yard (Plate 69). A large sliding door in the rear elevation (Plate 70) leads into KK but it wasn't possible to access KK. The ceiling of II is carried on steel joists (Plate 70), it was not possible to access the roof space of this bay which is shorter than HH and I.

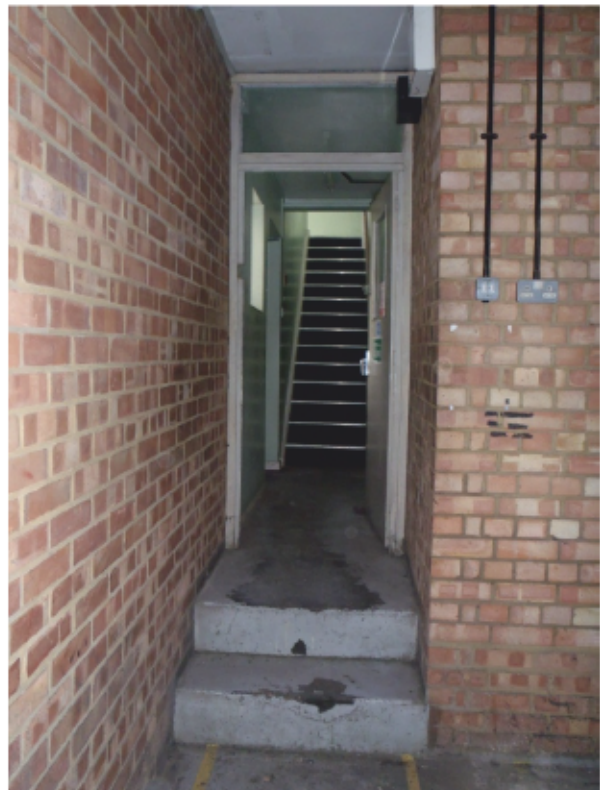
Plate 71

This room could not be accessed for the site visit, an external examination shows that it projects north of the rear boundary of the rear yard and is built of gault brick aligned east west (HH-II all being north-south) (Plate 71). A tall narrow window is visible near the apex of the gable.

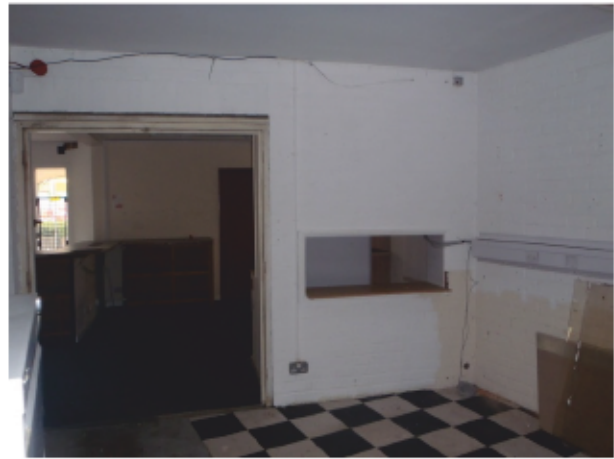
Plate 73

A modern wooden door with safety glass panel leads into this room from AAA, and there are three small square windows of 2 over 2 lights in timber frames with internal metal security bars to the left elevation (Plate 73). The walls are of painted brick and the floor is laid with vinyl tiles.

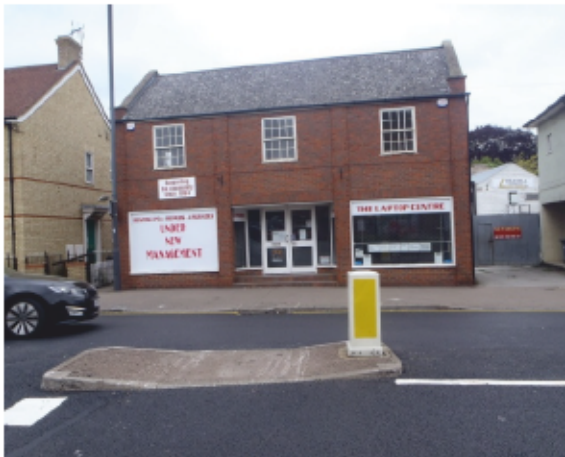
Plate 74

The front elevation has two openings – a counter level opening and a large doorway (Plate 74) – both lead into the front part of the building CCC.

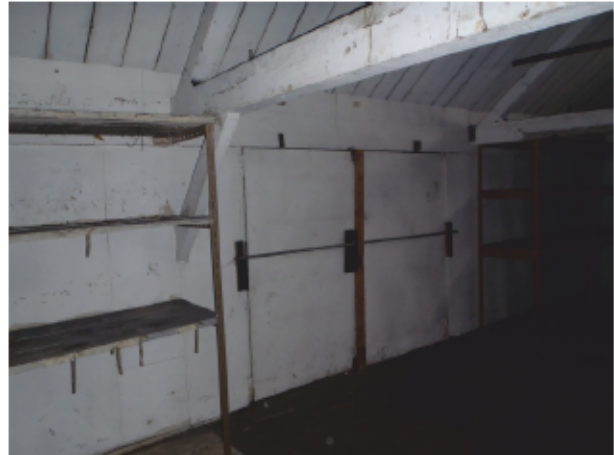
Plate 97

This room is open to the rafters and has exposed timber panels as a roof (Plate 97). The front, right and rear walls are of painted brick and there are metal shelving racks all around the walls. A triangular window in the top of the rear gable wall provides light (Plate 97). The left elevation is panelled with plywood and contains a plywood double door (Plate 98). The room is accessed up steps from WW through an opening which was previously the full height of the gable and now partially blocked by plywood beneath a steel joist (Plate 99)

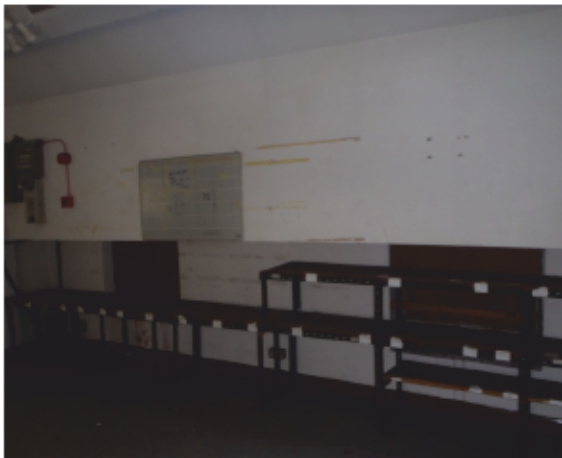
Plate 100

This room has a modern velux skylight to the right side of the roof, and two long windows in metal frames to the left elevation (Plate 100). An opening in the floor towards the rear of this room is surrounded by metal safety fencing and there are two blocked windows close to the floor in the right elevation (Plate 101). A sliding door leads to the stairs to QQ and a modern door leads through the rear gable wall into VV (Plate 102).

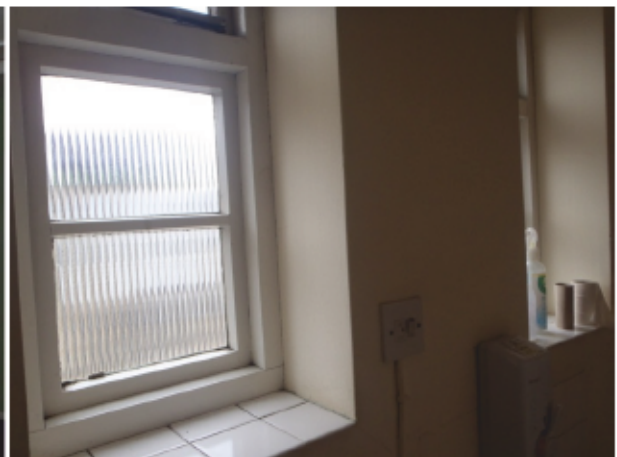
Plate 104

This room lies to the rear right of the building and is accessed via a modern plywood door from DDD. It is a WC and has two small modern windows of textured glass in wooden frames to the rear elevation (Plate 104). No features of architectural or historic interest were observed.

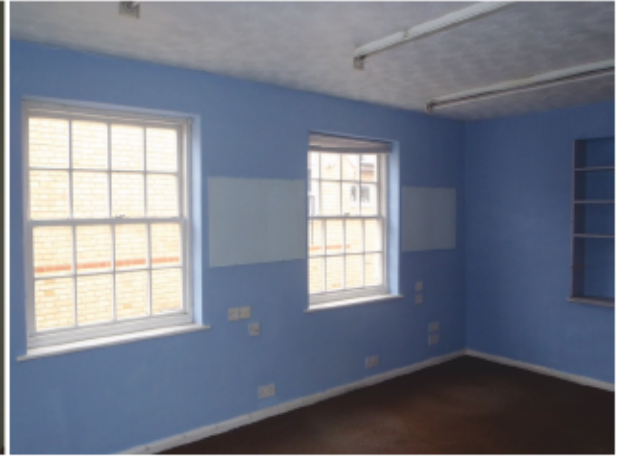
Plate 106

This room forms the left bay of 11-13 Baldock Street; there are modern sash windows to the front elevation (one window) and left elevation (two windows). A blocked opening in the rear elevation is now a book case (Plate 106). No features of architectural or historic interest were observed.

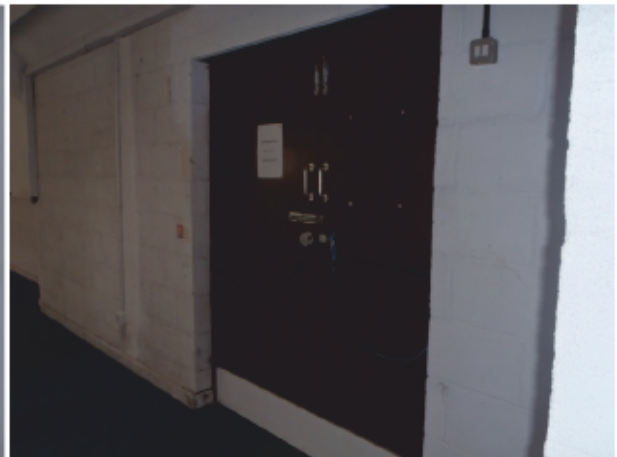
Plate 107

This room is accessed off the landing DDD, the front elevation is of concrete blocks whilst the left wall is plastered (Plate 107). The rear elevation opens onto KKK.

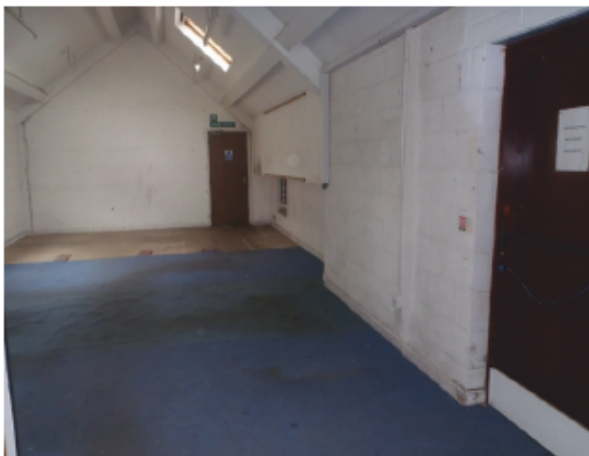
Plate 108

The right elevation of this room is of concrete blocks with a modern double door leading to the exterior yard (Plate 108). Externally it can be seen that this doorway has been inserted

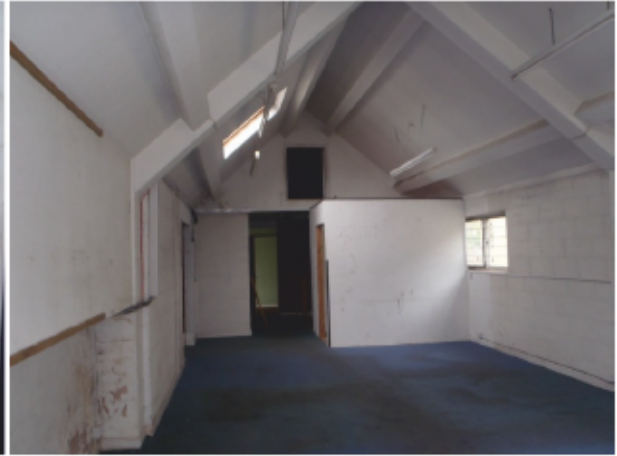
Plate 111

The left elevation is also of concrete blocks and contains two long windows in metal frames, one of which is partially cut off by an inserted partition (Plate 111). There is also a blocked opening in the gable of the front elevation (Plate 112). A modern door leads through a partition wall into WW.
