RUSH LANE, MARKET DRAYTON, SHROPSHIRE

ARCHAEOLOGICAL EVALUATION

commissioned by CgMs

August 2016

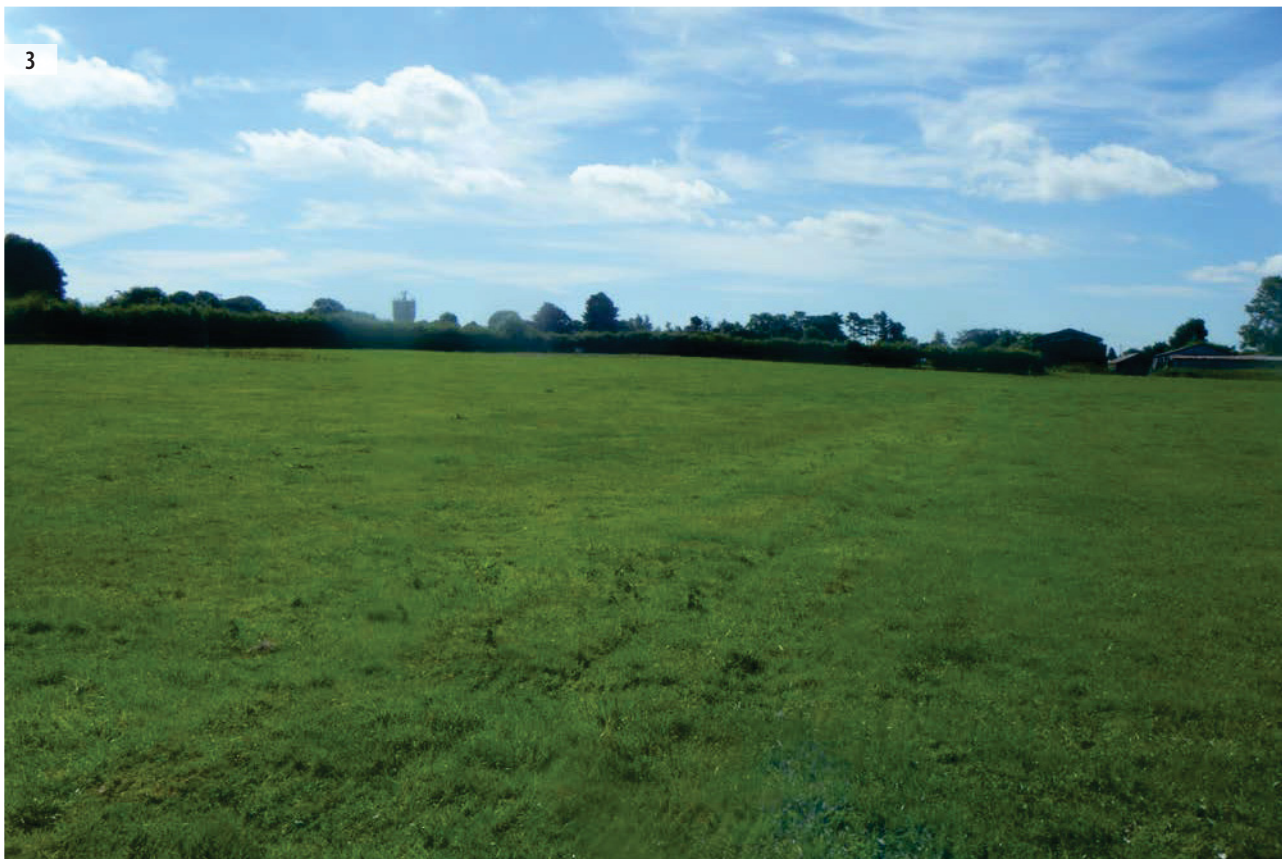
ILLUS 3 General shot of north field looking south **ILLUS 4** General shot of east field looking south-east **ILLUS 5** General shot of west field looking north

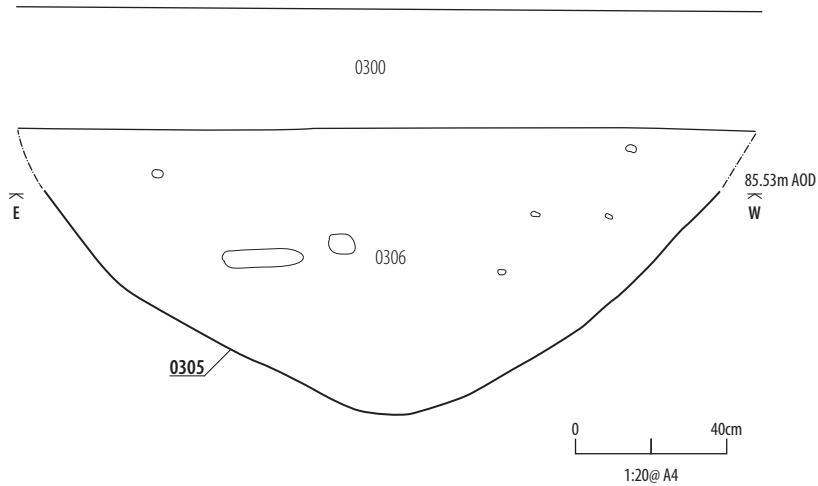
ILLUS 6 North facing section of ditch [0305]

In Trench 3 two linear ditches were encountered, respecting north to south alignment. Ditch [0305] was 1.8m wide and 0.50m in depth. Fragments of ceramic building material and coke were recovered. Ditch [0307] measured 1.5m wide and 0.43m in depth. Both features contained homogenous deposition (Illus 7).

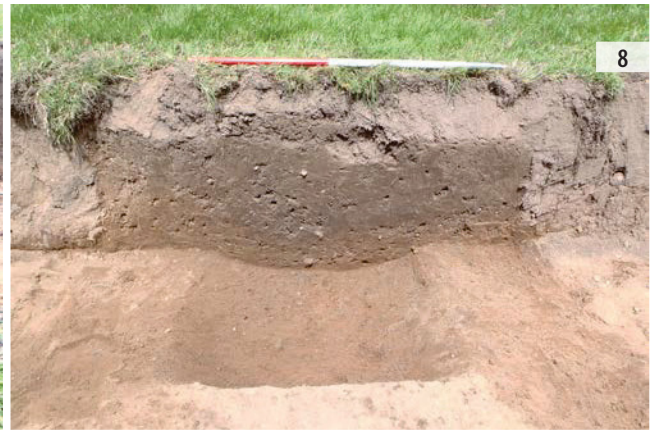
ILLUS 8 South facing section of ditch [0503]

Ditch [0503] was approximately 1.1m wide and 0.50m in depth (Illus 8). It contained a single humic backfill with base of bowl and wine glass bottle dated to the late 18th century recovered. Ditch [0203] was recorded in plan and remained unexcavated. It measured 1.6m in width (Illus 2).

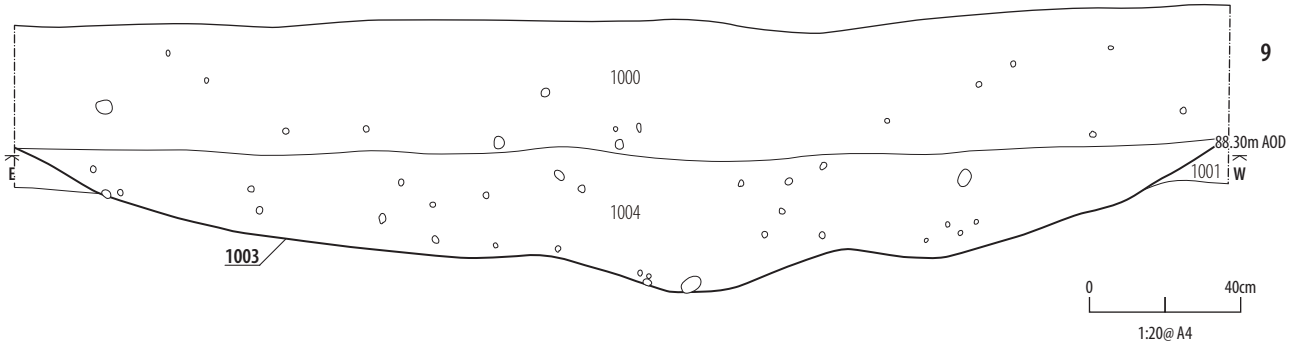
ILLUS 9 North facing section of ditch [1003]

In Trench 10, linear ditch [1003] was encountered, aligned north to south, measuring 1.62m wide and 0.34m in depth (Illus 9). It contained a single medium grey brown sandy silt deposit with a few abraded sherds of pottery and ceramic building material dated between 17th – 18th centuries.
