**Part Lane, Riseley, Reading**

**Archaeological Watching Brief**

*Prepared on behalf of Eight20*

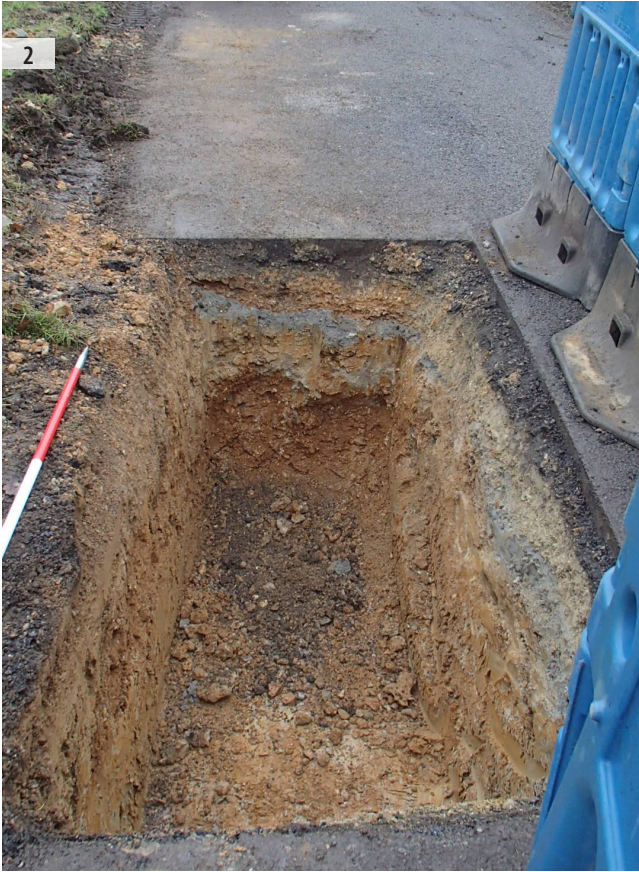
Fifteen drill reception trenches were constructed to facilitate the directional drilling of the pipeline. These were irregularly spaced along the extent of Part Lane (Illus. 1; Illus. 2). The overburden layer was consistent across the trenches and comprised tarmac and an underlying layer of gravel which was 0.10m-0.25m thick extending up to 0.25m below present ground level (bpgl). This overlay various natural deposits of gravels and clays which were found from 0.10m to 1.20m bpgl (see Appendix 1). Modern services were identified in Trenches (Tr) 01, 03, 12 and 13. The reception trenches varied in size and measured between 0.70m-2.90m in length, 0.5m-1.50m in width and 1.05m-1.30m in depth (Appendix 1).

TR05			
L (m)	W (m)	Min. D (m)	Max. D (m)
2.3m	1.3m	1.2m	1.2m
Context	Description	*D BPGL (m)	
0501	Overburden: tarmac and associated gravel road underlay.	0.25m	
0502	Natural: Light brown grey sandy clay with lenses of medium yellow red brown clay with patches of iron pan inclusions and gravel and sand.	0.25m-1.2m+	
Summary			
Reception Trench TR05. No archaeology was identified in TR05.

**ILLUS 2** General shot of reception Trench 5, looking south-west  
**ILLUS 3** North-west facing section of Test Pit 15

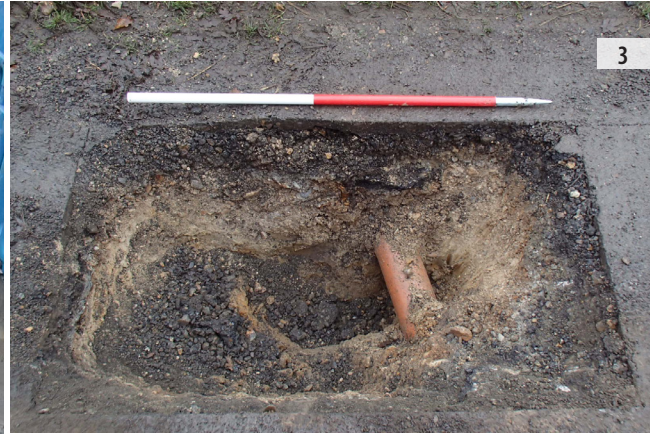
Six test pits were excavated at irregular intervals along the extent of Part Lane (Illus. 1; Illus. 3). They were opened to locate and therefore avoid any underground services. These were similar in form to the reception trenches but smaller in size. Tarmac and an underlying layer of gravel was found between 0.10m-0.25m bpgl. This overlay a modern backfilled layer and the services themselves were found between 0.25m-0.89m bpgl (see Appendix 1). The services were cut into the natural whitish gravel or a light clay (depending on the pit location) which were located between 0.89m and 0.92m bpgl. The test pits varied in size and measured between 1.30m-3.30m in length, 0.61m-1.30m in width and 0.70m-0.92m in depth (Illus. 3) (see Appendix 1).

TP015			
L (m)	W (m)	Min. D (m)	Max. D (m)
1.3m	0.8m	0.48m	0.71m
Context	Description	*D BPGL (m)	
1501	Overburden: tarmac and associated gravel road underlay.	0.25m	
1502	Fill of modern service trench: dark yellow sand and gravels.	0.25m-0.72m	
1503	Cut of modern service trench	0.71m	
1504	Natural: light whitish yellow grave and sand with iron pan flecking over light to medium yellow clay with light reddish-brown patches with frequent small rounded pebbles.	0.71m+	
Summary			
Trial Pit TP15. No archaeology was exposed during the excavation of TP15.

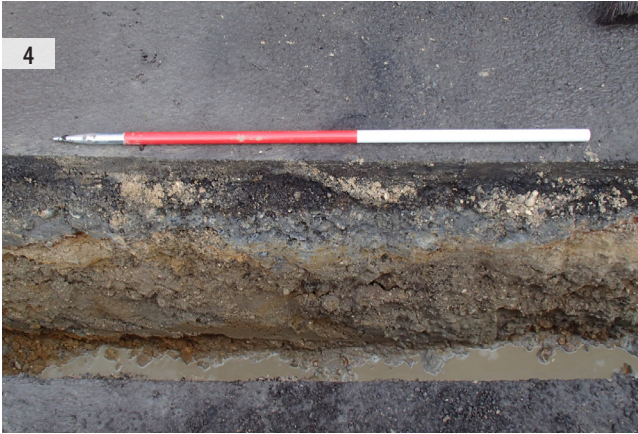
The open cut trenches were excavated in sections where the underlying geology between two reception trenches was considered unsuitable to be drilled. Five open cut trenches were excavated (Illus. 1; Illus. 4; Illus. 5). They were placed between reception trenches Tr01 and Tr02: Tr01A, Tr06 and Tr07: Tr06A, Tp3 and Tr09:Tr08a, Tr13 and Tr14: Tr13A and Tr14 and Tr21: Tr14A. The open cut trenches were 0.50m in average width and between 1.00m-1.20m in depth. They measured 96m, 24m, 53m, 100m, and 41m in length respectively (see Appendix 1). Five modern services (water mains) were found in the open cut trenches between Tr13 and Tr14 and Tr14 to Tr21 (Illus. 4 and 5).

TR01A			
L (m)	W (m)	Min. D (m)	Max. D (m)
96m	0.5m	1m	1.2m
Context	Description	*D BPGL (m)	
0101	Overburden: tarmac and associated gravel road underlay.	0.25m	
0102	Natural: Light whitish yellow to mid reddish yellow mottled brown silty sandy silt alternating with lenses of sandy gravel, yellow sand and light brown grey clay.	0.25m-1.2m+	
0103	Fill of modern electrical service trench: dark grey brown clay sandy silt with stones and old tarmac fragments.	0.25m-0.60m	
0105	Cut of modern electrical service trench	0.60m	
0104	Fill of electrical service trench: light to medium brown yellow grey clay sandy silt with occasional pebbles.	0.25m-0.60m	
0106	Cut of modern electrical service trench	0.60m	
Summary			
Long open trench TR01A connecting reception trench TR01 and TR02. Only two modern services pipes were exposed. No archaeology was exposed in TR01A.

**ILLUS 4** South-west facing section of Open Trench 1A connecting Reception Trench 1 and Reception Trench 2  
**ILLUS 5** General shot of southern section of TR13A, looking north-east

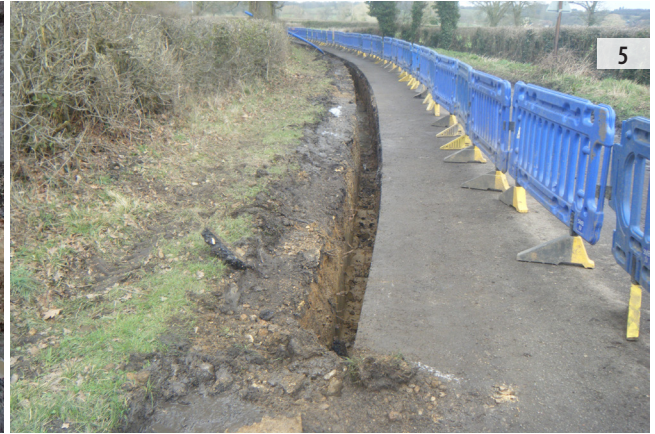
TR013A			
L (m)	W (m)	Min. D (m)	Max. D (m)
100.00m	0.52m	0.98m	1.00m
Context	Description	*D BPGL (m)	
1301	Overburden: Tarmac and associated gravels	0.25m	
1302	Natural: Mid-grey sandy gravel	0.25m-0.35m	
1303	Natural: Blue grey clay	0.35m-0.90m+
